INDIANA UNIVERSITY

ON-SITE REDESIGNED AIR BAG REPORT

CASE NUMBER - IN98-007
LOCATION - TEXAS
VEHICLE - 1998 FORD TAURUS SE
CRASH DATE - December, 1997

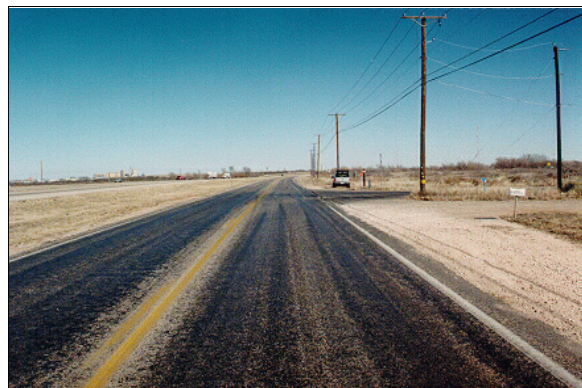
The case vehicle was traveling east in the eastbound lane of a two-lane, undivided, service road to an interstate highway (**Figure 1** and **Figure 11** below), and intended to continue its easterly travel path. Service road dimensions were 7.4 meters (24.3 feet) wide with 0.3 meter (1.0 foot) paved shoulders. The asphalt pavement was traveled and worn, with an estimated dry coefficient of friction of 0.60. Pavement markings for the service roadway included single solid white edge lines on each side of the roadway and a single broken yellow centerline. A single solid yellow line (i.e., no passing for eastbound traffic) was added to the centerline approximately 15.2 meters (50.0 feet) west of the "Tee" intersection. Ambient weather conditions at the time of the crash were: night time, dark and not lighted, clear, no precipitation, and a dry pavement. The roadway was undivided, straight, and level. There were no reported view obstructions, traffic controls, or roadway defects. The case vehicle's driver estimated her pre-impact travel speed at 66-80 km.p.h. (41-50 m.p.h.). The statutory speed limit for this roadway was 89 km.p.h. (55 m.p.h.).

Figure 1: Case vehicle's travel path in eastbound lane approaching "Tee" intersection; Note: eastbound lanes of Interstate are visible on left of photo (case photo #02)

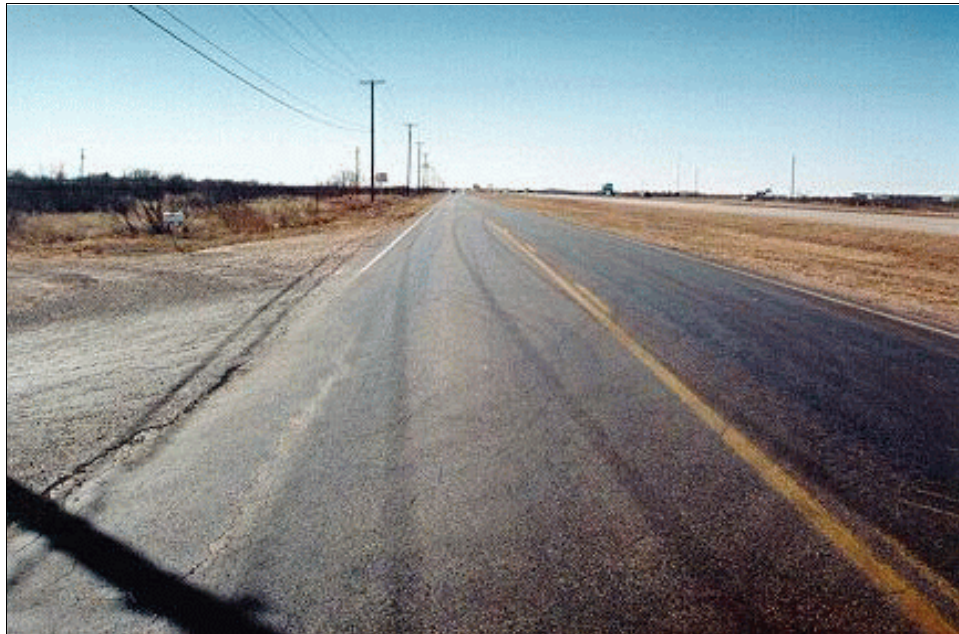
Figure 11: Westward view of case vehicle's eastbound approach path (case photo #09)

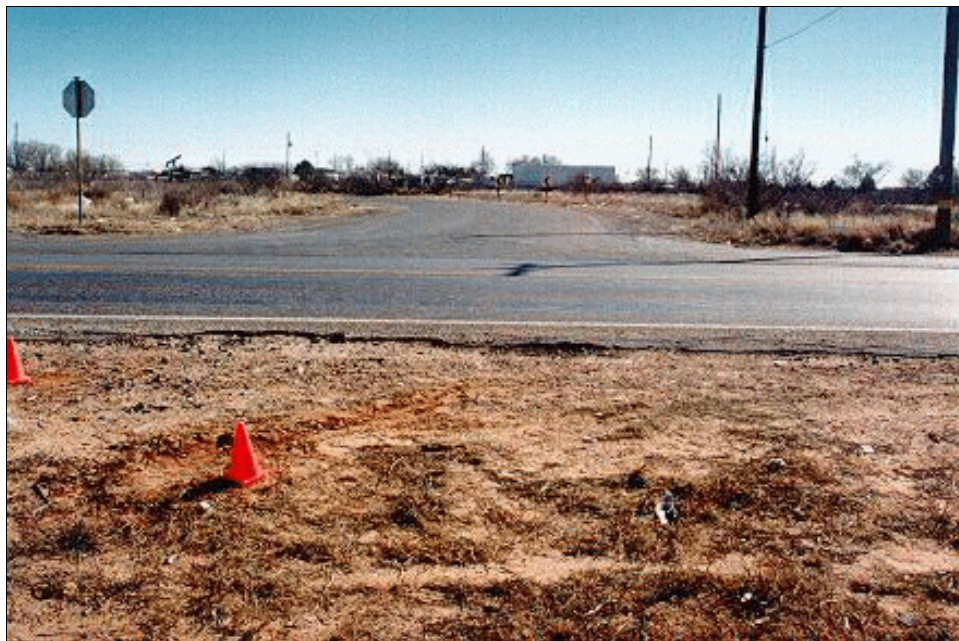
The Oldsmobile was traveling north in the northbound lane of a two-lane, undivided, city street that intersected the service road in a Tee configuration (**Figure 12** below) and intended to make a left turn and travel westward on that service road. The case vehicle's driver steered to the left and braked, attempting to avoid the crash. The crash occurred in the Tee intersection of the two roadways.

Figure 12: Southward view of Oldsmobile's northerly approach path, taken from north of case vehicle's final rest position (case photo #15)

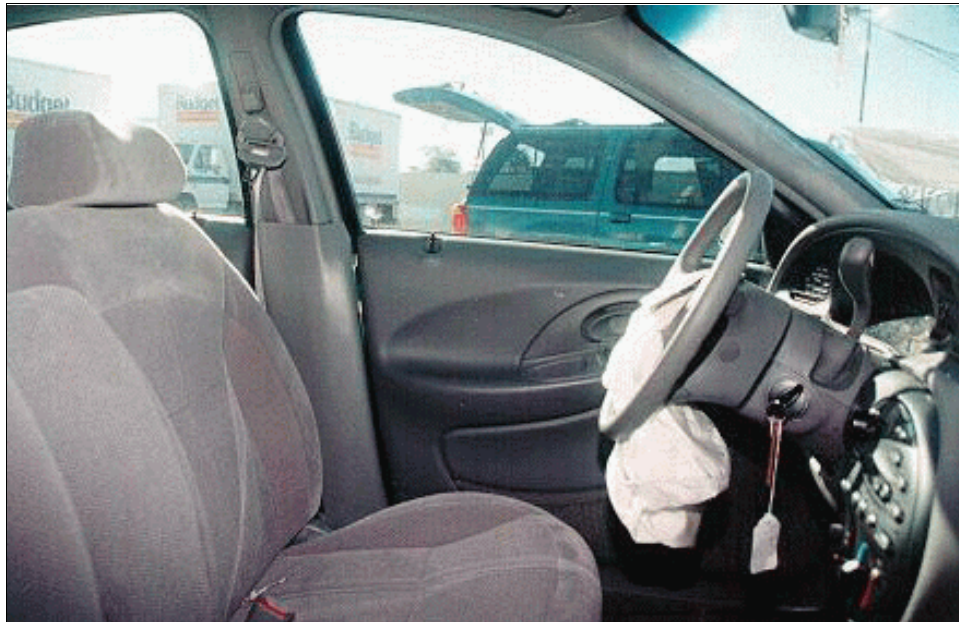
Figure 13: Case vehicle's driver seating area; Note: three-point, lap-and-shoulder, safety belt system (case photo #37)
