SCHOOL BUS CRASH

VERIDIAN CASE NO. CA98-040

1994 INTERNATIONAL AMTRAN SCHOOL BUS 1995 INTERNATIONAL AMTRAN SCHOOL BUS

CRASH DATE - JULY 1998

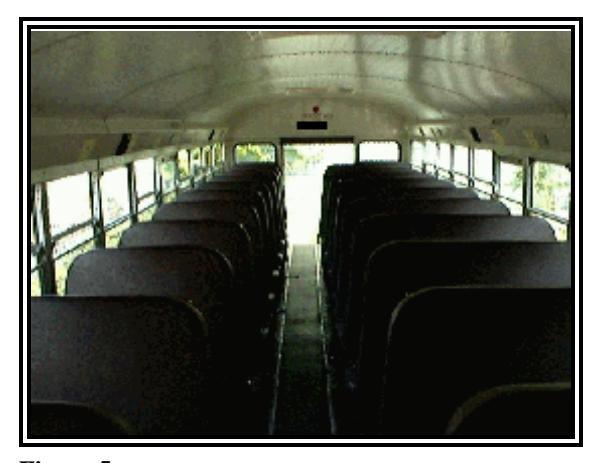
The school buses had a 54 passenger seating capacity. Vehicle #1 was transporting 39 children, 2 staff members, and 6 teen age counselors for a total of 47 passengers. Vehicle #2 was transporting 45 children, 2 staff members, 1 parent chaperon, and 5 teen age counselors for a total of 53 passengers. There were 11 seat rows in each bus with left side seats having three designated seating positions and the right side having two designated seating positions (refer to **Figure 5**). The last row on the left side of the bus had only two designated seating positions.

Figure 5 View of the interior of Vehicle #1 looking from the front to the back

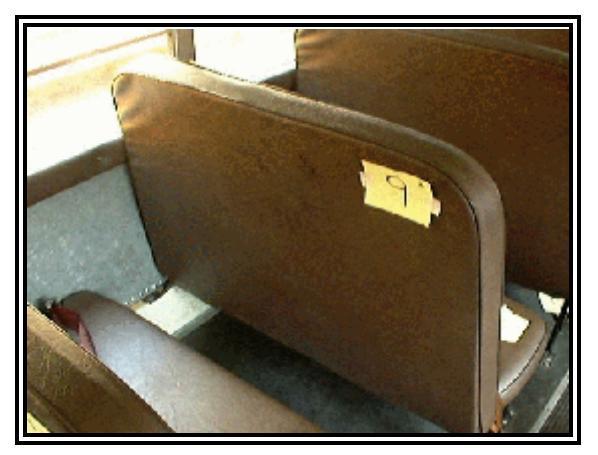
The high back seat designed measured 74.9 cm (29.5") above the seat cushion. The leading edge of the seat cushion was 39.4 cm (15.5") above the floor while the rear edge was 33.0 cm (13.0") above the floor (refer to **Figure 6**). The lateral dimension of the seat cushion was 112.4 cm (44.25") on the left side and 76.2 cm (30.0") on the right. The lateral width of the bus measured 229.2 cm (90.25") and the rubberized surface of the walk aisle measured 34.3 cm (13.5") wide.

Figure 6 View of the seat profile, row 9, Vehicle #2

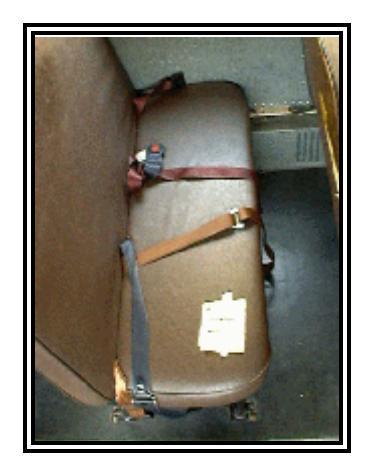
Each seat position was equipped with a color coded lap belt. The left side rows had a red belt in the outboard seat position, a blue belt in the center seat position, and a brown belt in the inboard (aisle) position. The right side rows had a blue lap belt in the outboard seat position and a brown belt in the inboard (aisle) seat position (refer to **Figures 7-8**).

Figure 7 View of lap belts on left side of bus

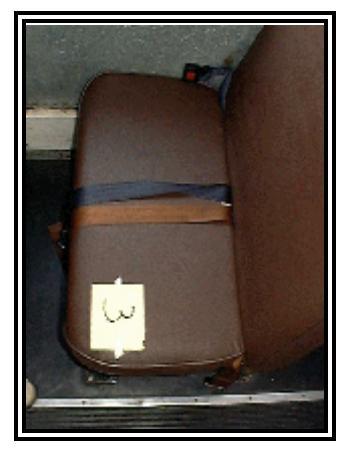
Figure 8 View of lap belts on right side of bus
