U.S. Department
of Transportation

National Highway
Traffic Safety
Administration

Analysis of Electronic Control Unit and Accelerator Pedal Mechanism Components Damaged During EMC Testing

February 2011

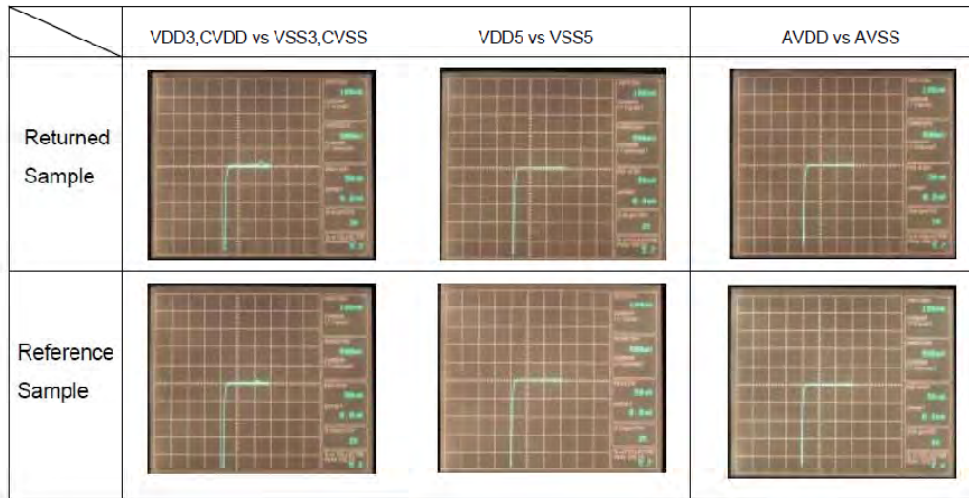
(2) I – V characteristic check : No abnormality was observed

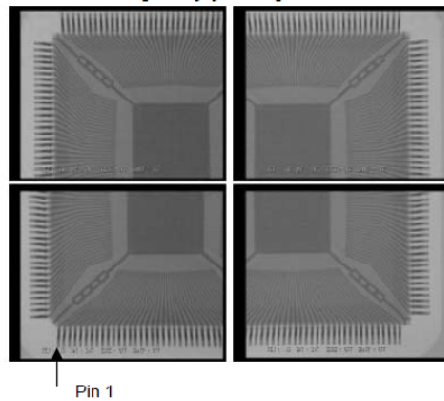
[X ray photo]

(3) X-Ray Analysis : No abnormality was observed

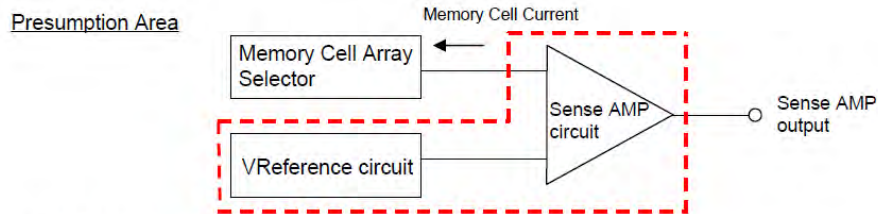
(6) Presumption of Defective area

The supplier is presuming that there will be defective point at the circuit relating FLASH reading in FLASH macro area .
 So they are going to do further analysis in this area .

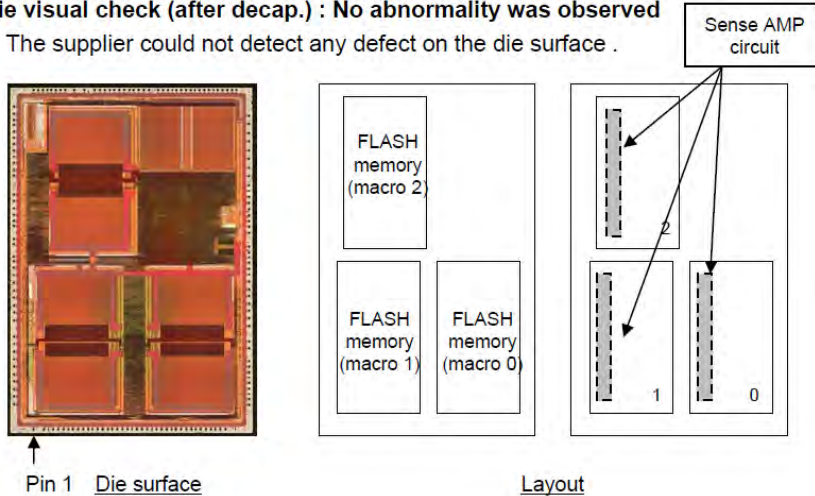
(1) Die visual check (after decap.) : No abnormality was observed

The supplier could not detect any defect on the die surface .

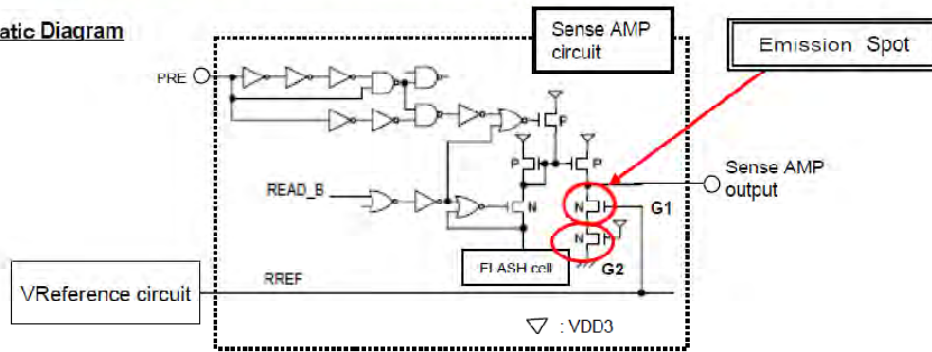
Schematic Diagram

(3) TEM check : Abnormality was observed

The supplier performed TEM analysis at the above emission point (N-ch Transistor) , and confirmed the abnormality (delamination & Void) .

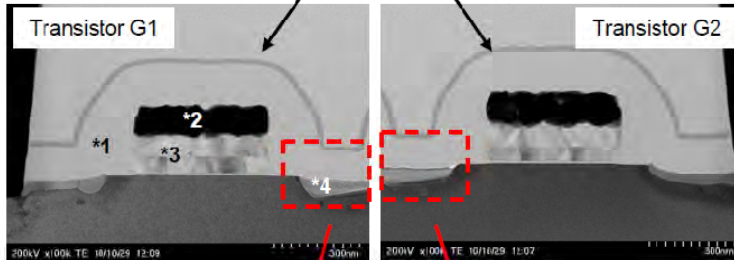
[Returned Sample]

- *1 : Interlayer insulator
- *2 : Gate silicide (WSi)
- *3 : Gate electrode (Poly Si)
- *4 : Silicide (TiSi)

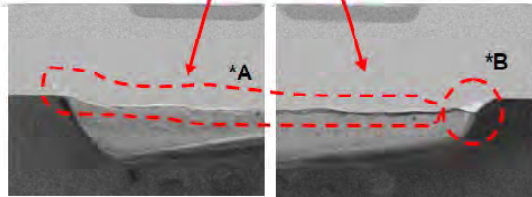
***A : Delamination between Silicide and Interlayer insulator**
***B : Void (Ti-ion was moved by heat)**

Above physical analysis revealed that the resistive impedance between G1 drain and G2 source goes up and it introduced malfunction of FLASH memory reading at high frequency .

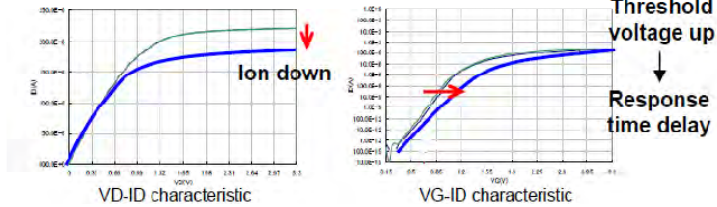
[Assumption]

The supplier assumed that the electrical characteristics of this transistor should be changed , for example , Ion current should be smaller and threshold voltage should be higher than normal .

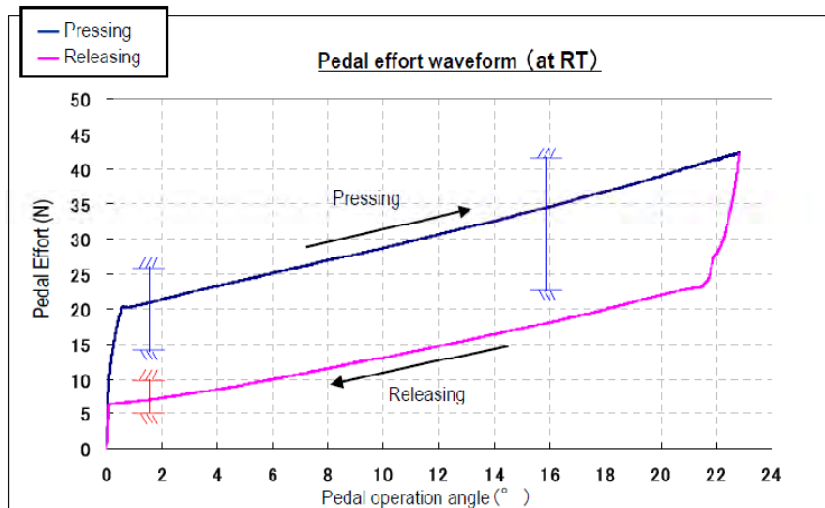
5) Pedal effort waveform

- We cannot find any sticks in the pedal opening angle.
- We cannot find any abnormalities in the pedal effort waveform.
- We cannot find any symptoms that lead to a defect.

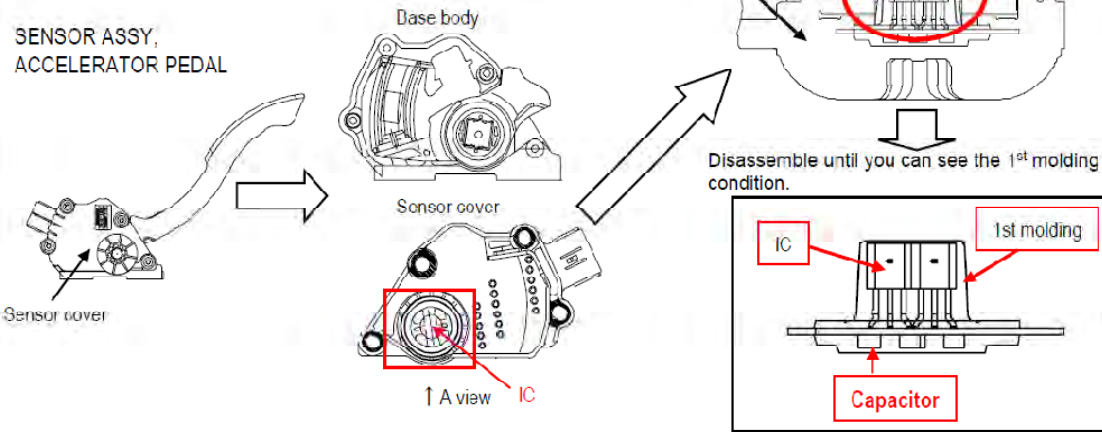
SENSOR ASSY,
ACCELERATOR PEDAL

- ① Disassembly check
(Disassemble the part until you can see the 1st molding condition)

- ② X ray check for the 1st molding condition.
The wire bonding was broken.

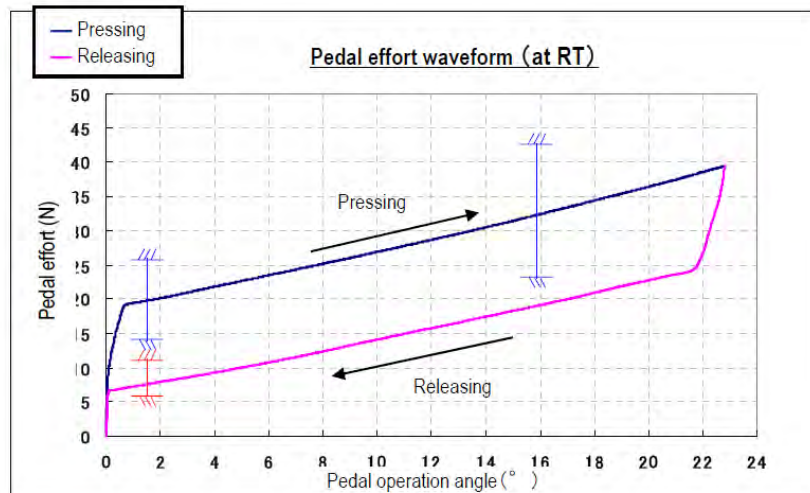
5) Pedal effort waveform

- We cannot find any sticks in the pedal opening angle.
- We cannot find any abnormalities in the pedal effort waveform.
- We cannot find any symptoms that lead to a defect.

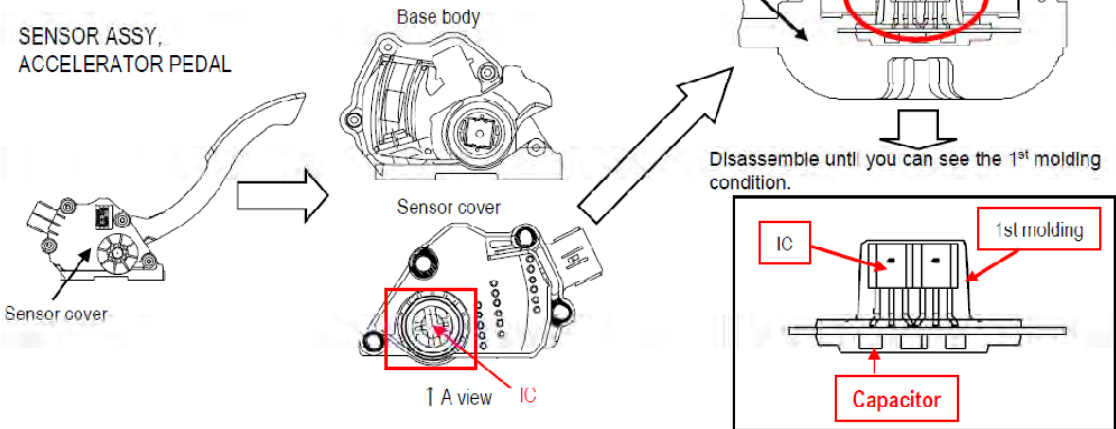
SENSOR ASSY,
ACCELERATOR PEDAL

(Disassemble the part until you can see the 1st molding condition)

② X ray check for the 1st molding condition.

The wire bonding was broken.
