Case 478 : Narrative

Case Vehicle (A): 2003 Ford	Vehicle (B): 2004 Saab	Vehicle (C): 2004 Ford
Type: Taurus SE, 4-door sedan	Type: 9-5 Aero, 4-door sedan	Type: Freestar SE, 4-door minivan
Driver: 38-year-old female	Driver: 42-year-old female	Driver: 67-year-old male
CDC: 01-FDEW-2, 09-LBEE-2	CDC: 12-FYEW-4	CDC: 99-0000-0

This was a fatal crash in which the belt-plus-airbag restrained driver of vehicle (B) died as a result of head, neck, and chest trauma in a severe frontal crash with case vehicle (A).

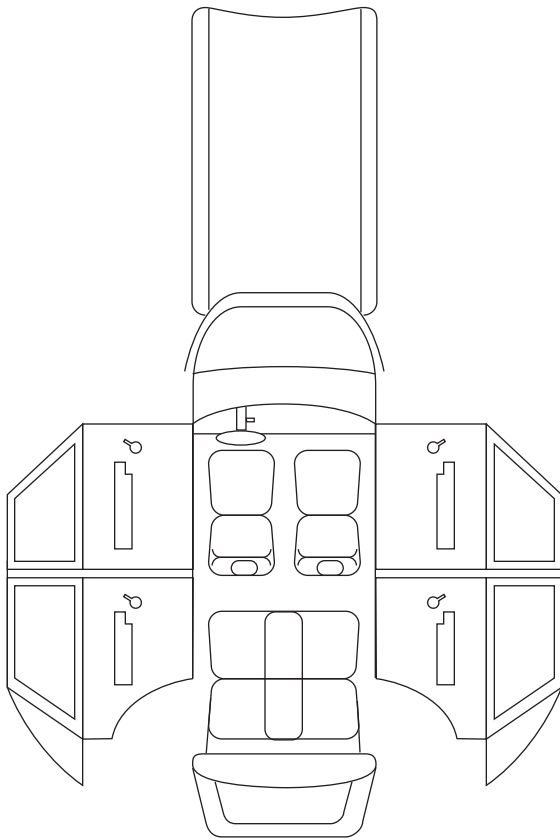
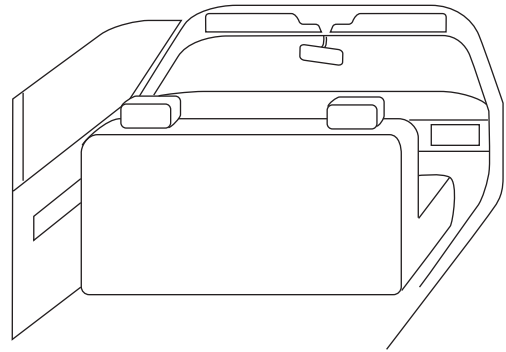
- A: knee bolster, loosened and deformed
- B: gas pedal, deformed and bent to right
- C: driver-door armrest, scuff
- D: glovebox, loosened and scuff
- E: A-pillar, scuff and blood

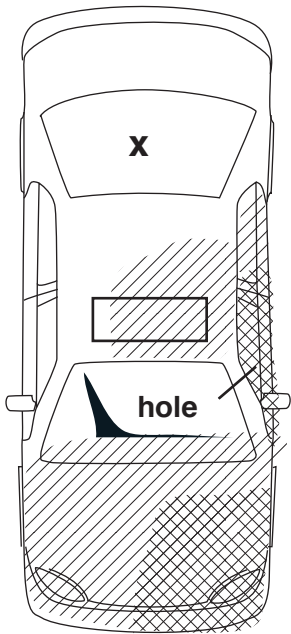
cut for extrication

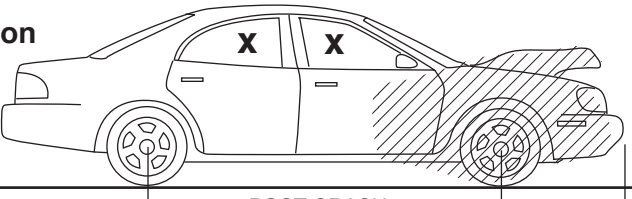
POST-CRASH
 Bumper corner 111 **274 (+4)** 79 Bumper corner
 Stringline 101 96 Stringline

Impact #1
85-cm direct damage
84-cm max crush
