REPORT NUMBER: 221-MGA-05-003

**SAFETY COMPLIANCE TESTING FOR
FMVSS NO. 221
SCHOOL BUS BODY JOINT STRENGTH**

**Les Entreprises Michel Corbell Inc.
2004 Corbell 30 Passenger School Bus
NHTSA No.: C40902**

**PREPARED BY:
MGA RESEARCH CORPORATION
5000 WARREN ROAD
BURLINGTON, WI 53105**

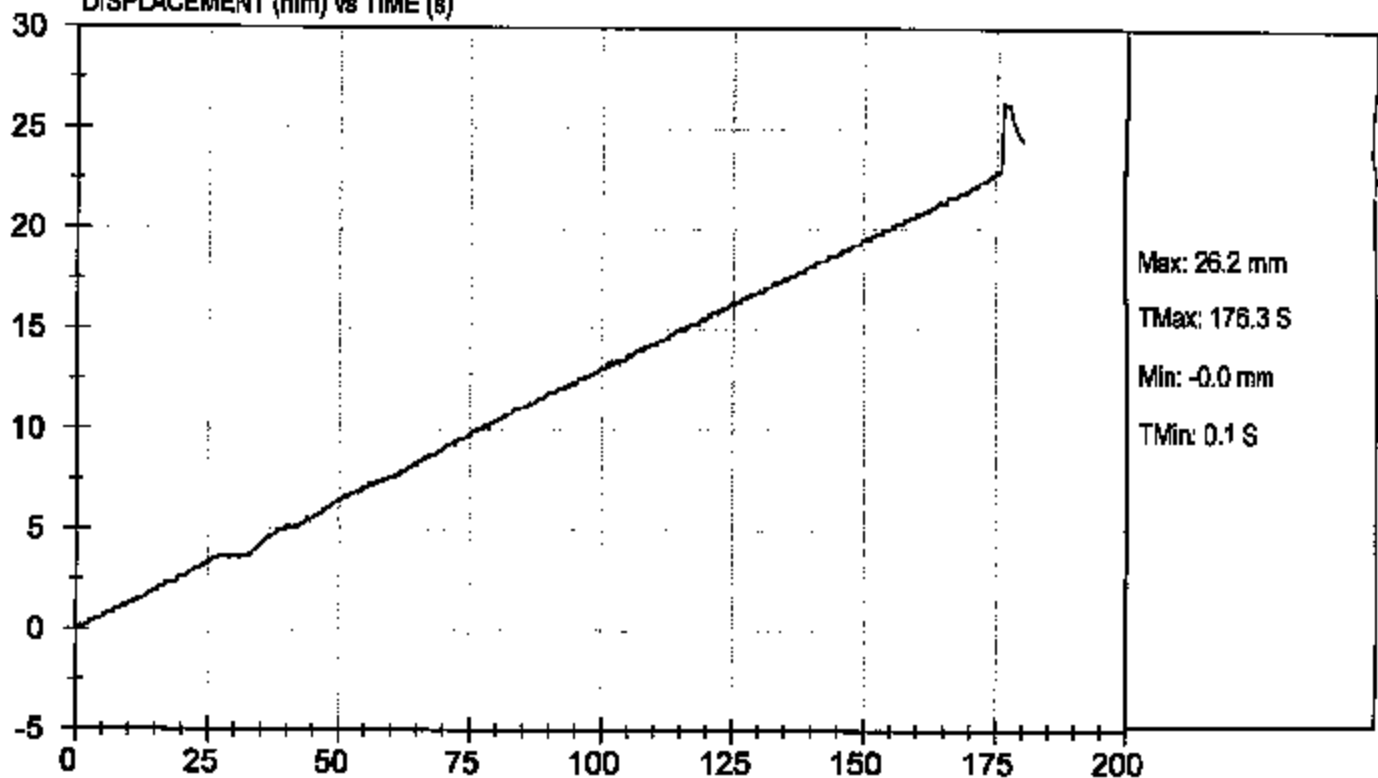
Maximum Load (N)	60% of Material Strength (N)	PASS/FAIL
Mid-Roof Interior	7002.6	16278.3	FAIL
Mid-Roof Interior	6495.2	16278.3	FAIL
Mid-Roof Exterior	14518.3	24721.9	FAIL
Mid-Roof Exterior	17760.2	23844.7	FAIL
