Report Number: 214-TRC-04-009

**Safety Compliance Testing For FMVSS 214**

**Side Impact Protection**

**Mitsubishi Motors North America, Inc.  
2006 Mitsubishi Eclipse GS 2-door sport coupe**

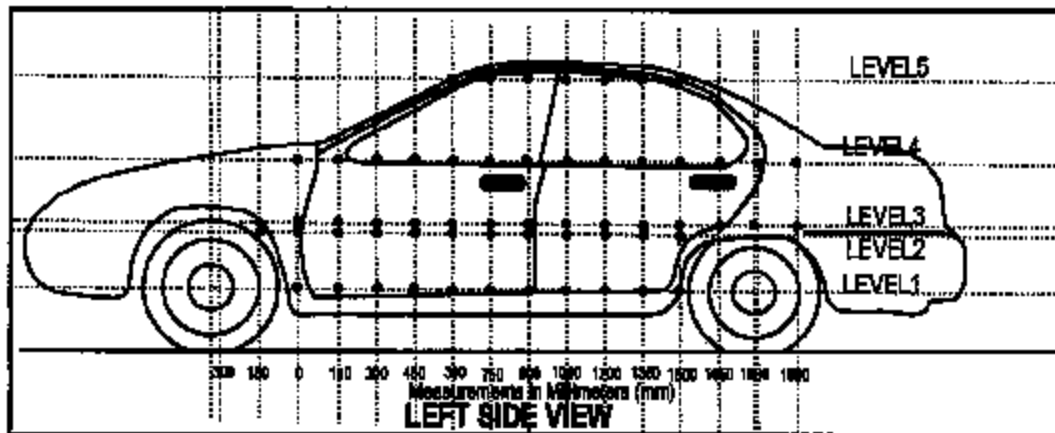
1. Level 1 (	<u>247</u>	mm above ground)	=	<u>0</u>	mm
2. Level 2 (	<u>495</u>	mm above ground)	=	<u>134</u>	mm
3. Level 3 (	<u>603</u>	mm above ground)	=	<u>156</u>	mm
4. Level 4 (	<u>821</u>	mm above ground)	=	<u>127</u>	mm
5. Level 5 (	<u>1300</u>	mm above ground)	=	<u>6</u>	mm

Maximum Post-Test Intrusion = 156 mm

Full length of induced damage was 1650 mm.
