SUBARU

REPAIR INSTRUCTIONS

APPLICABILITY: 2011MY Legacy & Outback with Moonroof **DATE:** September 9, 2011
SUBJECT: Interim Inspection and Repair Procedure
for Moonroof Glass WW-33 Stop Sale /
Recall

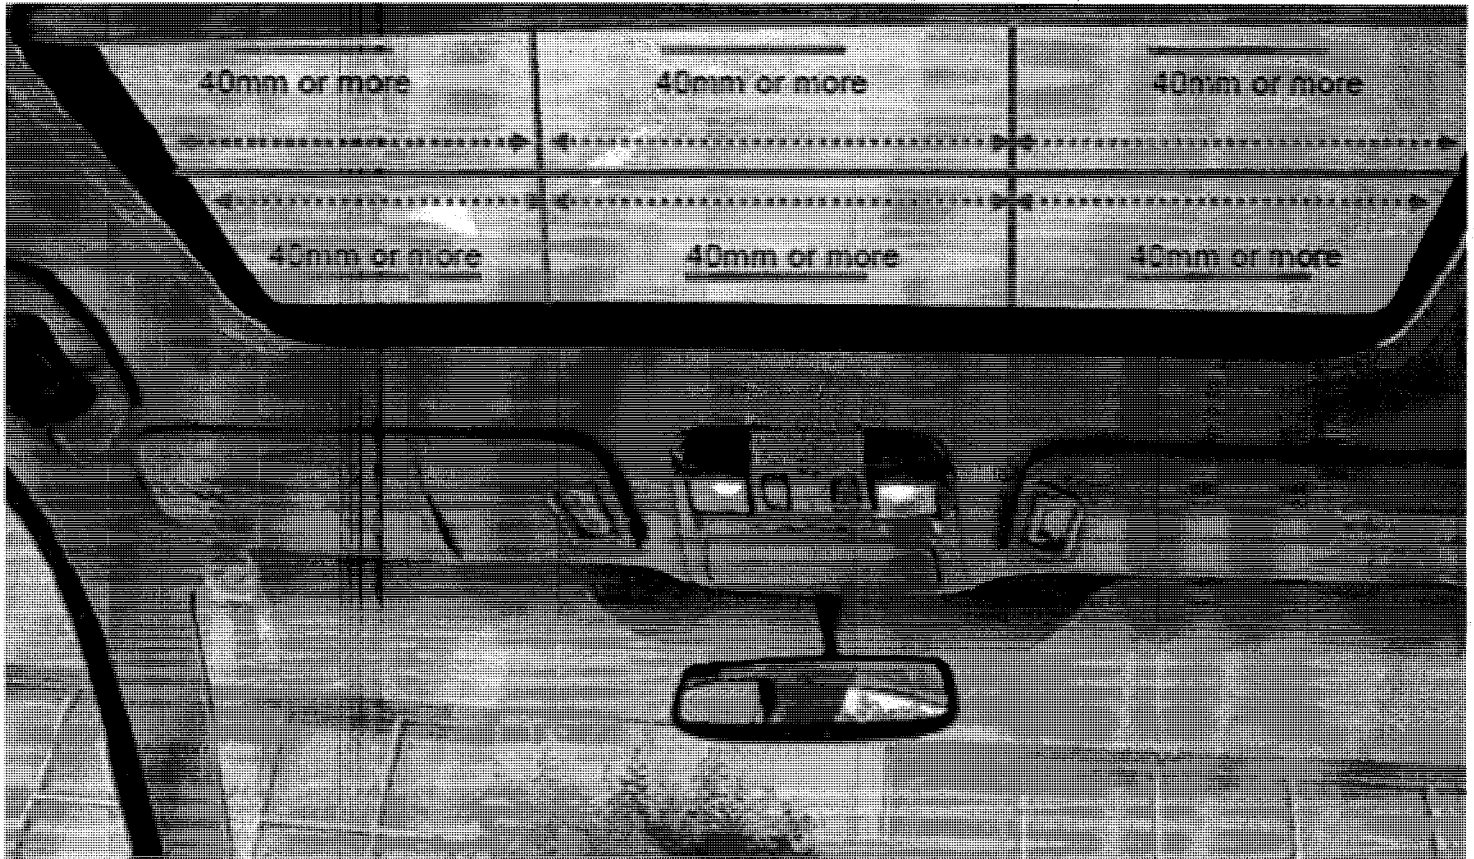
Verify the urethane beads are present (6 Beads / 40mm or more in length)

Imagine the moonroof being divided into 6 equal sections (270mm blue arrow). Inside each of the six squares there should be a 40mm or longer bead (red line) of urethane between the glass and frame in each section.

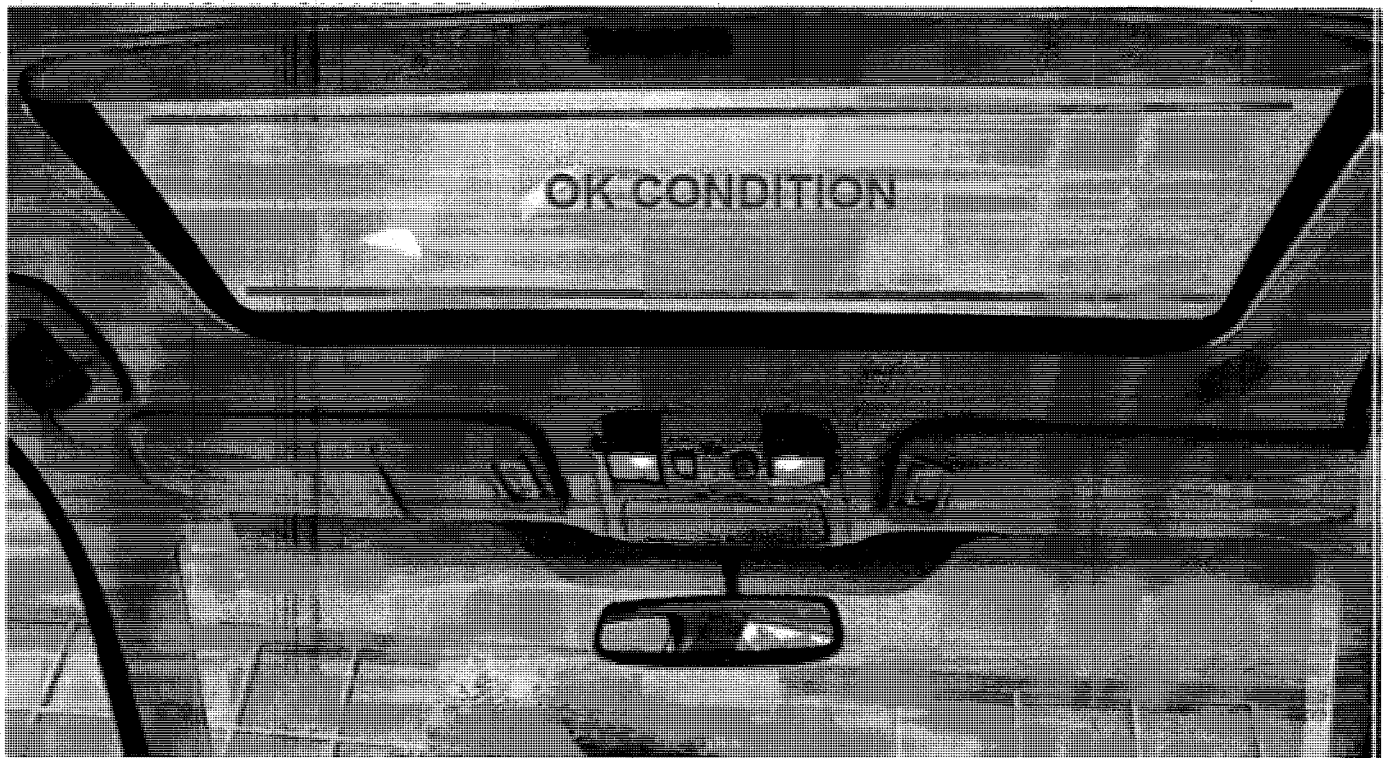
NOTE: Some vehicles may have two long urethane beads which is also acceptable.

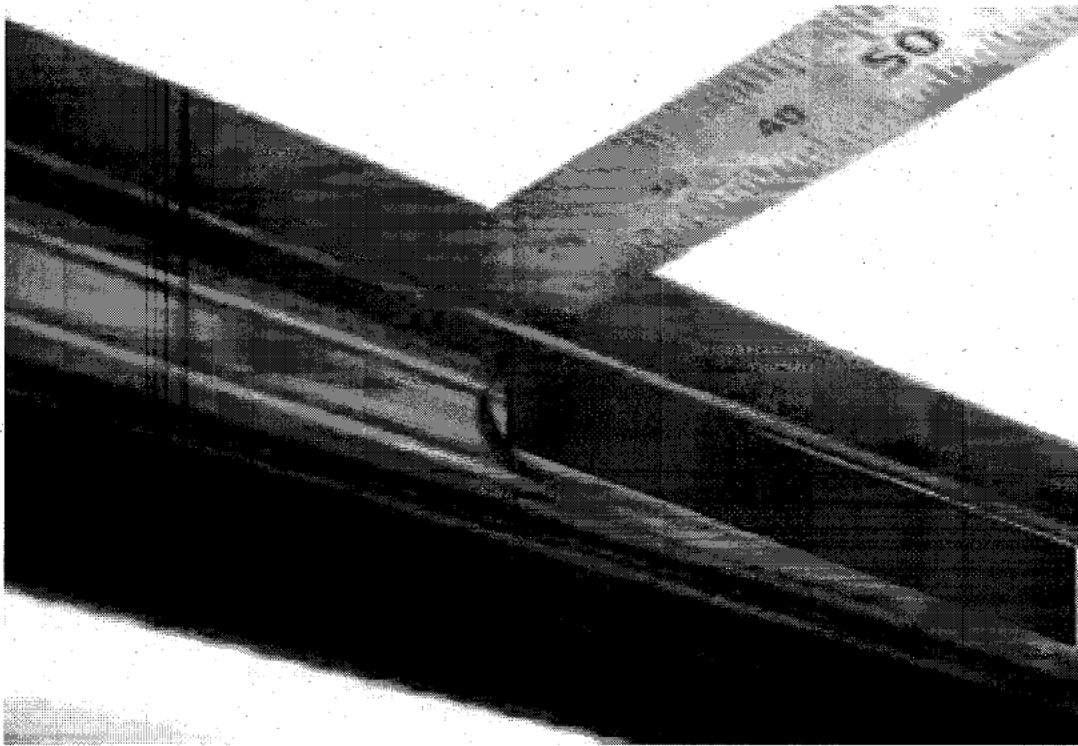
To locate the urethane beads, a metal ruler is used as a depth gauge which is inserted between the moonroof glass and the moonroof frame.

Urethane Not Present (approximately 38mm)

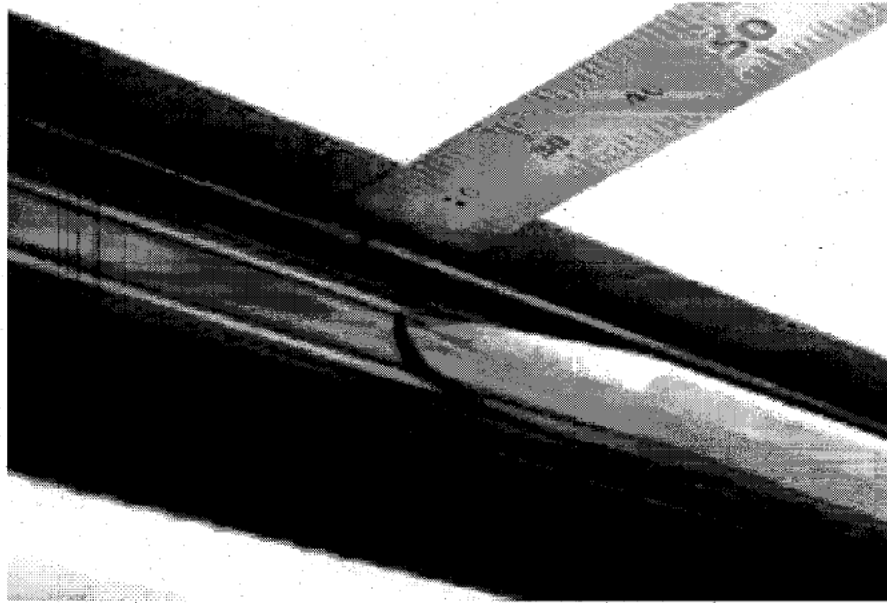
Slide the ruler between the moonroof glass and moonroof frame. Slide the ruler in a sideways motion until you locate one of the ends of the urethane bead. Using a pencil, place a small mark on the frame to mark the position.

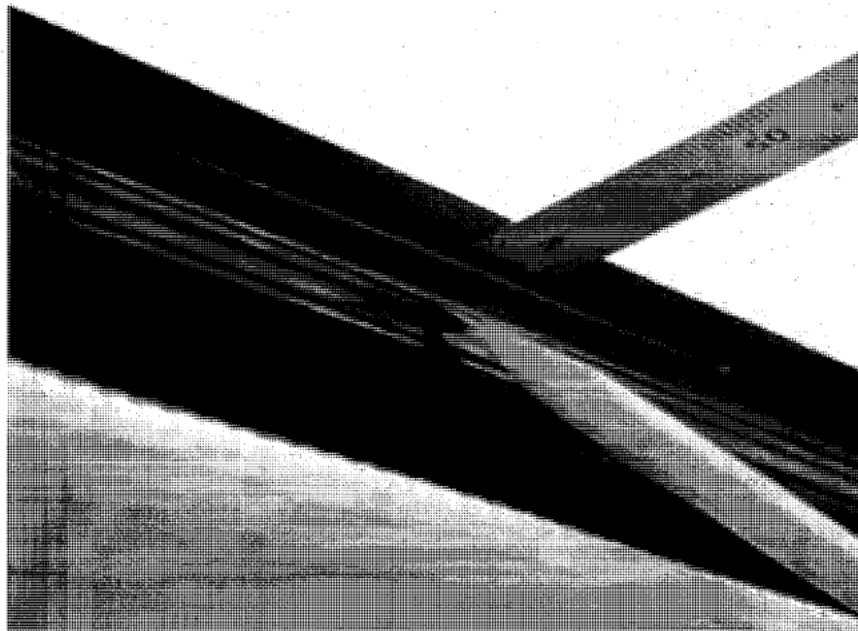
Slide the ruler along the bead until you can locate the other end of the urethane bead. Place a small mark on the frame to mark that position.

Measure the length of the urethane bead between the marks. The length of each bead must be at least 40mm. Repeat the step for the other five urethane beads.

If any of the six urethane beads measure less than 40mm in length the Adhesive Repair Procedure will need to be preformed. **NOTE:** Until Special Adhesive is available, it will be necessary to replace the moonroof glass and frame.

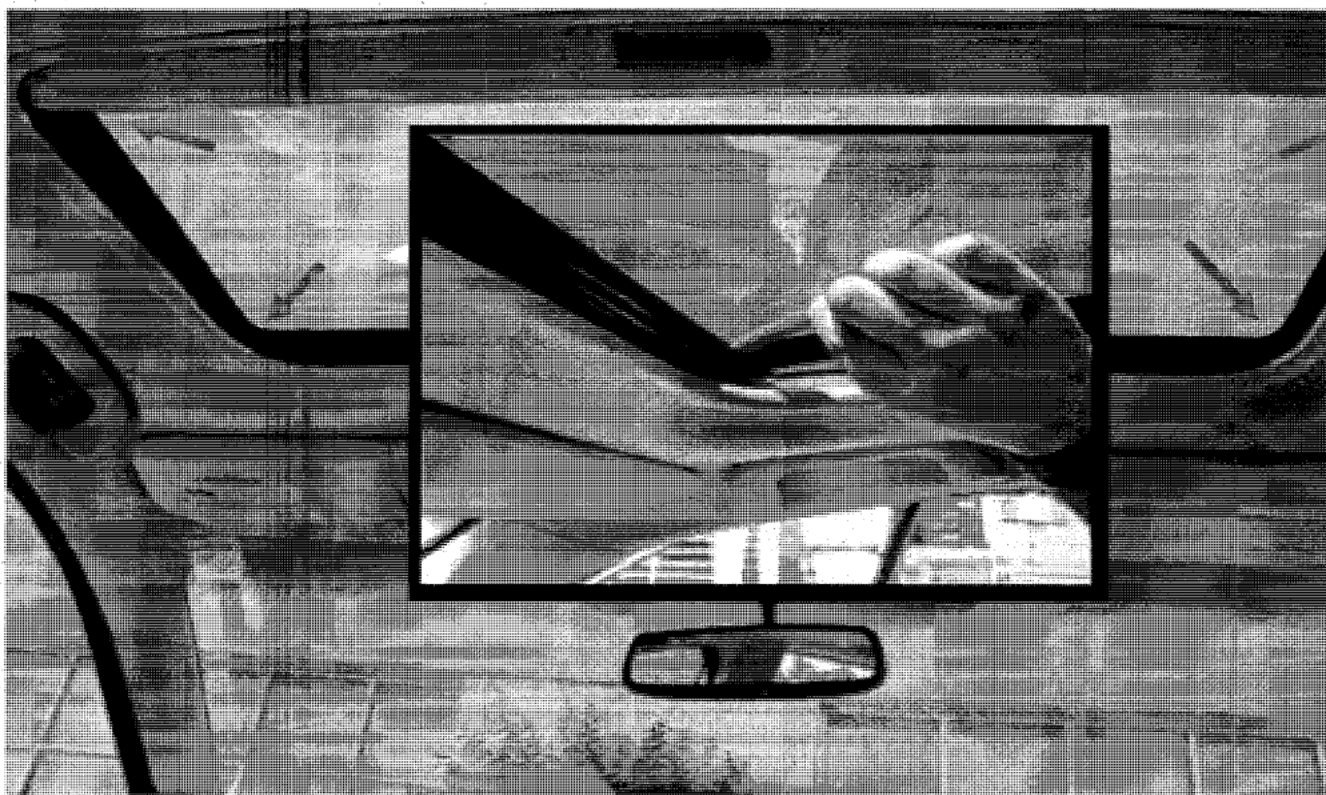
Using a plastic trim tool, check all four corners of the moonroof glass.

Insert the plastic trim tool between the frame and glass starting at the front left corner. Using a reasonable amount of force, attempt to rotate the plastic trim tool up to 90 degrees from the surface of the glass. While rotating the plastic trim tool, listen, look and feel for any separation of the glass from the frame. If adhesion is inadequate the frame will move easily. If adhesion is adequate there will be little to no movement. Check the remaining three corners. If any separation occurs at any of the four corners, the moonroof glass and frame will need to be replaced. Refer to the applicable Subaru Service Manual for the replacement procedure.
