## SCI/NASS COMBINATION CASE REPORT

CASE NUMBER - NASS-2000-48-088C

VEHICLE - 2000 OLDSMOBILE ALERO

CRASH DATE - May 2000

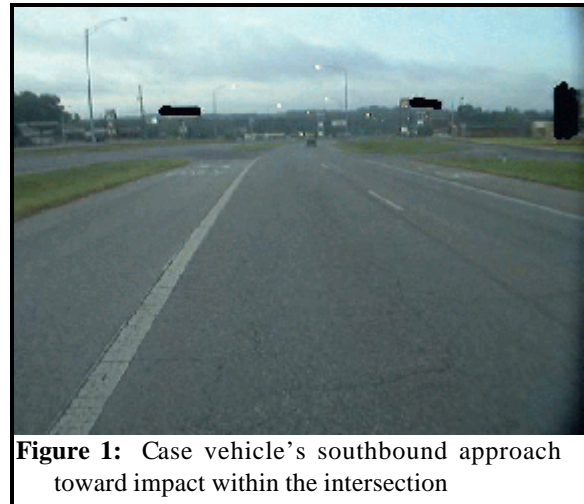
**Figure 1:** Case vehicle's southbound approach toward impact within the intersection

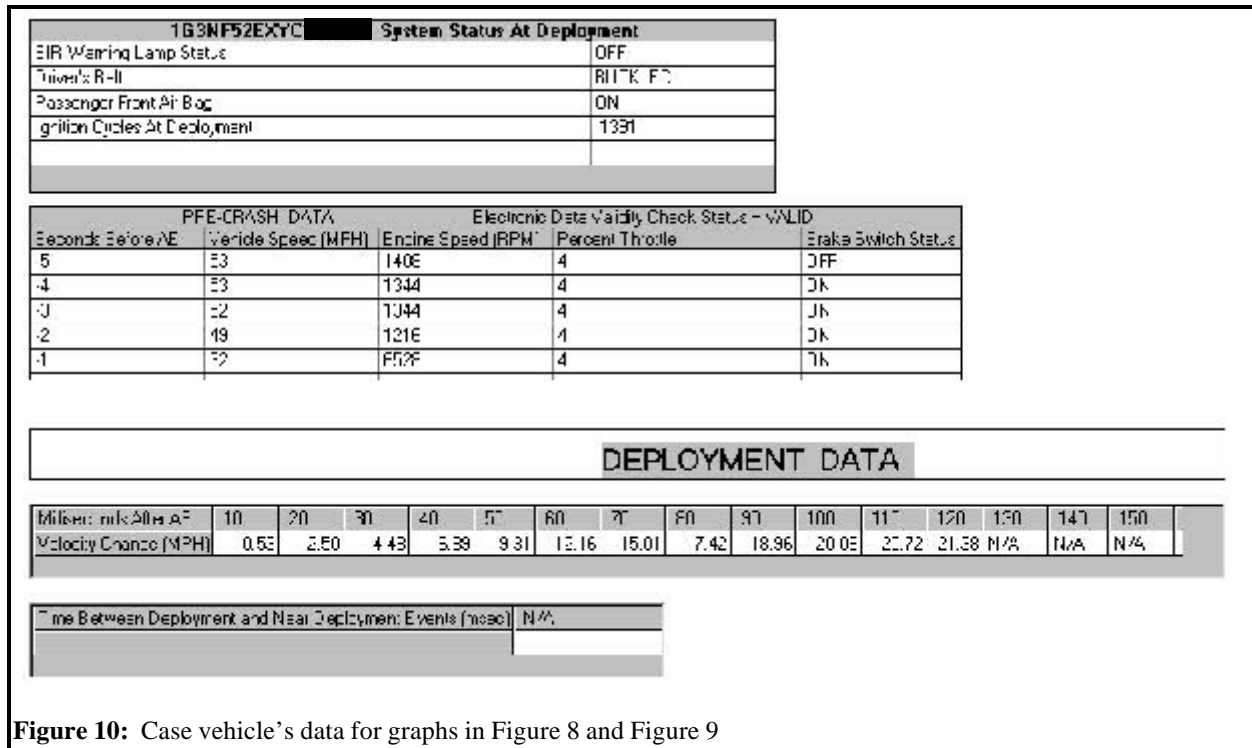
The case vehicle's EDR was downloaded (see **Figures 8, 9 and 10**, at end). The deployment occurred on ignition cycle 1,391. The Supplemental Inflatable Restraint (SIR) warning lamp was off, indicating no problems with the air bag system, and the driver's safety belt was recorded as buckled. The EDR pre-crash data (**Figures 8 and 10**) indicate that the case vehicle was traveling 85 km.p.h. [53 m.p.h.] five seconds before the device detected the impact ("algorithm enable"). Recall that the case vehicle was traversing a gentle curve to the right with a negative slope. The pre-crash data show that the throttle was at 4 per cent, that is, the driver's foot was probably off of the accelerator. The driver apparently braked lightly as the vehicle was rounding the curve, with the EDR pre-crash data showing the brake light switch circuit "on" at four seconds prior to algorithm enable. The case vehicle's travel speed slowed slightly to 79 km.p.h. [49 m.p.h.] over the next two seconds (from -4 to -2 seconds, see **Figures 8 and 10**). At approximately two seconds prior to algorithm enable, the driver apparently braked hard because the travel speed dropped steeply to 51 km.p.h. [32 m.p.h.] in the interval between -2 and -1 seconds.

The EDR deployment data (**Figures 9 and 10**) indicate longitudinal Delta V of -34.41 km.p.h. [-21.38 m.p.h.] during the 120 milliseconds [0.12 seconds] after algorithm enable (the EDR did not record deployment data beyond 120 milliseconds). The WinSMASH calculated estimate for longitudinal Delta V was -33 km.p.h. [-21 m.p.h.], indicating close agreement between the recorded data and the calculated estimate.

Figure 10: Case vehicle's data for graphs in Figure 8 and Figure 9
