**VERIDIAN ON-SITE FRONT DRIVER AIR BAG DEPLOYMENT/
FATALITY INVESTIGATION**

VERIDIAN CASE NO. CA00-006

VEHICLE - 1994 PONTIAC BONNEVILLE

CRASH DATE - FEBRUARY 2000

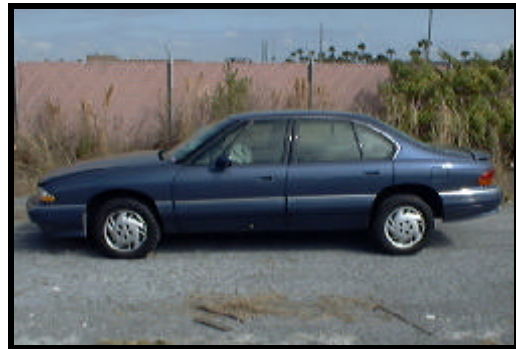
Figure 4: Left side view of the Pontiac.

The 1994 Pontiac Bonneville, 4-door sedan, was identified by a Vehicle Identification Number (VIN): 1G2HX52L0R4 (production sequence deleted), **Figure 4**. The date of manufacture was 12/93. The vehicle was equipped with a Supplemental Inflatable Restraint system that consisted of driver and front right passenger air bags. The power train consisted of a 3.8 liter, V-6 engine linked to a 4-speed automatic transmission. The vehicle's braking system was equipped with an anti-lock braking system (ABS). The odometer reading at the time of inspection was 243,511 km (151,315 miles).
