REMOTE AIR BAG REPORT

CASE NUMBER - IN00-009

VEHICLE - 1996 LEXUS ES300

CRASH DATE - October, 1999

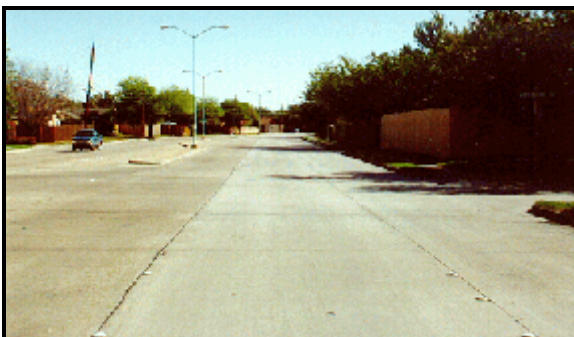
Figure 1: Case vehicle's eastward travel path in center eastbound through lane of divided seven-lane, divided trafficway approaching four-leg intersection (case photo #01)

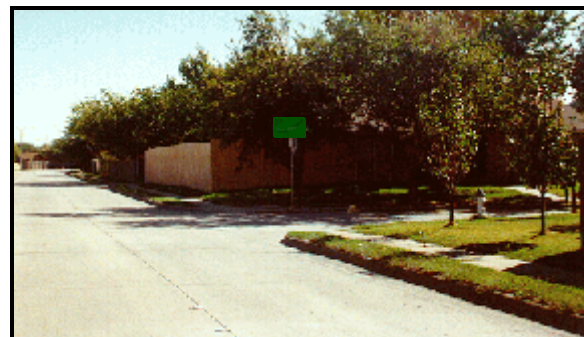
Figure 2: View from case vehicle's eastbound center lane of other vehicle's pre-impact position on south leg of four-leg intersection (case photo #02)

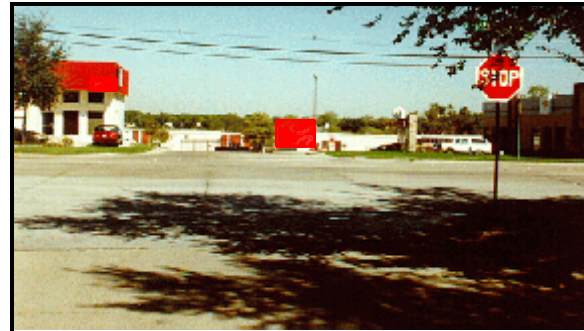
Figure 3: Other vehicle's travel path on south leg approaching four-leg intersection; Note: driveway access in background constitutes fourth (northern) leg (case photo #05)

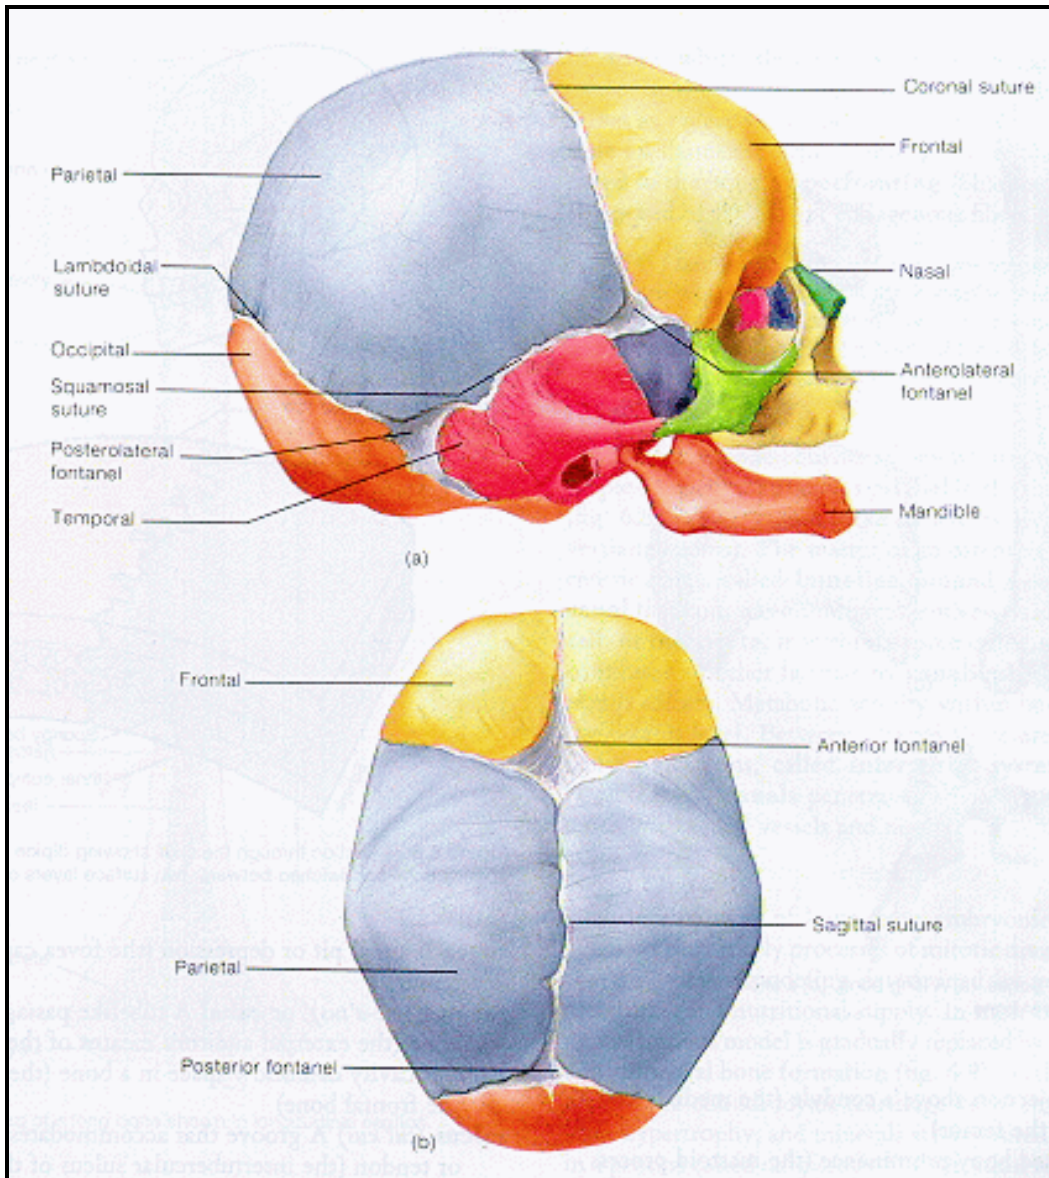
Figure 13: The fetal skull showing the six fontanels and the sutures; (a) a right lateral view and (b) a superior view.

1. **Anterior (frontal) fontanel**—The anterior fontanel is diamond-shaped and is the most prominent of the six. It is located on the anteromedian portion of the skull
2. **Posterior (occipital) fontanel**—The posterior fontanel is positioned at the back of the skull on the median line.
3. **Anterolateral (sphenoidal) fontanels**—The paired anterolateral fontanels are found on both side of the skull directly below the anterior fontanel.
4. **Posterolateral (mastoid)fontanels**—The paired posterolateral fontanels are located on the posterolateral sides of the skull.
