On-scene Investigation / Vehicle to Vehicle Dynamic Science, Inc. / Case Number: DS00015 1999 Porsche Boxster California May 2000 This document is disseminated under the sponsorship of the Department of Transportation in the interest of information exchange. The United States Government assumes no responsibility for the contents or use thereof.

Dynamic Science, Inc. Accident Investigation Case Number: DS00015

Crash Location: Crash Date: Notification Date: Field Work Completed: California May, 2000 August 25, 2000 NA

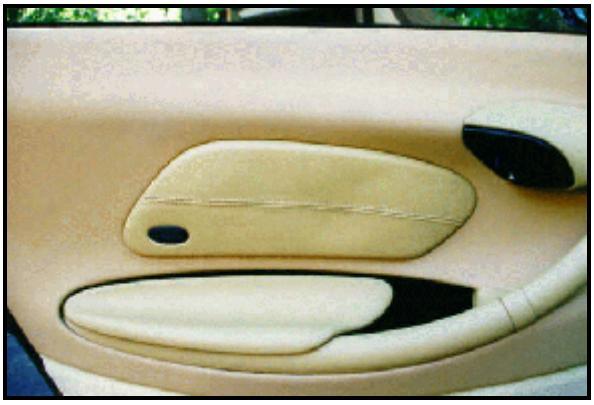
Figure 3. Exemplar view of driver's door mounted side air bag

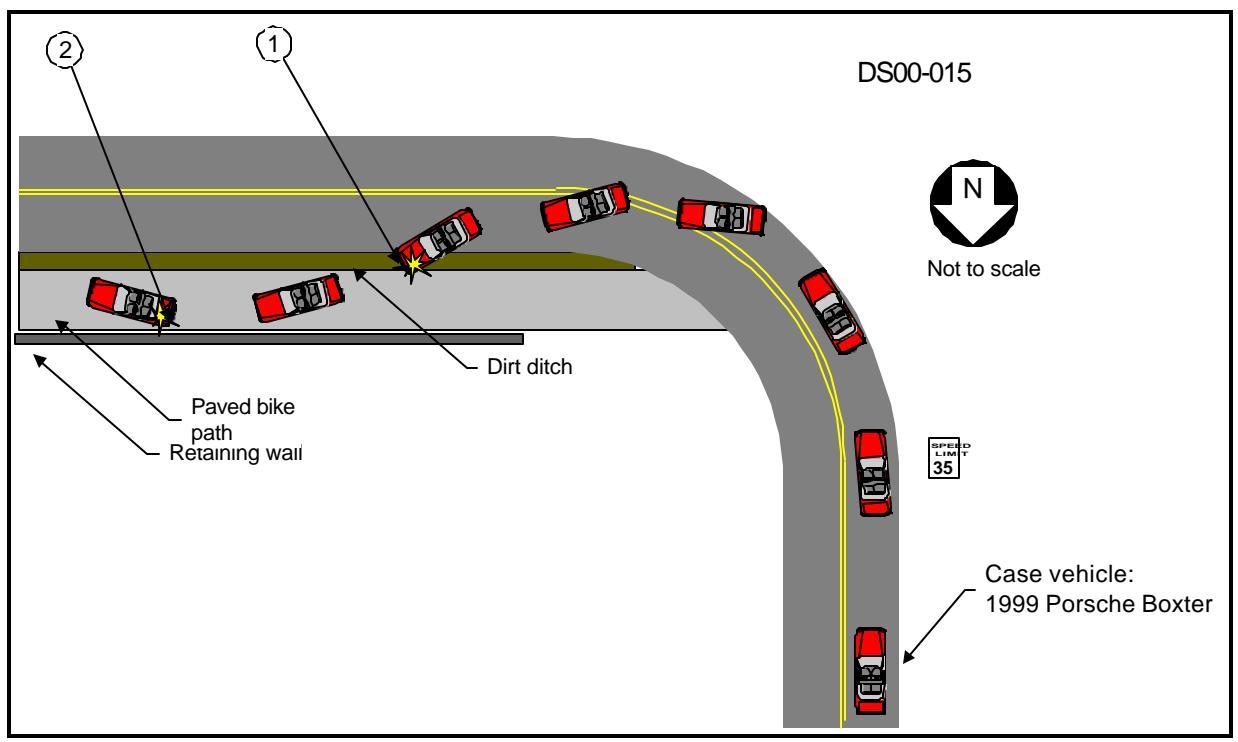
Figure 6. Scene diagram

The driver appears to have lost control in the curve, over-corrected to the left, and departed the roadway. The vehicle first struck the ditch–causing minor undercarriage damage. The driver corrected to the right and as the vehicle rotated it struck the retaining wall with the left side (10LZEW1). The case vehicle sustained a longitudinal delta v of -6.0 km/h and a lateral delta v of 10.5 km/h. The driver's door mounted side air bag deployed at this time. According to the driver, the deploying side air bag struck and fractured his left

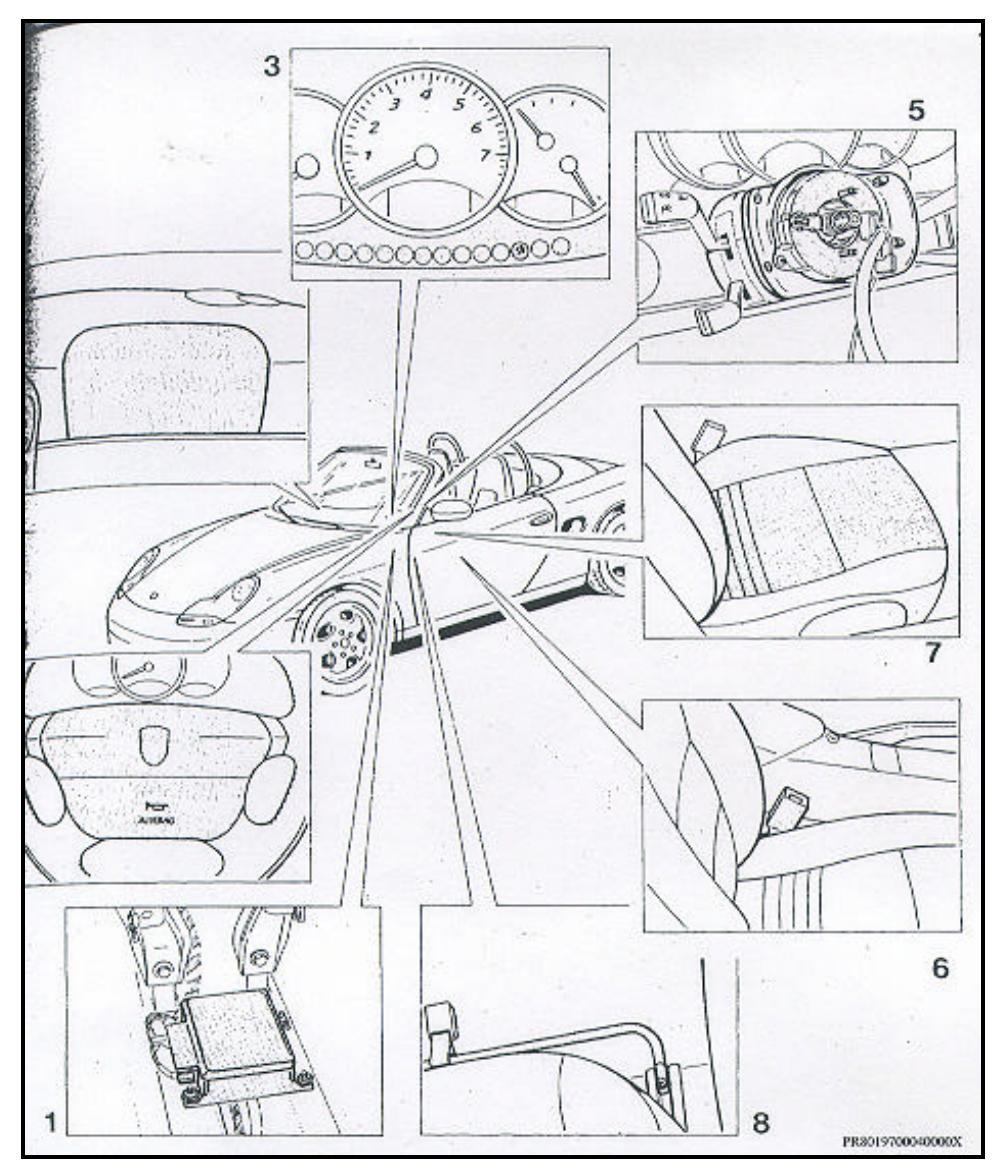
The Porsche was equipped with a driver's frontal air bag, a passenger's frontal air bag, a driver's door mounted side air bag, and a passenger's door mounted side air bag. The driver's side air bag is contained behind a two-flap trapezoidally- shaped module cover. The side air bag sensors are located on the inner lower side members on the left and right side of the vehicle.

Figure 9. SRS component locations (1=Control Unit, 2=Passenger's Air Bag Module, 3=SRS Warning Lamp, 4=Driver's Air Bag Module, 5=Side Air Bags, 6=Contact Unit, 7=Side Air Bag Sensor, 8=Belt Buckle)
