**REMOTE AIR BAG RELATED CHILD PASSENGER FATALITY INVESTIGATION
SCI TECHNICAL SUMMARY REPORT**

VERIDIAN CASE NO. CA00-049

SUBJECT VEHICLE - 1997 MITSUBISHI GALANT

CRASH DATE - MAY 1999

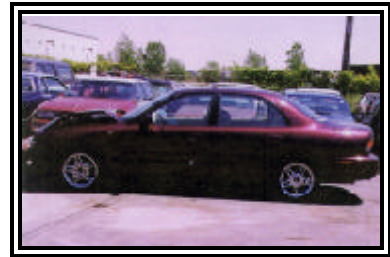
This remote investigation focused on a two vehicle crash that involved a 1997 Mitsubishi Galant (subject vehicle) and a 1992 Ford Taurus. The Galant (**Figure 1**) was occupied by a 31-year-old male driver and a 7-year-old male front right passenger. Neither occupant of the Galant was restrained. The Galant was equipped with frontal air bags that deployed as a result of an intersection collision with the Ford Taurus, which turned across the path of the Galant. Both occupants of the Galant initiated forward trajectories in response to the frontal impact with the Taurus. The driver of the Galant contacted the deployed driver's air bag and sustained police reported incapacitating injuries.

Figure 1. 1997 Mitsubishi Galant

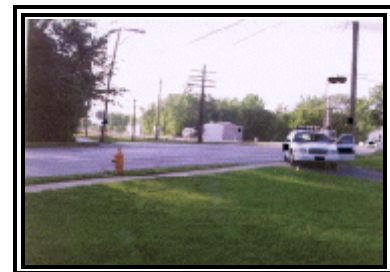
This two vehicle crash occurred during the daytime hours of May 1999. At the time of the crash, it was daylight with no adverse conditions as the asphalt road surfaces were dry. The crash occurred at a residential 3-leg (T) intersection of a four-lane undivided north/south roadway and a two-lane east/west roadway (**Figure 2**). Police reported the north/south roadway to be 14 m (46') wide and

Figure 2. View of intersection looking northwest

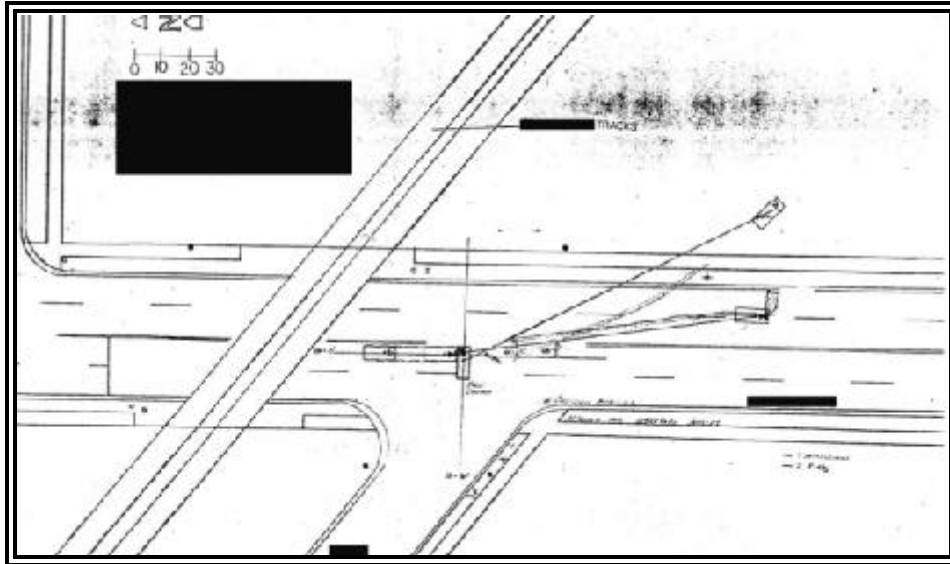
the east/west roadway to be 9 m (28') wide. The west leg intersected the north/south roadway at an approximate 45 degree angle. Railroad tracks crossed the north/south roadway at an angle approximately 21 m (70') to the north of the intersection. The roadside environment consisted of concrete curbs, sidewalks, residential driveways, lawn areas, and trees. Traffic control at the scene consisted of a stop sign for eastbound traffic. The posted speed limit for the north/south roadway was 56 km/h (35 mph). The scale police diagram (**Figure 3**) depicts the intersection configuration.

Figure 3. Police scale diagram showing impact and final rest positions

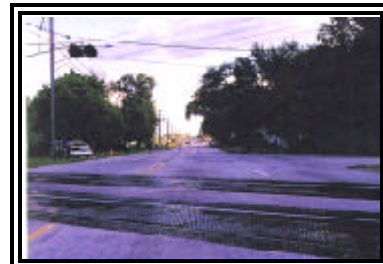
The 31-year-old male driver of the 1997 Mitsubishi Galant was operating the vehicle southbound on approach to the 3-leg intersection at a police estimated speed of 56 km/h (35 mph) (**Figure 4**). The 45-year-old female driver of the Taurus stated that she approached the intersection and stopped at the stop sign with the left turn signal activated (**Figure 5**). The driver of the Taurus initiated a left turn, but due to a medical condition, she lost consciousness and did not recall attempting the turn. The driver of the Galant realized the impending harmful event and braked with sufficient force to lock the front wheels. Skid marks were noted in the Galant's trajectory in the on-scene police photographs and the investigating officer documented the lengths on the scale police diagram. The approximate length of the left front tire mark was 10 m (32'), and the approximate length of the right front was 8 m (25').

Figure 4. Southbound approach for 1997 Mitsubishi Galant

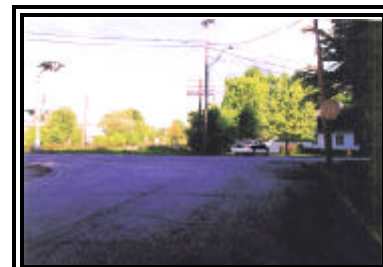
Figure 5. Eastbound approach for 1992 Ford Taurus
