**VERIDIAN ON-SITE AIR BAG RELATED DRIVER FATALITY INVESTIGATION
SCI TECHNICAL SUMMARY REPORT**

VERIDIAN CASE NO. CA00-060

SUBJECT VEHICLE - 1994 FORD F-150 4X2 PICKUP TRUCK

CRASH DATE - DECEMBER 2000

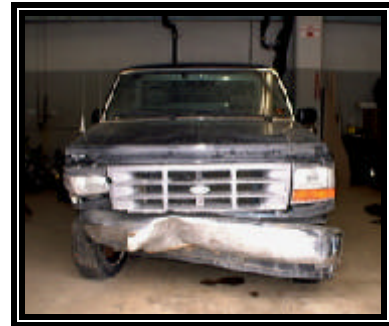
Figure 1. 1994 Ford F-150 pickup truck

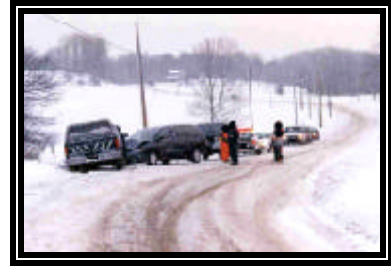
This crash occurred on a north/south rural county roadway in the dawn hours. At the time of the crash, it was snowing and the asphalt roadway surface was snow/ice covered. According to the National Weather Service weather history, the temperature was approximately -9 degrees Celsius (16 degrees Fahrenheit) and the wind was 13 km/h (8 mph) at the time of the crash. The crash occurred on a curved portion of a two-lane roadway that measured 6.2 m (20.3') wide and was bordered by dirt shoulders. The crash site was approximately 50.0 m (164.0') north of a hillcrest that was located at near the apex of the curve. The northbound grade was approximately 3.0 percent on the south side of the hillcrest, and -5.0 percent on the north side. Due to the slope and curvature of the roadway, the sight distance around the curve was obscured in both directions. The roadway was bordered by fields, scattered trees, and utility poles (**Figure 2**).

Figure 2. Northbound view of the crash site

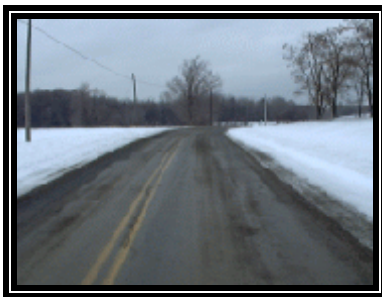
Figure 3. Northbound approach for the Ford F-150 pickup truck

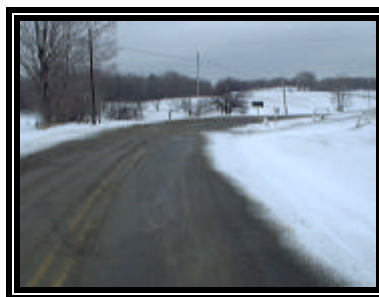
Figure 4. Approach #2 for the Ford pickup truck near the hillcrest

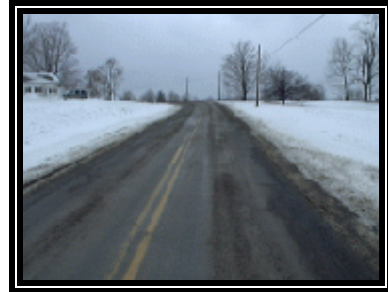
The driver of the 1997 Dodge Grand Caravan was operating the vehicle southbound toward the hillcrest (**Figure 6**) when he detected the Ford pickup truck approaching in the same lane in the opposite direction from around the curve. Due to the curve and hillcrest, the driver's vision was obscured and he did not detect the approaching Ford pickup truck until the collision was imminent.

Figure 6. Southbound approach for the Dodge Grand Caravan

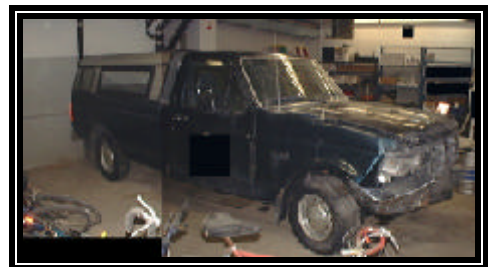
The 1994 Ford F-150 pickup truck (**Figure 7**) was identified by the Vehicle Identification Number (VIN): 1FTEF15N3RN (production sequence omitted). The vehicle was a regular cab, full size, 4 x 2 pickup truck equipped with a 5.0 liter V-8 engine, and automatic transmission with overdrive. It was also equipped with dual fuel tanks, one forward of center of the rear axle on the left side and the other centered aft of the rear axle. The box measured 248.9 cm (98.0") in length. Attached

Figure 7. 1994 Ford F-150 pickup truck

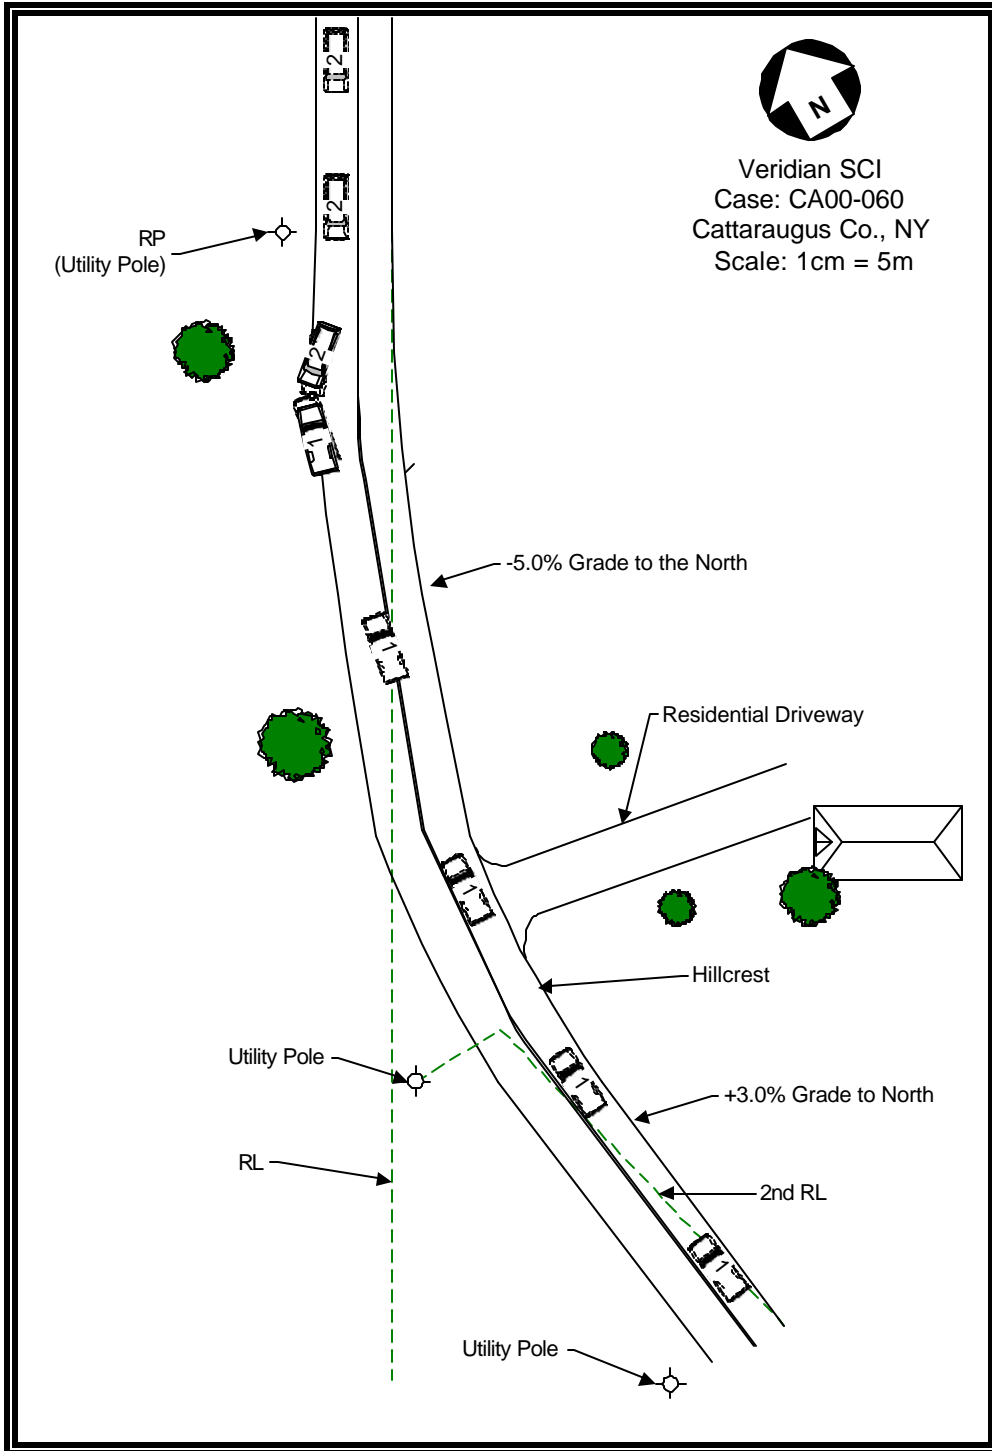
The front of the Ford pickup truck impacted the front of the Dodge Grand Caravan in a head-on configuration. Impact resulted in moderate damage to both vehicles. The direction of force was in the 12 o'clock sector for both vehicles. The damage algorithm of the WinSMASH program computed velocity changes of 17.2 km/h (10.7 mph) for the Ford F-150 pickup truck based on the documented crush profile. The longitudinal and latitudinal components were -17.0 (-10.5 mph) and -3.0 km/h (-1.9 mph), respectively. The damage algorithm of the WinSMASH program computed velocity changes of 18.8 km/h (11.7 mph) for the Dodge Grand Caravan based on the documented crush profile. The longitudinal and latitudinal components were -18.5 (-11.5 mph) and -3.3 km/h (-2.0 mph), respectively. The WinSMASH results appear conservative. The impact induced deceleration was sufficient to deploy the frontal air bag system in both vehicles. The front of the Ford F-150 pickup truck overrode the front bumper of the Dodge Grand Caravan. Both vehicles rotated clockwise (CW) approximately 10 degrees to final rest which was in close proximity to the point of impact. The Ford F-150 pickup truck came to rest facing north in the straddling the road edge. The Grand Caravan came to rest facing southwest straddling the edge of the roadside.

Figure 15. Scene schematic
