SCI/NASS COMBINATION CASE REPORT

CASE NUMBER - NASS-2001-74-010J

VEHICLE - 2001 Volvo V70

CRASH DATE - January 2001

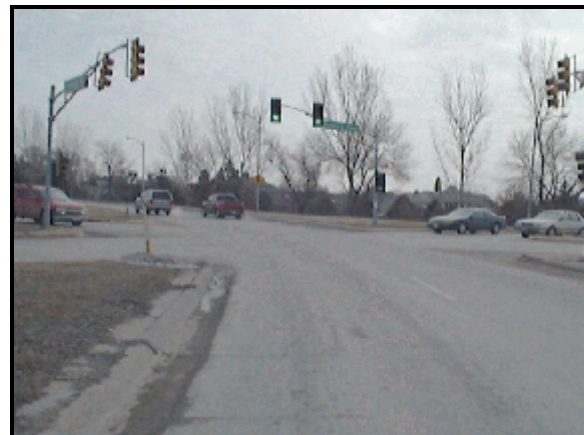
Figure 1: Case vehicle's eastbound approach; other vehicle coming from same leg as pickup by the signal pole on the far left

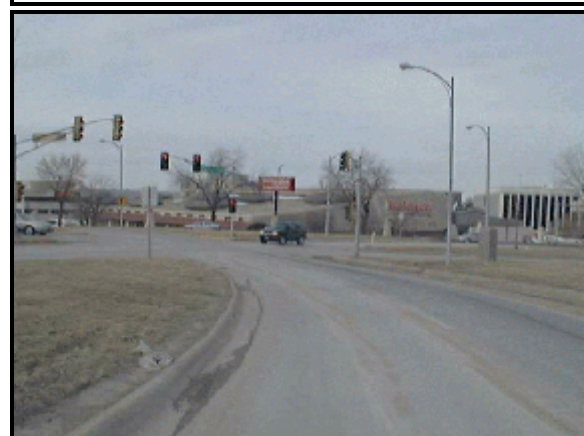
Figure 2: Other vehicle's southwestbound approach; case vehicle coming from same leg as black SUV
