ON-SITE ADVANCED OCCUPANT PROTECTION SYSTEM INVESTIGATION

CASE NUMBER - IN01-003
LOCATION - MISSISSIPPI
VEHICLE - 2001 LEXUS GS300
CRASH DATE - February, 2001

February 13, 2003

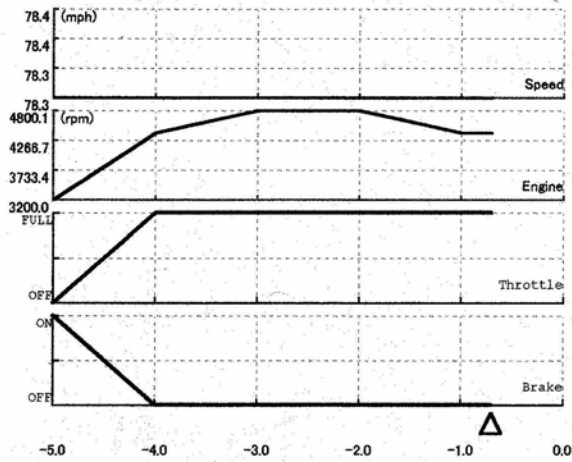
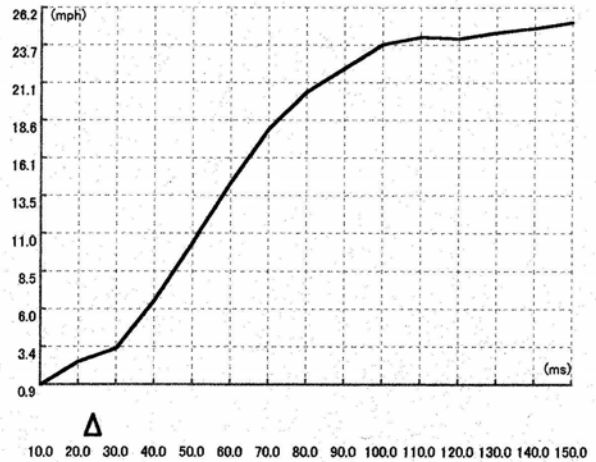
Memory Bank	0	
Belt Switch Status	D: Belted	P: UnBelted
Diagnostic	Not Detected	
Lamp On Time	0minutes	
Ignition Cycles	0	
Shift Position	Other	
Deployment Time	24ms	
Time From Last PreCrash Data	300ms	
Time From Previous Event	400ms

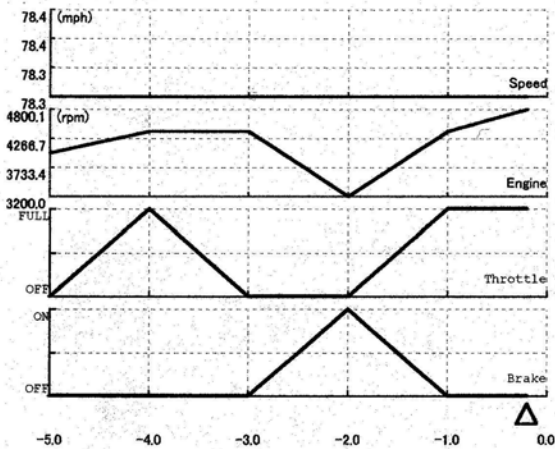
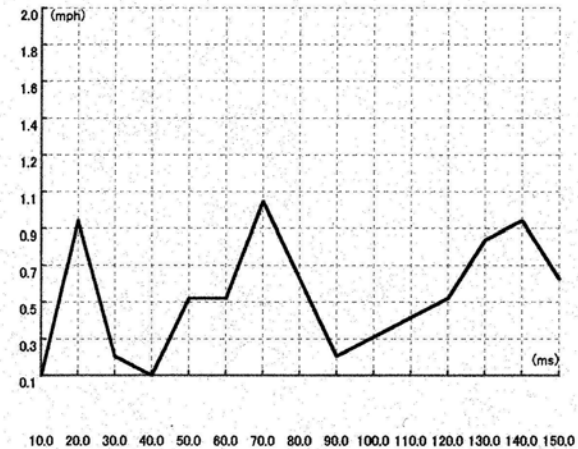
Figure 36: Case vehicle's near deployment event that had the highest change in velocity (Delta V). Shown are the pre-crash speed, brake switch status, and the case vehicle's change in velocity (Delta V) over the first 150 milliseconds of the event; this event corresponds to the case vehicle's impact with the curb

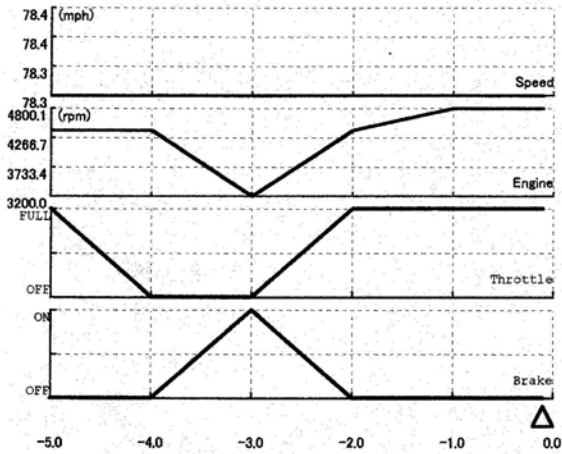
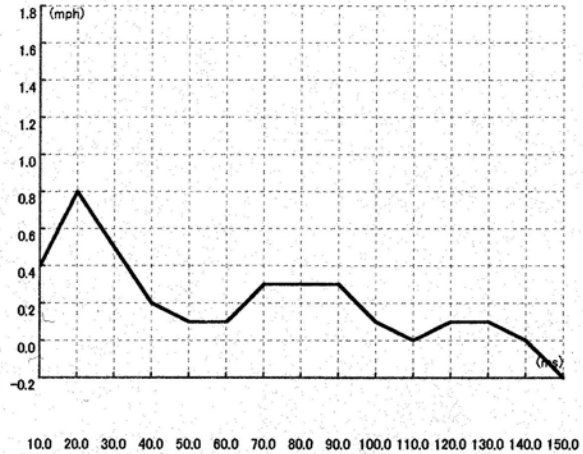
Figure 37: Case vehicle’s near deployment event that occurred immediately prior to the on-set of the deployment event. Shown are pre-crash speed, brake switch status, and the case vehicle’s change in velocity (Delta V) over the first 150 milliseconds of the event; this event corresponds to the case vehicle’s impact with the temporary warning sign
