### **ON-SITE CHILD AIR BAG-RELATED FATALITY INVESTIGATION**

CASE NUMBER - IN01-008  
LOCATION - TEXAS  
VEHICLE - 1995 PLYMOUTH NEON  
CRASH DATE - April, 2001

1. <i>Report No.</i> IN01-008		2. <i>Government Accession No.</i>		3. <i>Recipient's Catalog No.</i>	
4. <i>Title and Subtitle</i> On-Site Child Air Bag-Related Fatality Investigation Vehicle - 1995 Plymouth Neon Location - Texas			5. <i>Report Date:</i> September 13, 2002

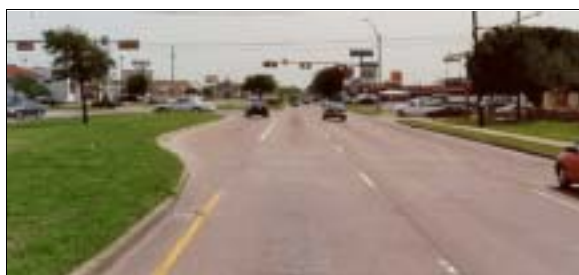
**Figure 1:** Case vehicle's eastward path of travel in inside through lane of eastbound roadway (case photo #00)

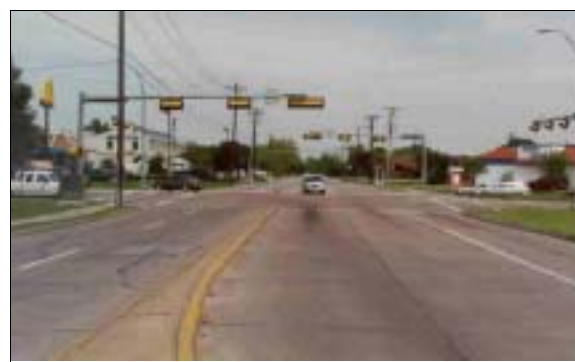
**Figure 2:** Chevrolet's northward path of travel in left-hand turn lane prior to four-leg intersection (case photo #05)

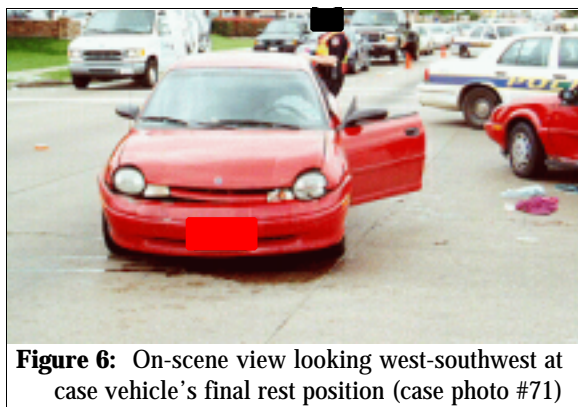
The front of the case vehicle (**Figures 3 and 4** above) impacted the left side of the Chevrolet (**Figure 5**), causing the case vehicle's driver and front right passenger supplemental restraints (air bags) to deploy. The case vehicle continued northward a short distance while rotating approximately 20 degrees counterclockwise and came to rest in the intersection heading east-northeast (**Figure 6**). The Chevrolet rotated approximately 100 degrees counterclockwise before coming to rest in the intersection heading southwest (**Figure 7**).

**Figure 6:** On-scene view looking west-southwest at case vehicle's final rest position (case photo #71)

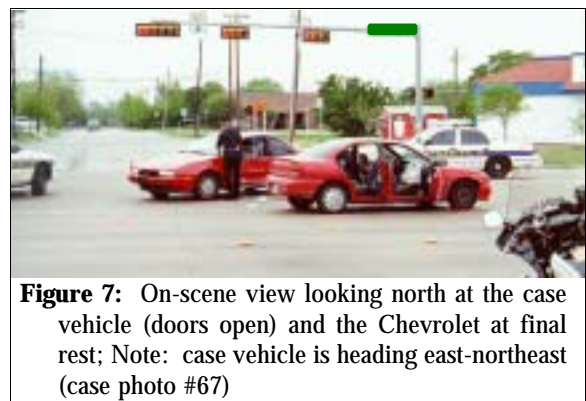
**Figure 7:** On-scene view looking north at the case vehicle (doors open) and the Chevrolet at final rest; Note: case vehicle is heading east-northeast (case photo #67)

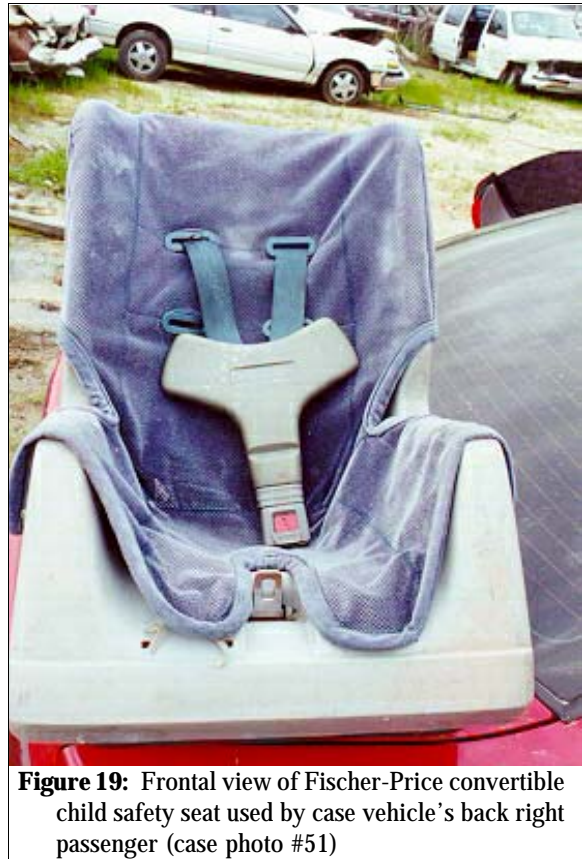
The child safety seat used by the case vehicle's back right passenger was a convertible child safety seat manufactured by Fischer-Price Products in 1984 and was identified by Model number "**9100**" (**Figure 19** below). The seat was equipped with a three-point harness with T-shield and two different shoulder height levels (dependent on height and size of child) that the webbing could be adjusted to fit through. In addition, the seat was designed with a retractor for the three-point harness and T-shield. There was only one slot for the buckle to connect the T-shield/harness portion between the child's legs. The inspection showed no visible evidence of

**Figure 19:** Frontal view of Fischer-Price convertible child safety seat used by case vehicle's back right passenger (case photo #51)
