SIDE IMPACT OCCUPANT PROTECTION INVESTIGATION

VERIDIAN CASE NO. CA01-012

VEHICLE - 2000 INFINITY I30

CRASH DATE - JANUARY, 2001

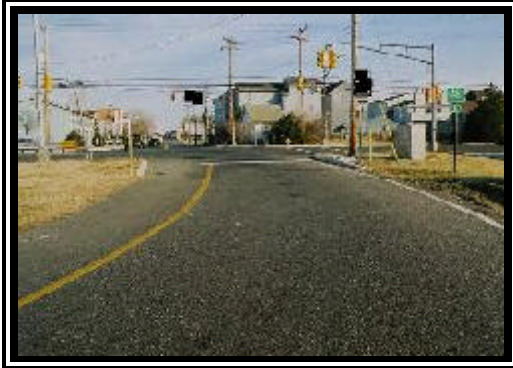
The 50 year old female driver of the 2000 Infinity I30 4-door sedan was initially stopped and facing east (**Figure 1**) when she entered the 4-leg intersection at a (driver reported) speed of 8 km/h (5 mph). Upon recognition of the impending harmful event, the driver accelerated in avoidance.

Figure 1. Eastbound approach for the 2000 Infinity I30.

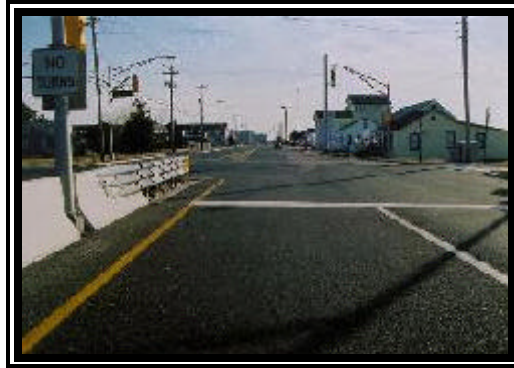
The 83 year old male driver of the 2000 Ford Focus SE 4-door sedan was operating the vehicle southbound (**Figure 2**) at a (driver reported) speed of 48 km/h (30 mph) when he failed to observe the red traffic signal or eastbound Infinity as he proceeded straight through the 4-leg intersection. Upon recognition of the impending harmful event, the driver steered left and braked in avoidance.

Figure 2. Southbound approach for the 2000 Ford Focus.

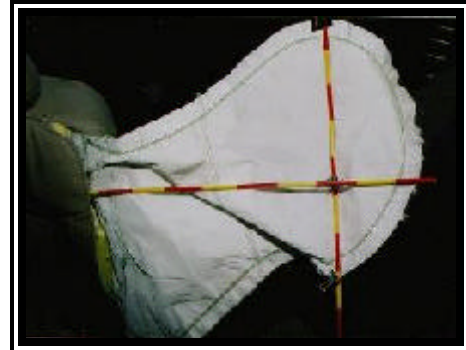
Figure 11. Close-up view.

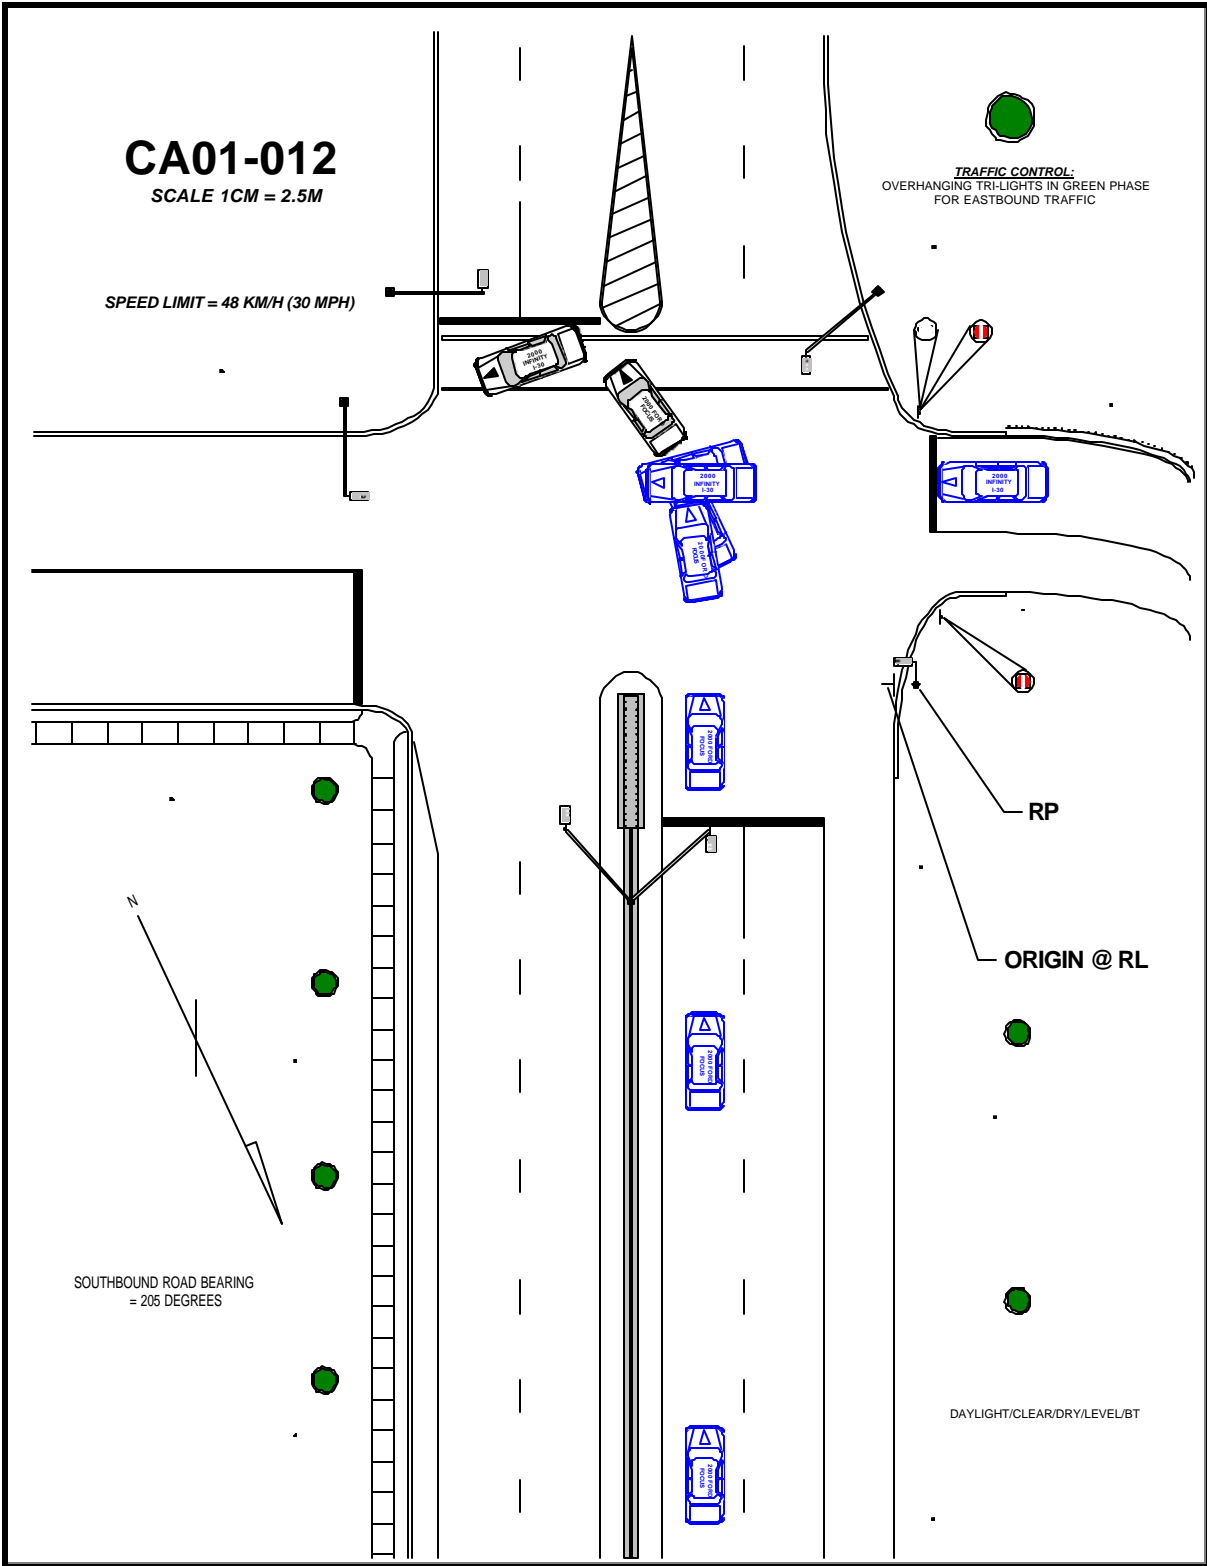
Figure 12. Scene Diagram.

This two vehicle crash occurred during the morning hours of January, 2001. At the time of the crash, it was daylight with no adverse conditions as the roads were dry. The crash occurred at a straight and level 4-leg intersection (see **Figure 12 - page 7**) which was controlled by an overhead signal system in green phase for eastbound traffic. The north/southbound lanes consisted of four asphalt travel lanes divided by a concrete (Jersey) barrier in the north sector of the intersection and by a painted median strip in the south sector. The roadway was bordered by wide paved shoulders and barrier curbs. An exit ramp (or "jug handle") was located approximately 274.0 meters (300.0 yards) north of the crash site which allowed southbound traffic access to the eastbound secondary road. The eastbound access road consisted of one asphalt lane which curved left on approach to the intersection. This access road was bordered by a W-beam guardrail to the south and a grassy median to the north. The posted speed limit at the crash site was 48 km/h (30 mph).
