On-scene Investigation / Vehicle to Vehicle  
Dynamic Science, Inc. / Case Number: DS01-013  
1997 Nissan Quest  
North Carolina  
May, 2001

1. Report No. DS01-013		2. Government Accession No.		3. Recipient Catalog No.	
4. Title and Subtitle In-Depth Accident Investigation				5. Report Date	
				6. Performing Organization Report No.

**Dynamic Science, Inc.**  
**Accident Investigation**  
**Case Number: DS01-013**

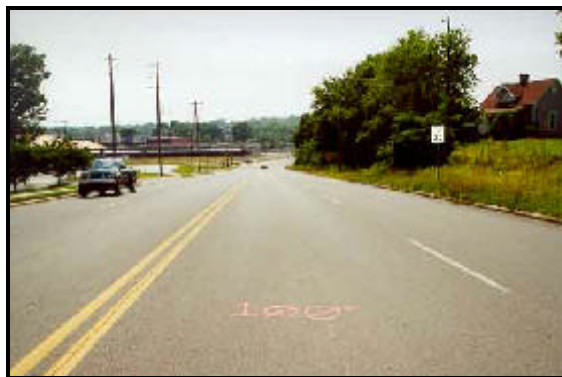
The crash occurred near a three-leg intersection in North Carolina in May, 2001 at 1508 hours. The westbound leg of the intersection is comprised of two westbound and two eastbound travel lanes. The road surface is asphalt. It was dry and free of defects. There is a -6% down grade approaching the intersection. There are no applicable traffic controls for westbound traffic. The speed limit for westbound traffic is 56 km/h (35 mph).

**Figure 1.** Overview of approach to impact area

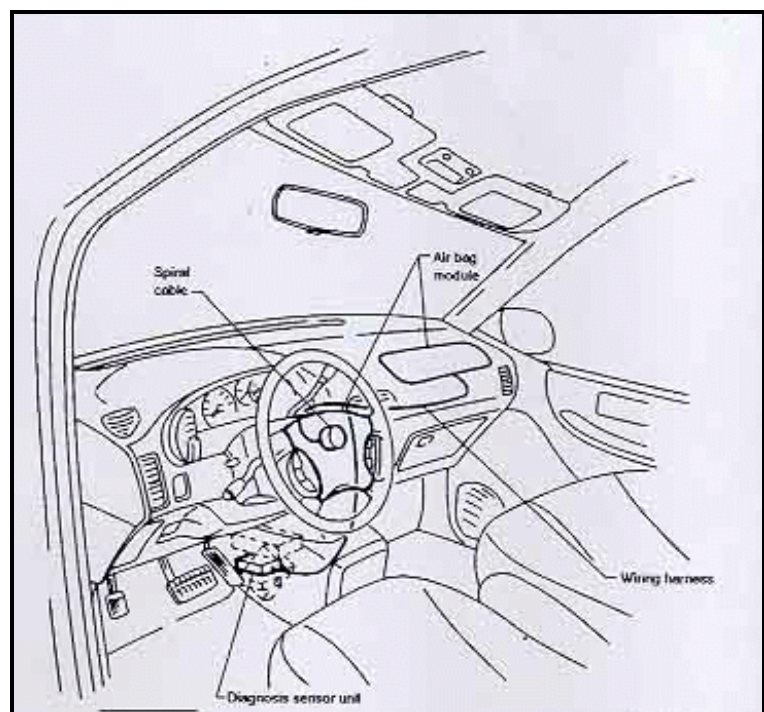
The case vehicle was equipped with a driver's air bag and a front right passenger's air bag. The driver's air bag was circular in shape and measured 67 cm (26.3 in) and had circular vent ports at the 11 and 1 o'clock positions. The air bag had four tethers and there were four visible horizontal and vertical folds; it was not damaged. The H-configuration air bag module cover was not damaged. The front right passenger's air bag was rectangular in shape and measured 54 cm (21.2 in) high by 72 cm (28.3 in) wide and had circular vent ports at the 10 and 2 o'clock positions.

**Figure 9.** SRS component locations

There were no tethers. There was no damage or visible contact to the air bag or the module cover.

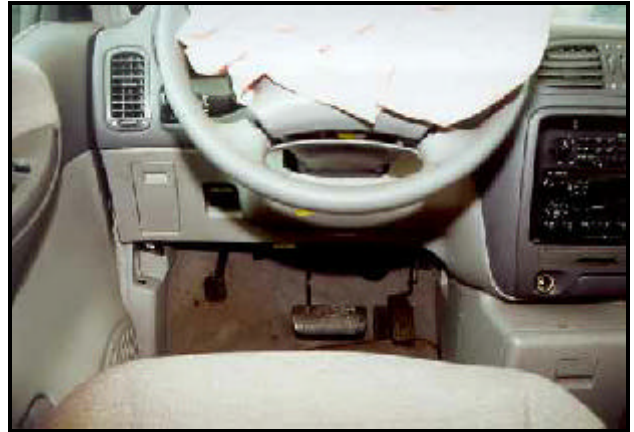
The 30-year-old driver of the case vehicle was seated in the cloth-covered bucket seat in a normal, upright fashion. The seat was adjusted to the rear-most track position at the time of the inspection. She was wearing the available lap and shoulder belt. The shoulder belt adjuster was in the full up position. Prior to impact, her right foot was on the brake. At impact, she pitched forward and engaged the deployed air bag. She continued moving forward and engaged the lower instrument panel with both knees—leaving scuff marks. She did not, however, report any injuries.

Figure 10. Front left seat position

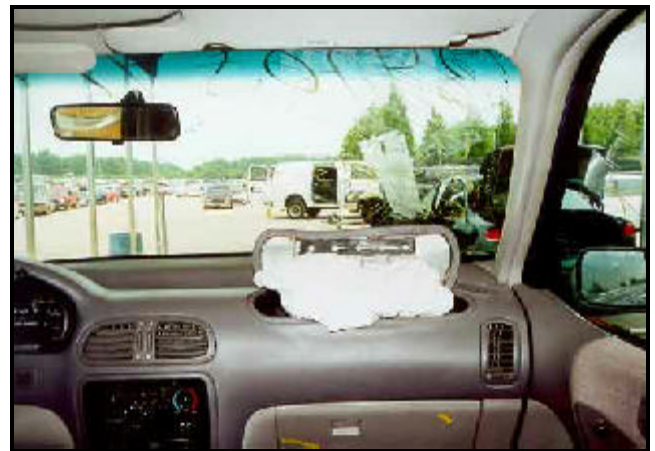
The 9-year-old male front right occupant was seated in the cloth-covered bucket seat in a normal, upright fashion. The seat back was slightly reclined. The seat was adjusted to the rear-most track position at the time of the inspection. He was not wearing the available lap and shoulder belt. He was facing to the left to some degree. This occupant initially responded to the braking forces by pitching forward. He likely raised his arms in a protective gesture. At impact responded to the 12 o'clock impact force by moving directly forward. His right arm was above the air bag module cover and likely contacted the windshield. There was no contact to the module cover itself. There was damage noted to the glove box door which was the result of knee loading from this occupant. While his arm was in contact with the windshield, the air bag deployed upward and rearward. The air bag struck his right arm, near the elbow. With his arm pinned by the windshield, the force was directed upward through the joint. This fractured the distal humerus lateral condyle. The deploying air bag pushed his arm up sharply causing the following injuries to his right arm/shoulder area: burns/abrasions, complete avulsion of the brachial plexus, complete avulsion of the sub-clavian artery, complete avulsion of the lower brachial nerve roots from the spinal cord, and a complete avulsion of the upper brachial nerve roots. He also sustained contusions to the right side of the face.

Figure 11. Front right seat position
