INDIANA UNIVERSITY

ON-SITE CHILD AIR BAG-RELATED FATALITY INVESTIGATION

CASE NUMBER - IN01-015
LOCATION - TEXAS
VEHICLE - 2001 FORD F150 XLT
CRASH DATE - May, 2001

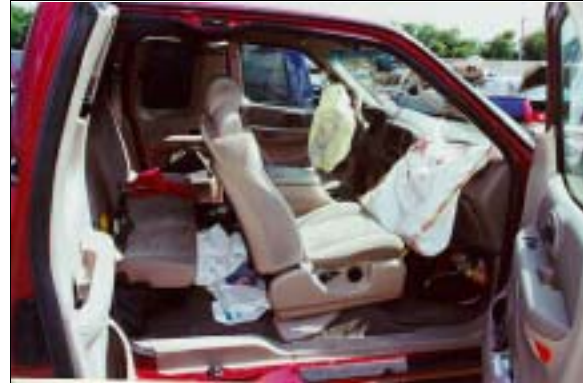
The 2001 Ford F-150 XLT was a rear wheel drive, 4x2, six-passenger, four-door, super cab, standard bed, pickup truck (VIN: 2FTZX172X1C-----) equipped with a 4.2L, V-6 engine and a four-speed automatic transmission. The back doors were hinged at the "C"-pillars with the locking latch mechanisms located at the top and bottom of where the "B"-pillars were normally

located (**Figure 6**). Braking was achieved by a power-assisted, front and rear disc, four-wheel, anti-lock system. The case vehicle's wheelbase was 352 centimeters (138.5 inches), and the odometer reading at inspection {was 9,249 kilometers (5,747 miles).

Figure 6: Case vehicle's interior with both right side doors open showing super cab and deployed front air bags (case photo #28)

Inspection of the vehicle's interior revealed adjustable front bucket seats with adjustable head restraints; a non-adjustable back bench seat without head restraints for the back seating positions; integrated (i.e., seat back-mounted) continuous loop, three-point, lap-and-shoulder, safety belt systems at the front outboard positions; continuous loop, three-point, lap-and-shoulder, safety belt systems at the back outboard positions; and a two-point, lap belt system at the back center position. None of the seat belt systems were equipped with manually operated, upper anchorage adjusters for the "D"-rings. The vehicle was equipped with knee bolsters for both the driver and front right passenger, neither of which were deformed. Automatic restraint was provided by a Supplemental Restraint System (SRS) that consisted of a redesigned frontal air bag for the driver and front right passenger seating positions. Both frontal air bags deployed as a result of the case vehicle's frontal impact with the Crown Victoria.

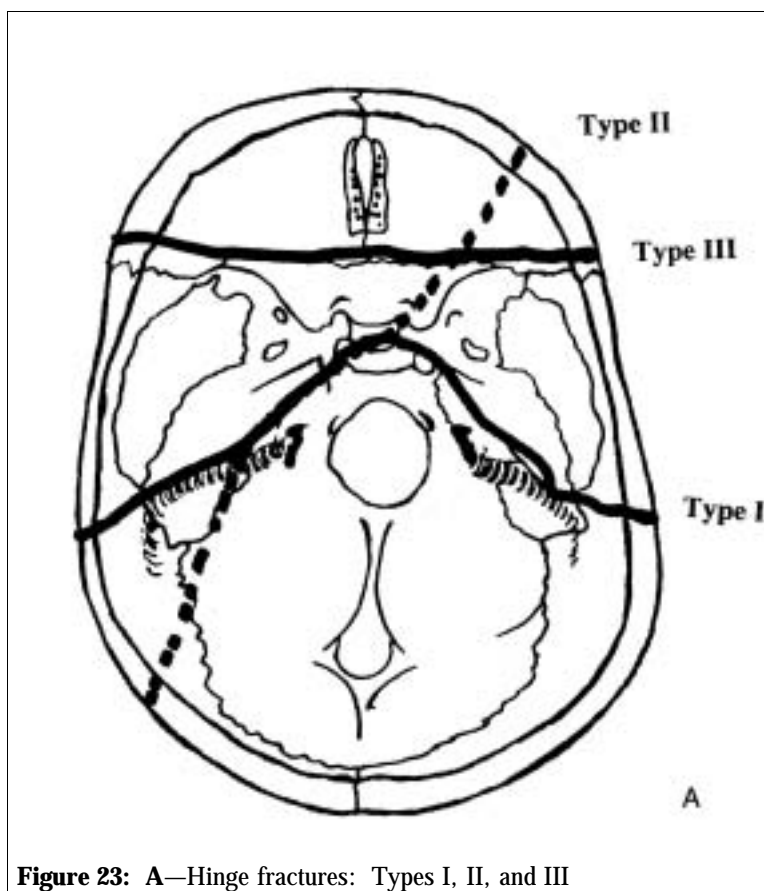
HINGE FRACTURES are transverse fractures of the base of the skull that completely bisect the base of the skull, creating a "hinge." The authors divide them into three categories (**Figure 23**). Type I run in the coronal plane, extending from the lateral end of one petrous ridge, through the sella turcica, to the lateral end of the contralateral petrous ridge. Type II run from front to the contralateral back, passing through the sella turcica. Type III run from side to side in the coronal plane but do not pass through the sella turcica. *Type I hinge fractures are the most common form of transverse fractures of the base of the skull.* They have traditionally been ascribed to impacts on the side of the head and, less commonly, to impacts on the tip of the chin. In the latter instance, one would expect a laceration of the tip of the chin, through not necessarily fracture of the mandible.

Figure 23: A—Hinge fractures: Types I, II, and III

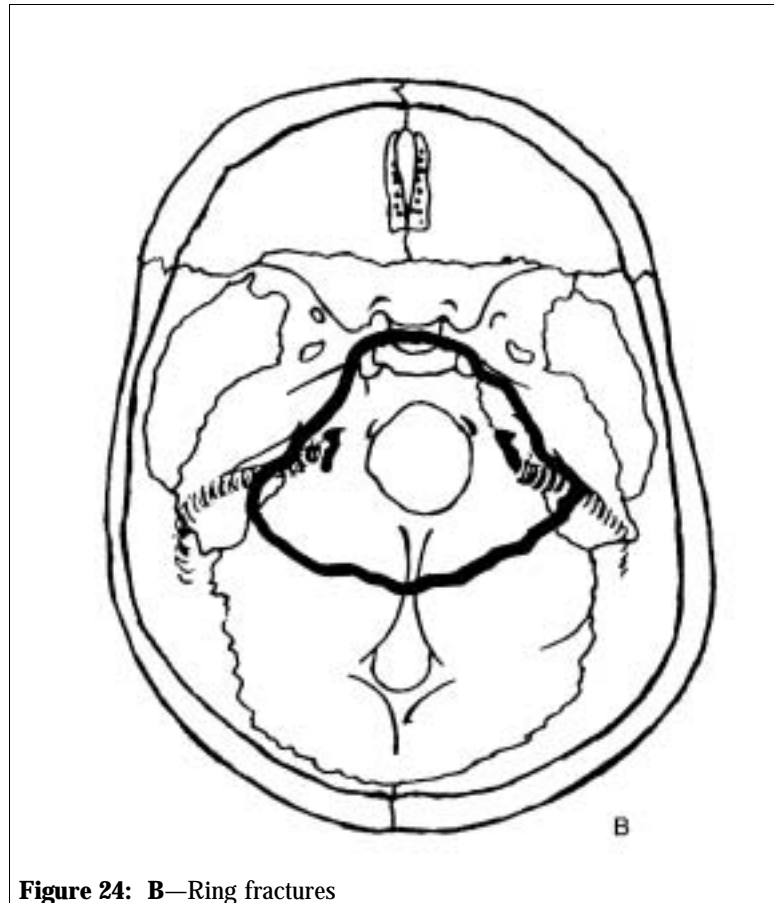
RING FRACTURES are circular fractures of the base of the skull that surround the foramen magnum. Typically, they run from the sella turcica partly down the petrous ridges, before turning posteriorly, and then medially, joining in the posterior fossa, enclosing the foramen magnum (**Figure 24**). They may be due to impacts on the top of the head that drive the skull downward onto the vertebral column, falls on the buttocks that drive the spine into the base of the skull, and impacts to the tip of the chin. In ring fractures from impacts on the tip of the chin, almost invariably there is a laceration of the chin. Even though the force of impact is transmitted through the mandible to the base of the skull, in most instances, fractures of the mandible are not present. Experiments have revealed that more force is needed to fracture the mandible than to produce a basal fracture.

Figure 24: B—Ring fractures
