**VERIDIAN ON-SITE CHILD SAFETY SEAT CRASH INVESTIGATION
SCI TECHNICAL SUMMARY REPORT**

VERIDIAN CASE NO. CA01-024

VEHICLE - 1996 CHEVROLET BLAZER

CRASH DATE - APRIL 2001

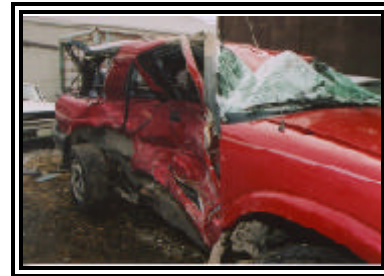
This on-site investigation focused on a two-vehicle intersection crash that involved a 1996 Chevrolet Blazer (subject vehicle) and a 1997 Ford Explorer. The front of the Explorer struck the right side of the Blazer and caused the Blazer to trip-over onto its roof (**Figure 1**). The Chevrolet Blazer was driven by a 26-year-old male who was restrained by the 3-point manual lap and shoulder belt. The 3-year-old female passenger, who incurred minor injuries, was positioned in the right rear seat of the Chevrolet Blazer in a shield booster seat. The Ford Explorer was occupied by a 41-year-old female driver and a 39-year-old female front right passenger. Both occupants of the Explorer were restrained. Impact resulted in severe damage to the Blazer and moderate damage to the Explorer. The impact caused the deployment of the frontal air bag system in the Ford Explorer. The driver of the Blazer initiated a lateral trajectory to the right and loaded the center console. The use of the 3-point manual lap and shoulder belt prevented additional movement throughout the vehicle. He sustained minor hand abrasions, arm abrasions, and a posterior right upper arm contusion. He was transported by ambulance to a regional trauma center where he was treated and released. The 3-year-old child passenger initiated a lateral trajectory and jackknifed over the right side aspect of the shield booster and struck her head on intruding components. She sustained abrasions and contusions on her right hand and a minor abrasion over her right eye. She was transported by ambulance to a regional children's hospital where she was admitted and was released the following day. Both occupants of the Explorer initiated forward trajectories and loaded the manual restraints and deployed frontal air bags. The driver had a police-reported complaint of back pain, and the front right passenger sustained police-reported facial bleeding. Both were transported by ambulance to a local hospital. Their admission status was not reported.

Figure 1. 1996 Chevrolet Blazer

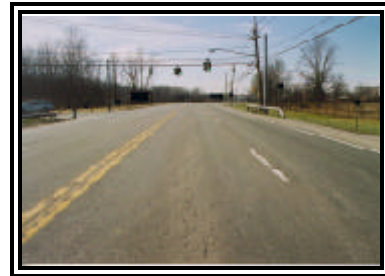
Figure 2. Approach #1 for the Chevrolet Blazer

The 26-year-old male driver of the 1996 Chevrolet Blazer was stopped south of the intersection in the inboard northbound lane behind an uninvolved vehicle (**Figure 2**). Both vehicles were waiting for southbound traffic to clear so they could make a left turn onto the east/west roadway. At the time he came to a stop, the traffic signal was still in the green phase for north/south traffic. According to the driver of the Blazer, he thought the traffic signal had cycled from green to red for north/south traffic, and the vehicle in front of the Blazer initiated the left turn in an attempt to clear the intersection (**Figure 3**). He noted that a vehicle to his right in the outboard northbound lane had stopped for the traffic signal. The driver of the Blazer followed the other vehicle in an attempt to clear the intersection. The driver of the Blazer noted that there was no cellular telephone present and that the radio was not on at the time of the crash.

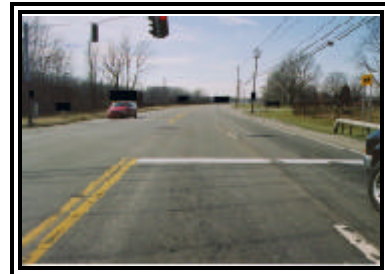
Figure 3. Approach #2 for the Chevrolet Blazer

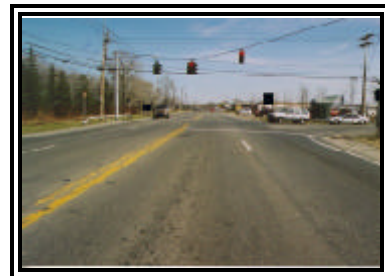
The 41-year-old female driver of the 1997 Ford Explorer was operating the vehicle southbound in the inboard lane on approach to the 3-leg intersection (**Figure 4**). She detected the uninvolved vehicle initiating a left turn across her path in the intersection. She steered to the right and traveled toward the outboard lane and entered the intersection. As the uninvolved vehicle cleared the intersection, the driver of the Explorer failed to detect the Blazer turning left behind the uninvolved vehicle. The driver of the

Figure 4. Approach for the 1997 Ford Explorer

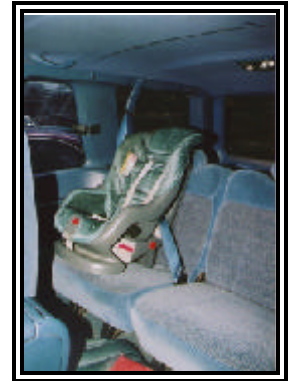
the driver's seat back and plugged into the accessory outlet. The rear seat was configured with a two-person split bench seat with folding backs and adjustable head restraints. The front seating positions were equipped with 3-point manual lap and shoulder belts with sliding latch plates. The front right lap and shoulder belt was equipped with a switchable retractor. Both front lap and shoulder belts showed signs of loading and were operational. Both latch plates were abraded, which indicated frequent usage. The upper anchorage adjustments were both in the full-up position, and there were no indications of failure. Both rear seating positions were equipped with 3-point manual lap and shoulder belts with switchable retractors and sliding latch plates. Both latch plates indicated frequent usage. The rear left 3-point manual lap and shoulder belt was in its stowed position and had one twist in the webbing between the retractor and the upper D-ring anchor, and two additional twists between the upper D-ring anchor and lower anchor point. The rear right 3-point manual lap and shoulder belt was routed through the forward facing belt path of a convertible child safety seat that was installed in the rear right position (**Figure 10**). The child safety seat had 10.0 cm (3.9") of lateral movement at the belt path. The lap and shoulder belt webbing had one twist in it between the retractor and upper D-ring anchor and was crimped as the shoulder belt webbing passed through the latch plate.

Figure 10. Child safety seat in the Ford Explorer

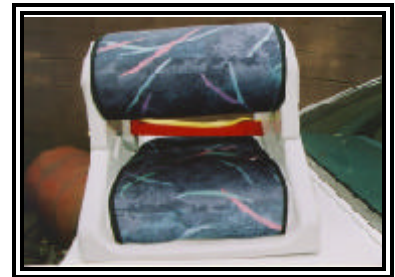
The child safety seat that was installed in the Chevrolet Blazer was a Gerry "Double Guard" shield booster (**Figure 12**). The model number was 675 and the manufacture date was May 4, 1994. The driver of the Blazer did not have access to an owner's manual, as the seat had been given to him from a family member who purchased the seat new approximately 8 years ago. A copy of the owner's manual was obtained from NHTSA, and provided the basis for evaluating the use of this child safety seat.

Figure 12. Gerry "Double Guard" shield booster seat

Damage to the Gerry “Double Guard” booster seat was minor, which was attributed to compartment intrusion and occupant contact. The integrated lap belt showed signs of occupant loading from the impact forces and the child being suspended upside down by the belt after the Blazer tipped onto its roof. Scuff marks were noted on the right outer aspect of the booster seat from contact with the intruded right interior side panel aft of the B-pillar (**Figures 15 and 16**). Abrasions were noted on the outboard aspects of the vehicle belt path from the lap and shoulder belt as the booster seat loaded the vehicle’s lap and shoulder belt. The rigid plastic bottom aspect of the child safety seat was scuffed from the lateral travel on the rear seat cushion.

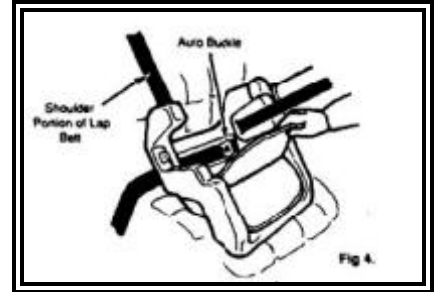
Figure 13. Illustration of proper belt path from owner's manual
