**TRANSPORTATION SCIENCES
CRASH DATA RESEARCH CENTER**

ADVANCED OCCUPANT PROTECTION SYSTEM INVESTIGATION

VERIDIAN CASE NO. CA01-034

VEHICLE: 2000 MERCURY SABLE

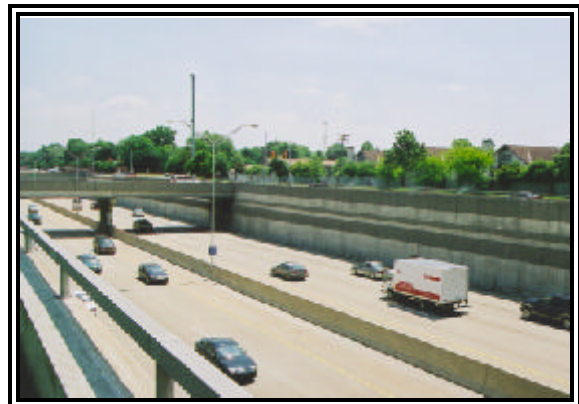
Figure 1: Southeastward view of the crash scene.

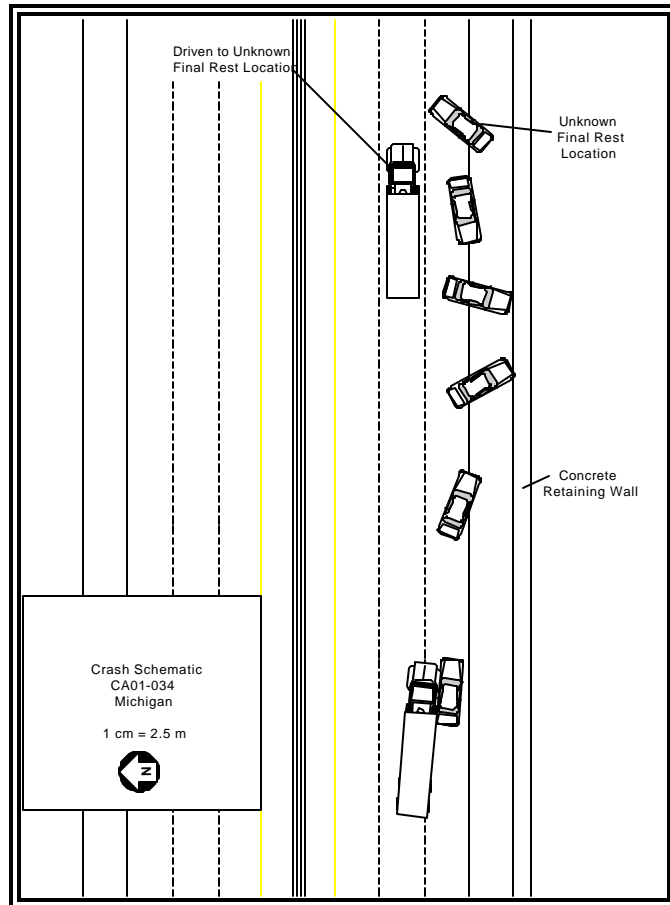
In the process of the lane change maneuver, the right drive wheels of the tractor sideswiped the left side of the Mercury in the area of the left rear door. The driver of the Mercury steered to the right in an avoidance maneuver and lost control of the vehicle. The Mercury continued to the right, traveled through the breakdown lane and impacted the concrete retaining wall on the south side of the roadway. The front plane of the Mercury struck the wall resulting in a direction of force in the 11 o'clock sector. The impact induced deceleration was above the required air bag deployment threshold and the vehicle's frontal air bags deployed. The Mercury's momentum caused the vehicle to rotate clockwise along the concrete wall and it came to rest facing northeastward. The tractor trailer came to a controlled stop on the roadside, east of the Mercury. The final rest locations of the vehicles were not documented by the police investigation. **Figure 2** is a schematic of the crash.

Figure 2: Crash schematic.
