**VERIDIAN ON-SITE SIDE IMPACT OCCUPANT PROTECTION
INVESTIGATION**

VERIDIAN CASE NO. CA01-047

VEHICLE - 2000 PONTIAC MONTANA

CRASH DATE - OCTOBER, 2001

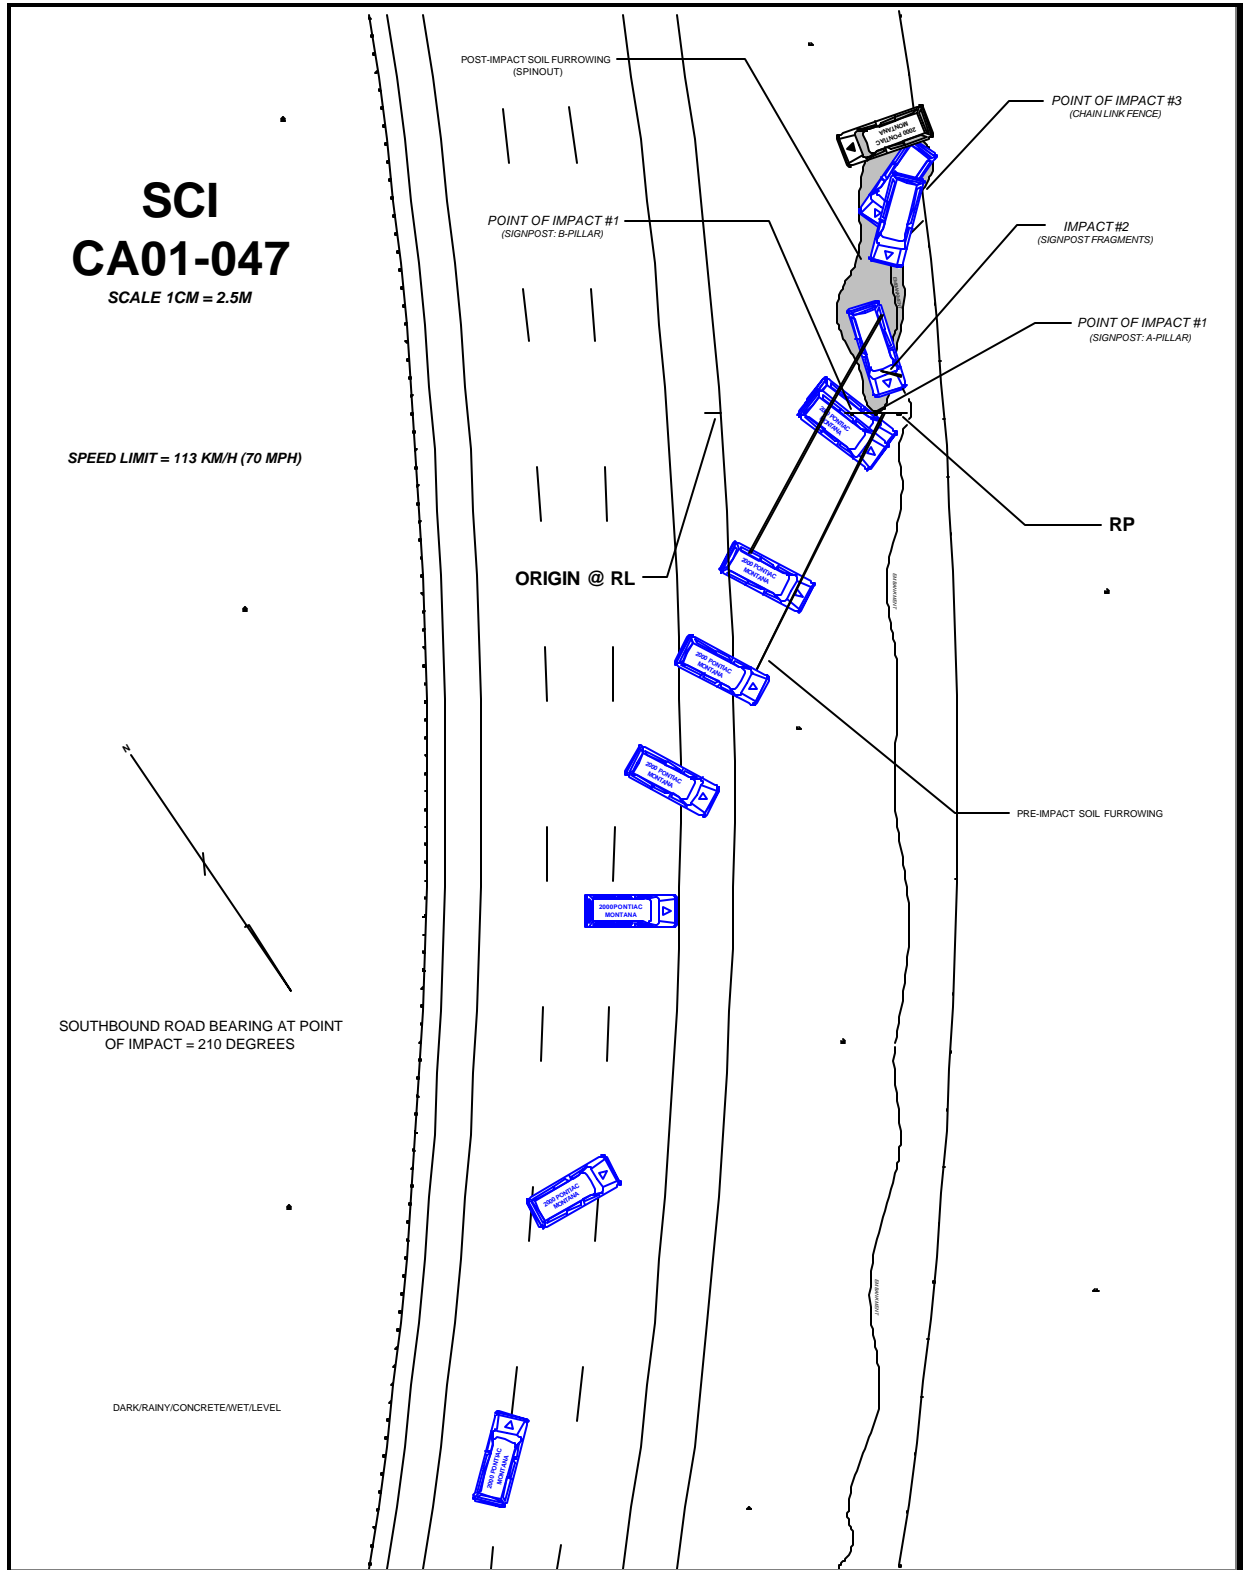
Figure 13. Scene Diagram.

This single vehicle crash occurred during the morning hours of October, 2001. At the time of the crash, it was dark (street not lighted) with rainy conditions as the roads were wet. The crash occurred off the west pavement edge of a (level) multi-lane north/south state roadway (see **Figure 13 - page 8**) which curved left for southbound traffic. The concrete surfaced roadway was bordered by wide paved shoulders and divided by a three-beam median barrier. Environmental features also included a road sign located 7.3 meters (24.0 feet) off the west shoulder supported by three 15.2 cm x 20.3 cm (6.0 in x 8.0 in) treated posts spaced 1.3 meters (4.3 feet) apart. A chain link fence was also documented 12.4 meters (39.7 feet) off the west pavement edge with support posts spaced on 3.2 meter (10.5 feet) centers. No traffic control was present at the scene which had a posted speed limit of 113 km/h (70 mph).
