**REMOTE NASS/SCI COMBINED  
ADVANCED OCCUPANT PROTECTION/DRIVER FATALITY INVESTIGATION**

**VERIDIAN CASE NO. 2002-05-013A**

**VEHICLE - 2001 VOLVO S40**

**CRASH DATE - JANUARY, 2002**

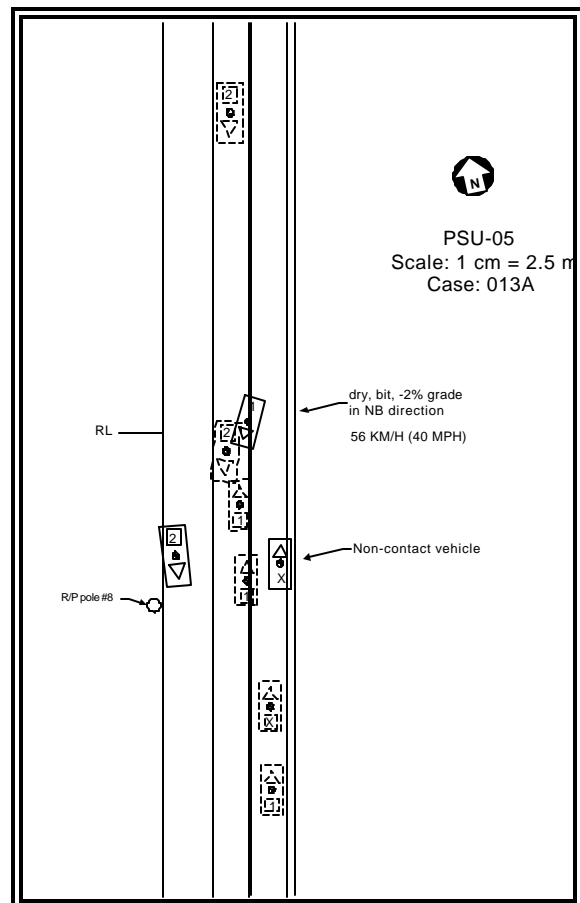
**Figure 2:** Crash schematic.

The crash occurred with the left front of the Volvo impacting the left front of the Chevrolet in an offset frontal impact configuration. The force of the impact caused the Volvo to rotate counterclockwise, as it disengaged from the van. The Volvo rotated approximately 180 degrees and came to rest in-close proximity to (and north of) the point of impact (POI). Two gouge marks in the southbound lane, near the double yellow centerline, identified the point of impact (POI). The Chevrolet van was deflected to its right and into the breakdown lane bordering the southbound lane. The van came to rest against the outboard curb facing south. The velocity changes (delta V's) calculated by the Damage Algorithm of the WINSMASH model were 68.0 km/h (42.3 mph) and 42.0 km/h (26.1 mph) for the Volvo and Chevrolet, respectively. **Figure 2** is a schematic of the crash.
