**VERIDIAN REMOTE ADVANCED OCCUPANT PROTECTION SYSTEM  
INVESTIGATION  
SCI TECHNICAL SUMMARY REPORT**

**NASS/SCI COMBO CASE NO. 02-08-148E**

**VEHICLE – 2003 DODGE STRATUS**

**CRASH DATE – AUGUST 2002**

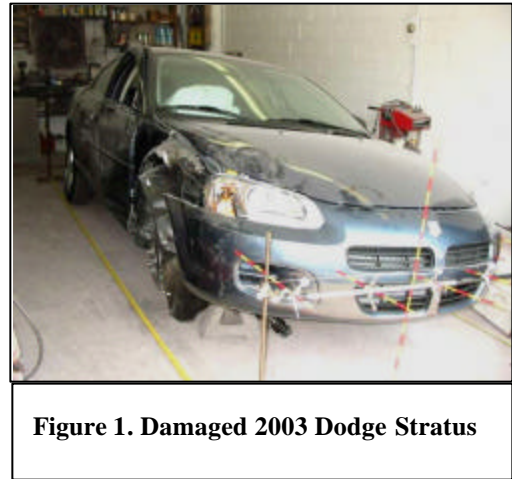
This remote investigation focused on the performance of the Advanced Occupant Protection System (AOPS) in a 2003 Dodge Stratus sedan (**Figure 1**). The AOPS included safety belt pretensioners and multi-stage frontal air bags. The Stratus was occupied by a 36-year-old male driver who was unrestrained. He was operating the Stratus on a two-lane roadway on approach to a four-leg intersection. The driver lost control of the vehicle and departed the roadside after traveling through the intersection. The vehicle struck a wood utility pole with the front right aspect in sideswipe configuration, which caused the right front alloy wheel to fracture. The Stratus sustained moderate right side damage and the impact was sufficient to deploy the frontal air bag system. The unrestrained driver loaded the driver's air bag and sustained a minor right scalp laceration and contusion from contact with the rear-view mirror. The driver was transported by ambulance to a local hospital and treated for minor severity injuries, and released.

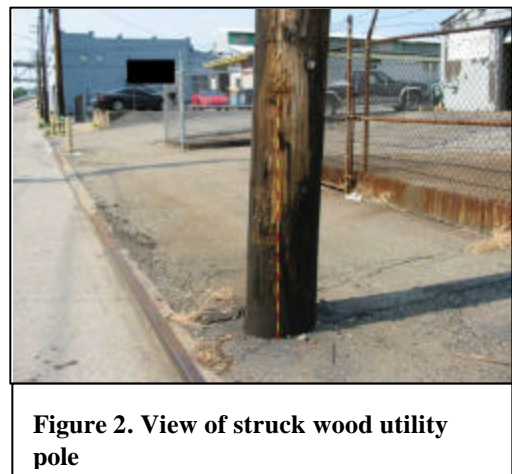
This single-vehicle crash occurred during the nighttime hours of August 2002 in the state of Pennsylvania. At the time of the crash, it was dark and the asphalt roadway surface was dry. The crash occurred on an unmarked, north/south, two-lane, local roadway bordered by 7.6 cm (3.0") concrete curbs. The roadway was straight and level at the crash site and was illuminated by overhead lights on wood utility poles. The utility poles (**Figure 2**) were located along both sides of the roadway, measured 35.6 cm (14.0") in

diameter, and were located 50.8 cm (20.0”) outboard of the curb lines. The roadside environment consisted of concrete sidewalks and commercial buildings. The posted speed limit for the north/south roadway was 24 km/h (15 mph). A four-leg intersection was located approximately 61 m (200’) south of the crash site. Traffic flow through the intersection was controlled by stop signs on each corner. The NASS scene schematic is included as **Figure 13** of this report.
