**VERIDIAN REMOTE ADVANCED 208-COMPLIANT VEHICLE INVESTIGATION  
SCI TECHNICAL SUMMARY REPORT**

**NASS/SCI COMBO CASE NO. 02-08-235E**

**VEHICLE – 2003 HONDA ODYSSEY**

**CRASH DATE – DECEMBER 2002**

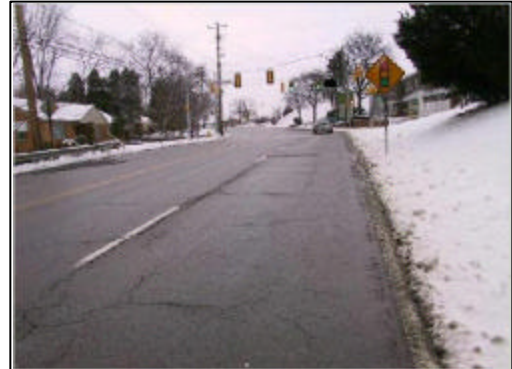
**Figure 2. Eastbound approach for the Honda Odyssey**

The 40-year-old female driver of the 2003 Honda Odyssey was operating the vehicle eastbound on approach to the four-leg intersection (**Figure 2**). A 2002 Dodge Intrepid was stopped in traffic prior to the intersection, and a 2001 Ford Excursion was stopped behind the Intrepid. It was not known which phase the traffic signal was in for east/west traffic. The driver of the Odyssey stated in the NASS interview that for unknown reasons she looked away from the roadway as the vehicle was approaching the intersection. When she subsequently looked at the roadway, she detected the stopped vehicles in the lane ahead of the Odyssey. The driver did not attempt any avoidance maneuvers prior to the impact with the Ford Excursion.

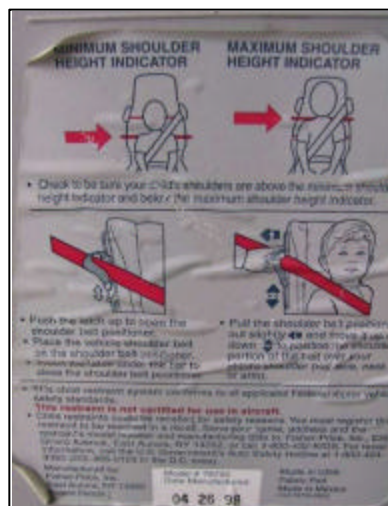
**Figure 7. View of height recommendations on the rear aspect of the booster CSS**

A Fisher-Price high-back belt-positioning booster CSS (**Figure 7**) was positioned in the second row left bucket seat of the Odyssey. The model number was 79750 and the Date of Manufacture was April 26, 1998. The CSS was not configured with a harness system. The CSS was not configured with Lower Anchorages and Tethers for Children (LATCH) attachments or a tether. The CSS was designed for use with the vehicle's manual 3-point lap and shoulder belt system in a forward-facing orientation. The booster seat was also configured with adjustable shoulder belt positioners on each side of the seat. The label (**Figure 8**) affixed to the rear aspect of the CSS indicated the minimum and maximum height recommendations by an illustration which identified two lateral indicators that were on the CSS seat back.

There was no identifiable damage to the Fisher-Price CSS .

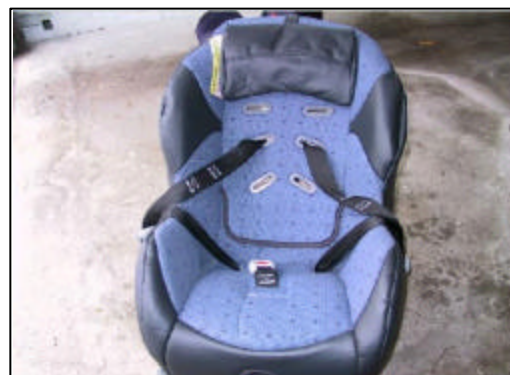
**Figure 9. Graco ComfortSport Convertible CSS**

A Graco ComfortSport convertible CSS (**Figure 9**) was installed in a rear-facing orientation on the second row right bucket seat of the Odyssey. The model number was 8432BLK and the date of manufacture was July 15, 2002. The CSS was configured with lower LATCH attachments. They consisted of clips fixed to a section of webbing which was positioned through the CSS belt path. The CSS was also configured with a tether. The lower LATCH attachments were used for the installation, however, the tether was not. The CSS was configured with a 5-point harness system and the harness straps were positioned through the middle harness slots. The CSS was also configured with a padded head rest on the top aspect of the seat.

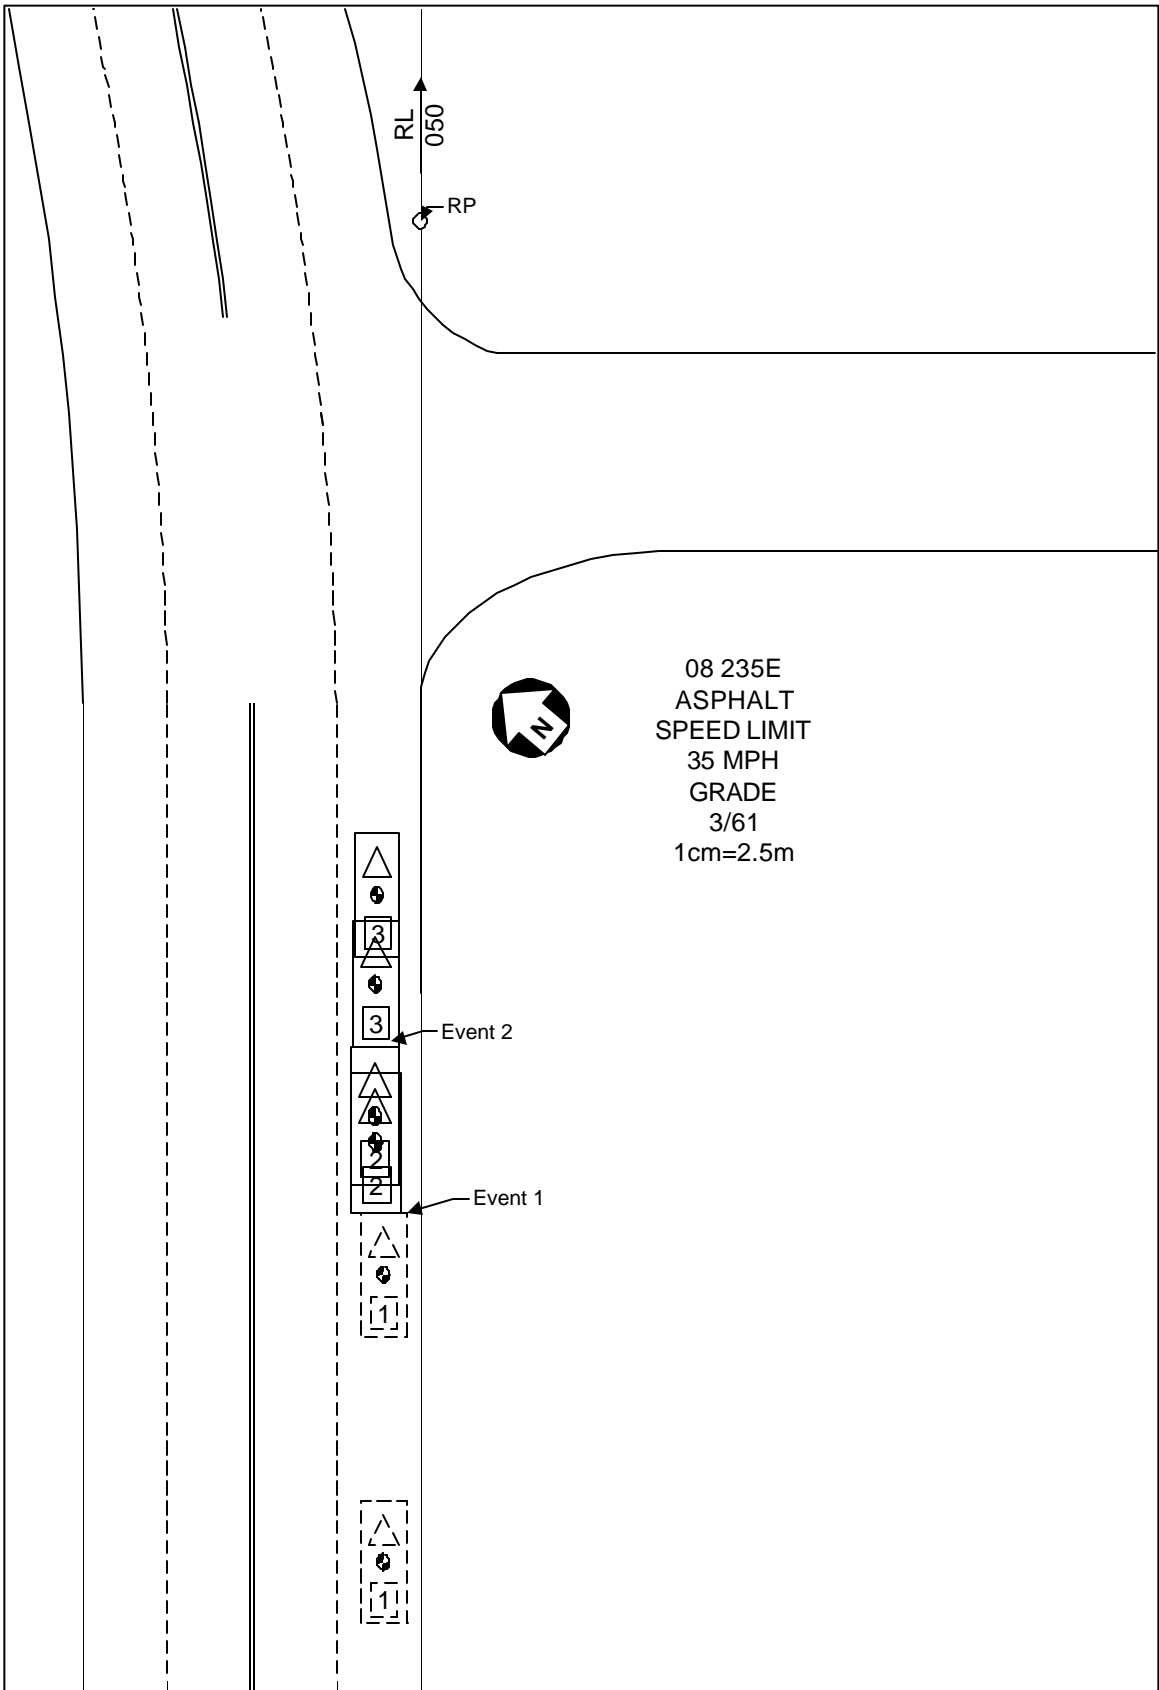
Figure 12. NASS scene schematic

centerline. The roadway was bordered by white fog lines adjacent to concrete curbs. The roadway was straight at the crash site and exhibited an eastbound left curve on the east leg of the intersection. The roadway also exhibited a positive 4 percent eastbound grade. Traffic flow through the intersection was controlled by overhead three-phase traffic signals. A yellow traffic signal warning sign was present on the roadside of the west leg of the intersection. The roadside environment consisted of private residences and commercial buildings. The posted speed limit for the east/west roadway was 56 km/h (35 mph). The NASS scene schematic is included as **Figure 12** of this report.
