Combination Investigation / Vehicle to Vehicle
Dynamic Science, Inc. / Case Number: 2002-75-053A
2000 Toyota 4-Runner SUV
Colorado
May, 2002

1. Report No. 2002-75-053A	2. Government Accession No.		3. Recipient Catalog No.	
4. Title and Subtitle In-Depth Accident Investigation		5. Report Date February 3, 2003

Description: This possible front right seat occupant air bag related fatality case was generated through NASS PSU 75. The case vehicle is equipped with redesigned air bags. DSI was assigned the case on May 28, 2002. This three-vehicle case was investigated as a combination case.

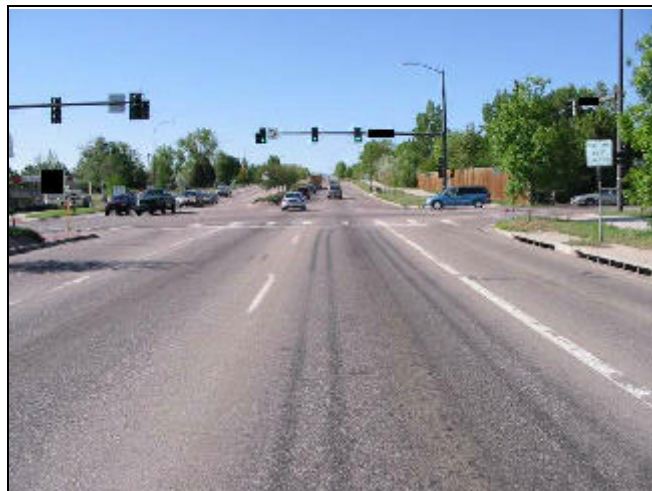
Figure 1. Path of travel—case vehicle (southbound)

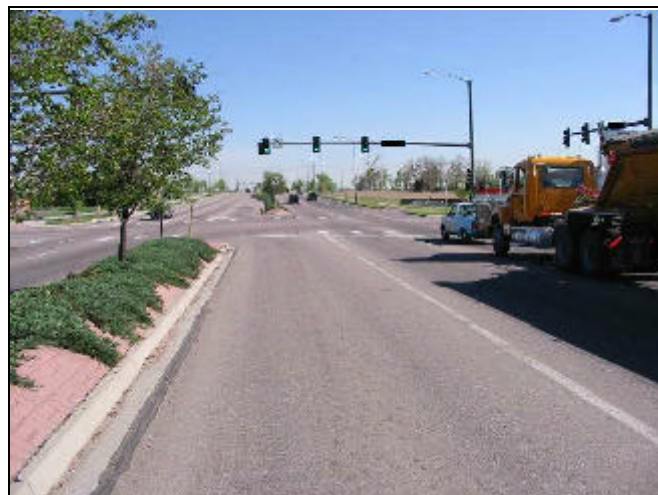
Figure 2. Path of travel—first other vehicle (northbound)

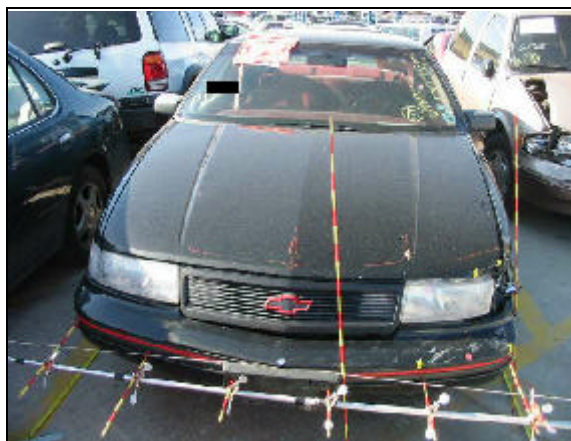
Figure 6. Second other vehicle—Chevrolet Lumina

During this impact, this vehicle sustained 29 cm (11 in) of direct contact to the front left bumper. The maximum crush was located at C1 and measured 4 cm (2 in). The principle direction of force was within the 11 o'clock sector and was an estimated 340 degrees. The impact energy was managed by the forward structures of the vehicle. The damaged components included the bumper facia and reinforcement bar and the left fender. There was no measured change in the wheelbase dimensions. There were no glazing fractures and all doors remained operational.

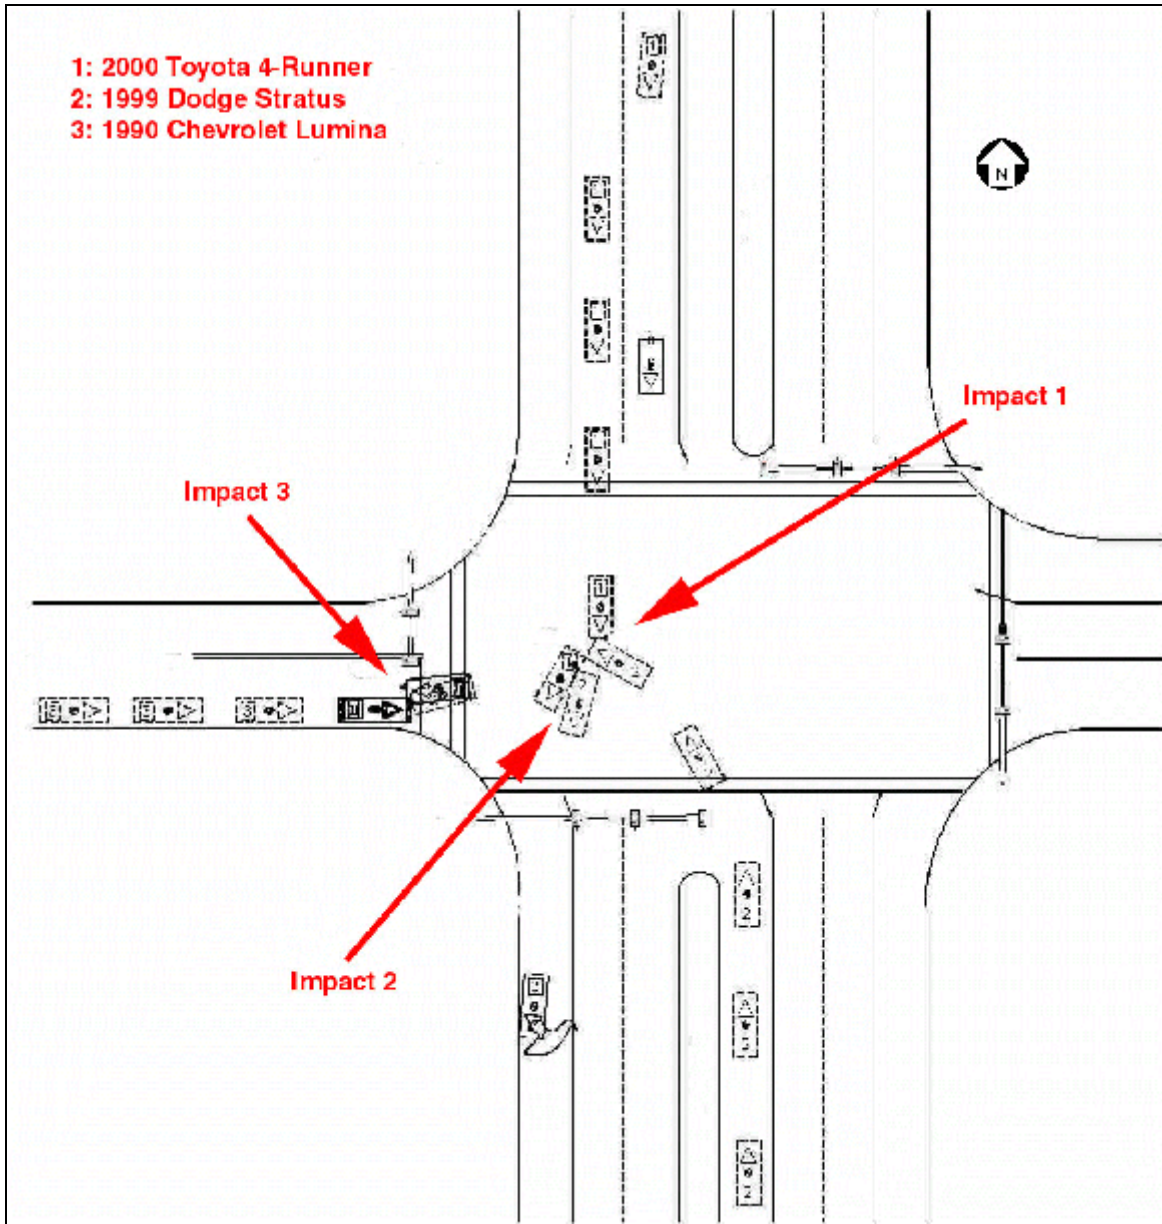
Figure 7. Scene diagram

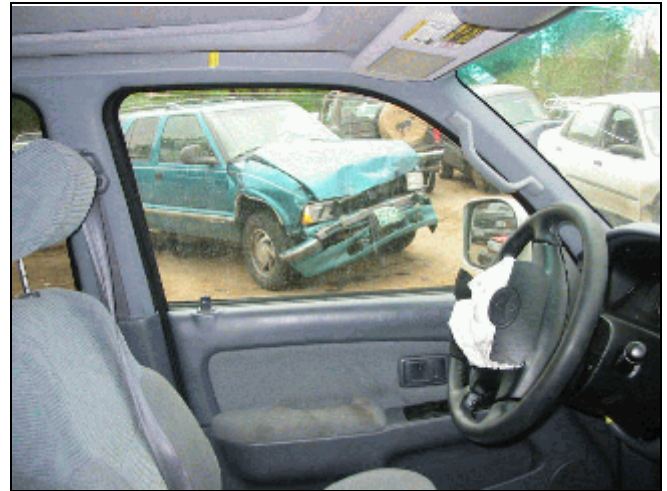
The front left seat was occupied by a lap and shoulder belt restrained 32-year-old female (170 cm/67 in, 53 kg/117 lbs). She was seated in a bucket seat that had been adjusted to between the middle and rear most track position. The seat belt anchorage was in the full up position. Both hands were on the steering wheel. This seat position was equipped with a driver's air bag, a seat belt pretensioner, and seat belt force limiters. Upon impact, the driver's pretensioner fired and the frontal air bags deployed. The driver responded to the 11 o'clock direction of force by moving forward and to the left and loading the pretensioned and locked manual restraint system. She likely contacted the air bag to some degree, but there were no residual occupant contacts. Her right hand came off the steering wheel and struck the windshield—causing a minor contusion. An unspecified part of her right leg struck the knee bolster—causing a contusion.

Figure 13. Driver's seated position

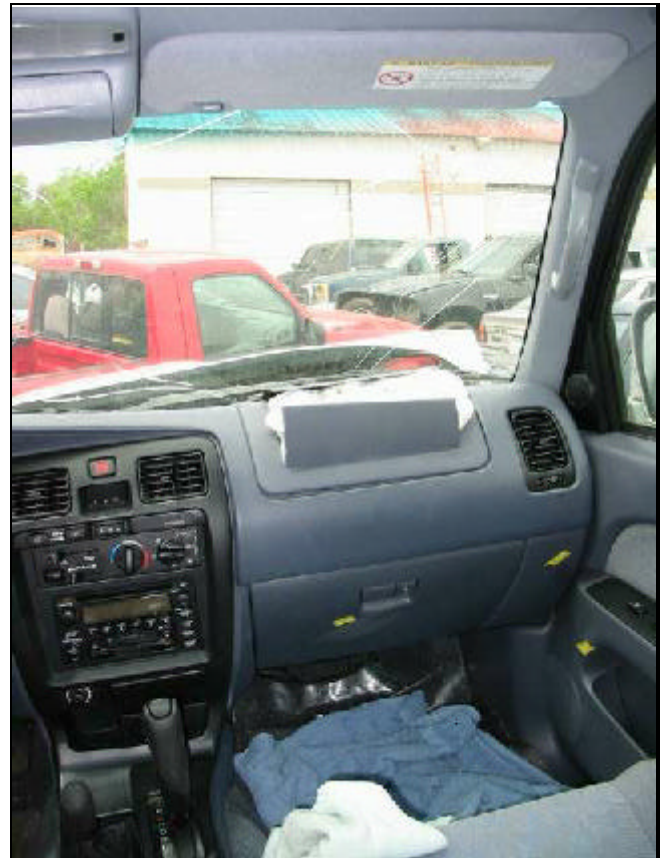
The front right seat was occupied by a lap and shoulder belt restrained 71-year-old female (150 cm/59 in, 54 kg/120 lbs). She was seated in a bucket seat that had been adjusted to between the middle and rear most track position. The seat belt anchorage was in the full up position. This seat position was equipped with a front right passenger air bag, a seat belt pretensioner, and seat belt force limiters. Upon impact, the seat belt pretensioner fired and the passenger air bag deployed. The front right occupant responded to the 11 o'clock direction of force by moving forward and to the left and loading the pretensioned and locked manual restraint system—causing the liver and heart lacerations. Both knees engaged the glove compartment. As this occupant pitched forward, she engaged the deployed air bag with her head (the interviewee reported blood coming from her mouth). Her head was forced rearward—causing the neck fracture. She continued rebounding rearward until striking the head restraint—causing the brain injuries.

Figure 16. Front right occupant seated position

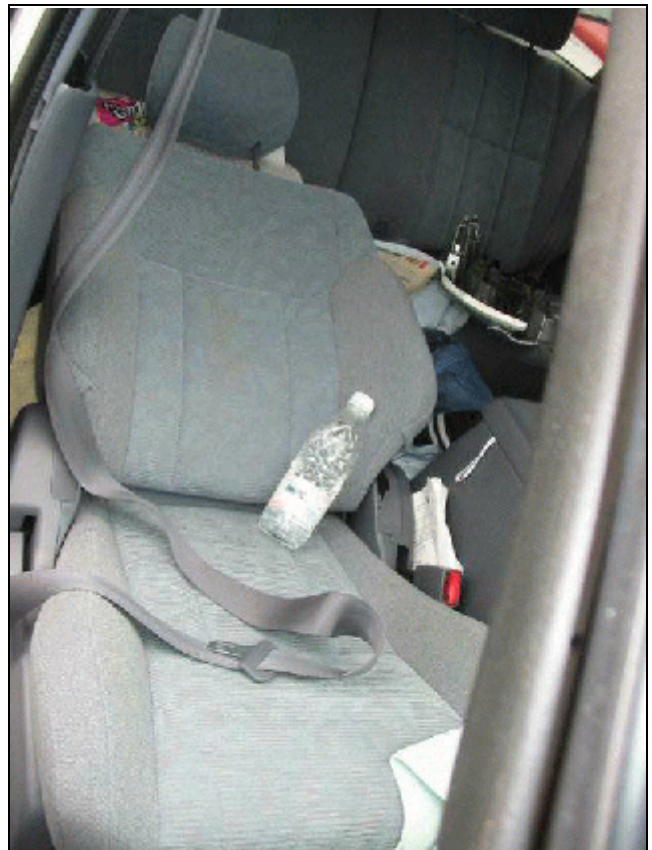
Figure 18. Front right passenger seat back and seat belt
