Combination Investigation / Vehicle to Vehicle
Dynamic Science, Inc. / Case Number: 2002-82-104F
2003 Volkswagen Passat GLS four-door
Washington
December, 2002

1. Report No. 2002-82-104F		2. Government Accession No.		3. Recipient Catalog No.	
4. Title and Subtitle Side Air Bag Crash Investigation				5. Report Date September 2, 2003

Dynamic Science, Inc.
Accident Investigation
Case Number: 2002-82-104F

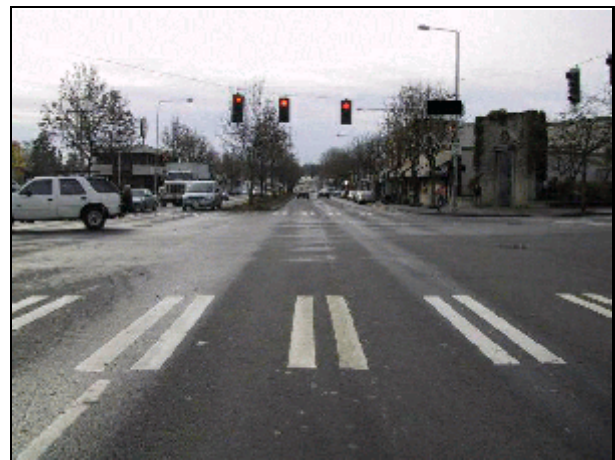
Figure 1. Approach to area of initial vehicle to vehicle impact (south).

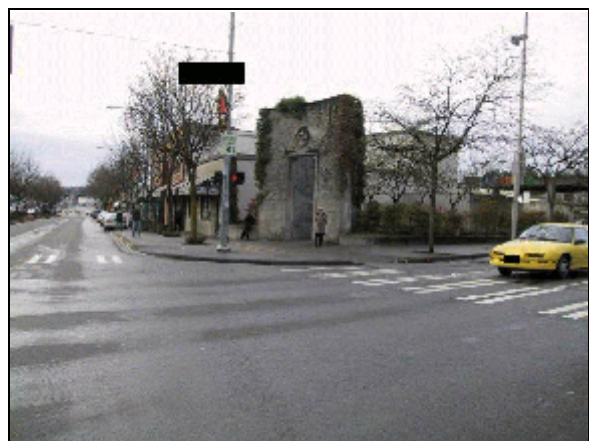
Figure 2. Post-impact path of case vehicle

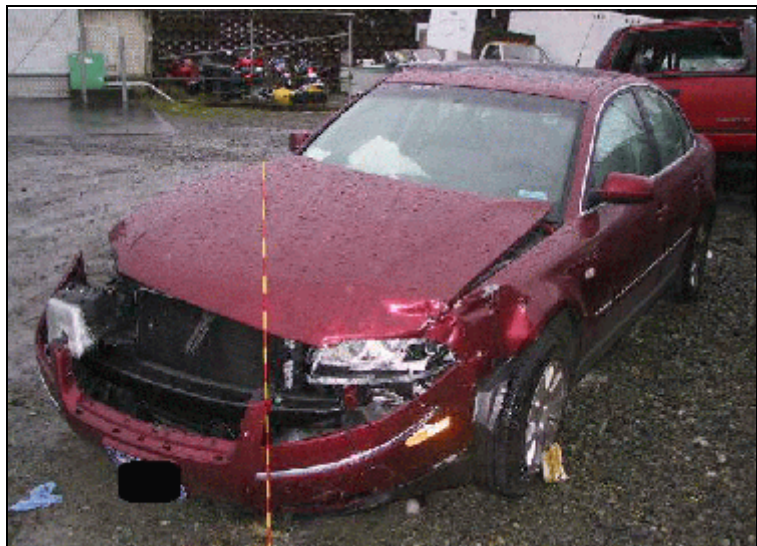
Figure 4. Case vehicle (VW Passat)

The Passat sustained 22 cm (9 in) of direct contact damage that began at the left bumper corner. The residual crush measured across the front bumper was as follows: C1=3 cm (1 in), C2=5 cm (2 in), C3=6 cm (2 in), C4=6 cm (2 in), C5=4 cm (2 in), C6=0 cm (0 in). The maximum crush was located between C2 and C3; it measured 6 cm (2 in). The principle direction of force was within the 11 o'clock sector was an estimated 340 degrees. The impact energy was managed by the forward structures of the vehicle. The damaged components from the initial

impact included the bumper fascia and reinforcement bar, the hood, and the left fender. There were no glazing fractures and all the doors remained closed and operational. There was scratching/scuffing to the front right tire/rim.

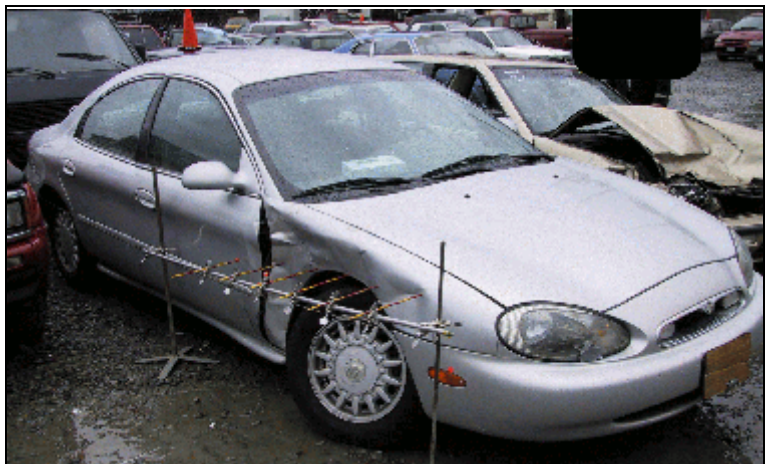
Figure 6. Other vehicle (Mercury Sable)

The Sable sustained 116 cm (295 in) of direct damage beginning 215 cm (136 in) forward of the right rear axle. The residual crush measured at the mid-door level was as follows: C1=1 cm (.5 in), C2=8 cm (4 in), C3=9 cm (4 in), C4=7 cm (3 in), C5=4 cm (2 in), C6=0 cm (0 in). The maximum crush was located 256 cm (116 in) forward of the right rear axle and measured 9 cm (4 in). The principle direction of force was within the 3 o'clock sector and was an estimated 100 degrees. The damaged components included the right fender and right tire/rim. There were no glazing fractures and all the doors remained closed and operational.

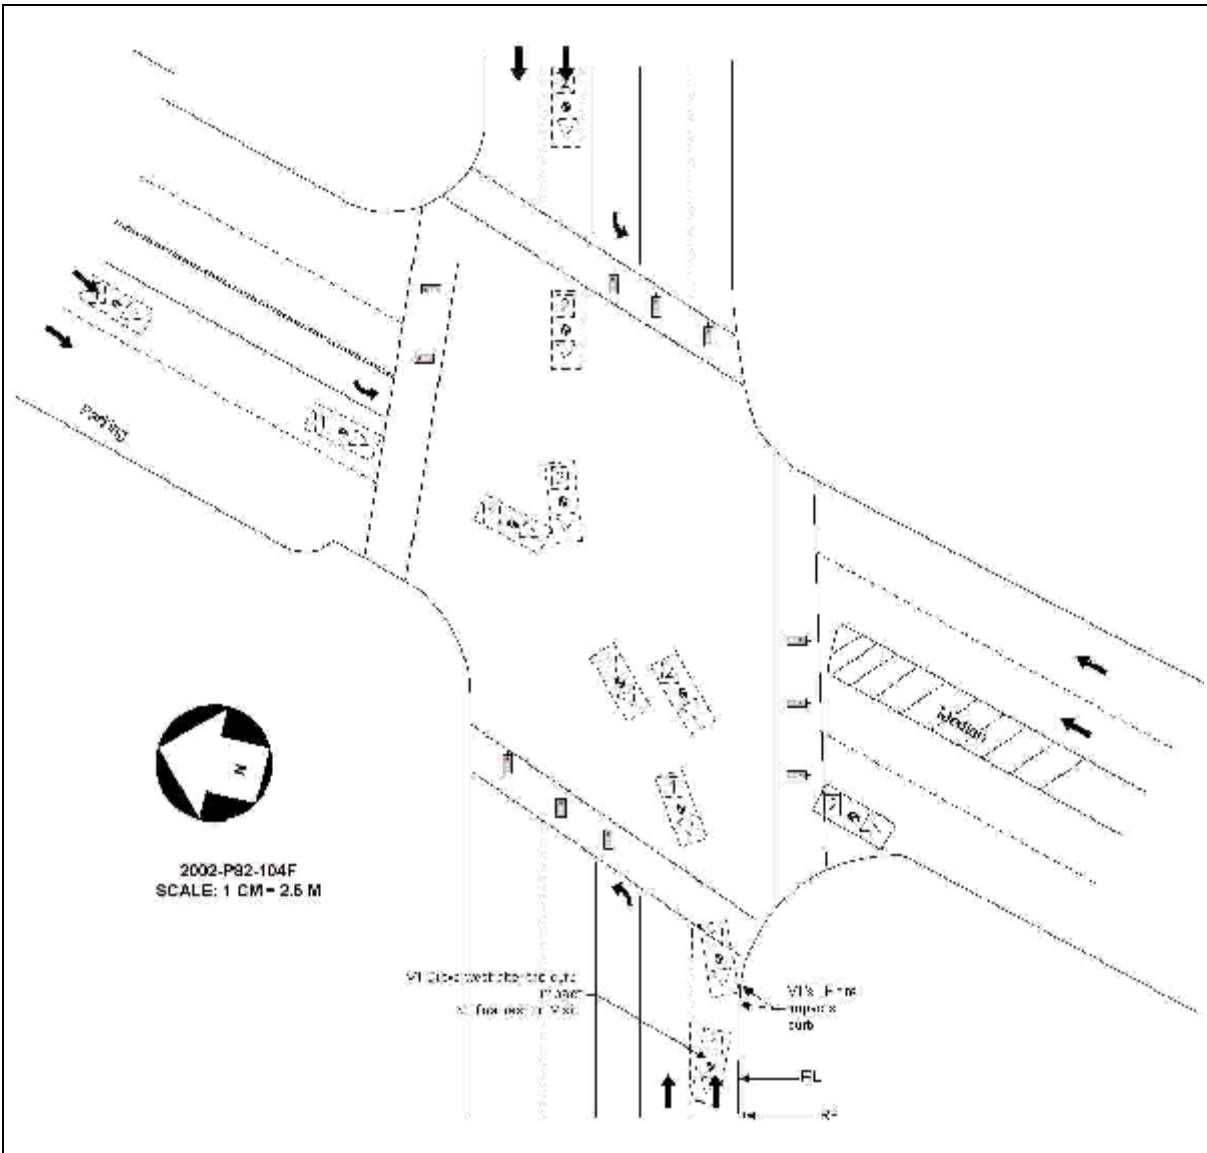
Figure 7. Scene Diagram

As both vehicles entered the intersection, the driver of the case vehicle began braking. The front of the case vehicle struck the right side of the other vehicle (11FLEE2). The total velocity change calculated by the WinSmash collision model was 10 km/h (6 mph). The longitudinal and lateral delta V components were -9 km/h (6 mph) and 3 km/h (2 mph), respectively. The front right passenger's air bag deployed and the driver's pretensioner fired at this point. The case vehicle was redirected to the right, entered the western leg of the intersection and struck a curb on the south side of the roadway with its left front tire (10LFWN1). This impact caused the driver's side curtain and seat mounted side impact air bag to deploy.

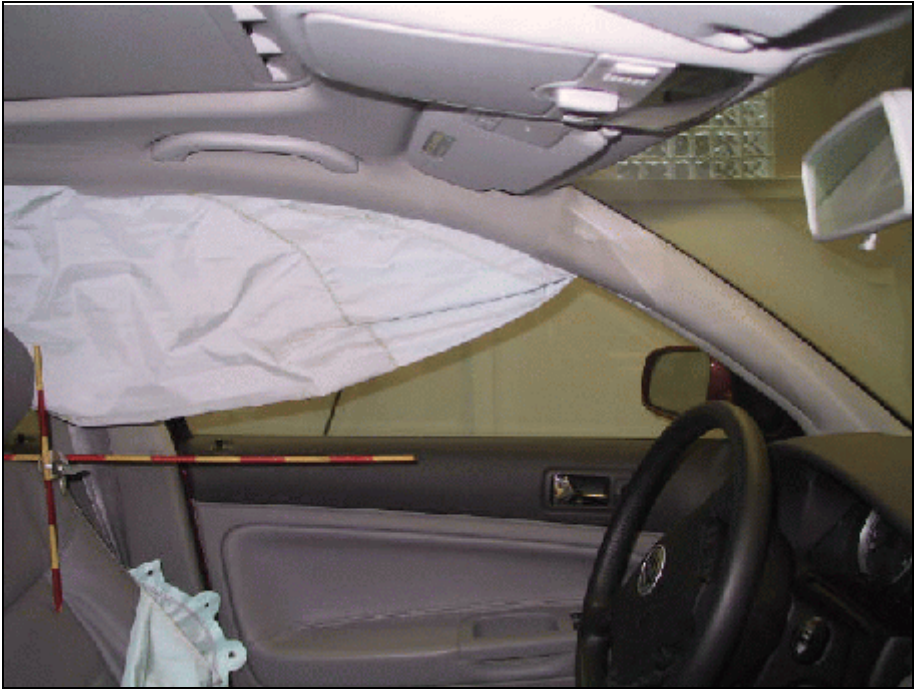
At impact, the driver's pretensioner fired and the passenger's front air bag deployed. The driver responded to the 11 o'clock direction of force by moving forward and to the left loading the pretensioner and locked manual restraint system. There were no indications of any occupant contacts from this occupant.

Figure 14. Driver's seated position

The case vehicle continued through the intersection, turning right. The left front tire struck the curb. The driver responded to the 10 o'clock direction of force by moving to the left. The curb impact caused the driver's side curtain and seat mounted side impact air bag to deploy. The driver likely engaged these air bags, but there was no evidence of any contact or injury.
