**ON-SITE CHILD SAFETY SEAT CRASH INVESTIGATION
SCI TECHNICAL SUMMARY REPORT**

VERIDIAN CASE NO. CA02-003

VEHICLE - 1989 GMC JIMMY

CRASH DATE - JANUARY 2002

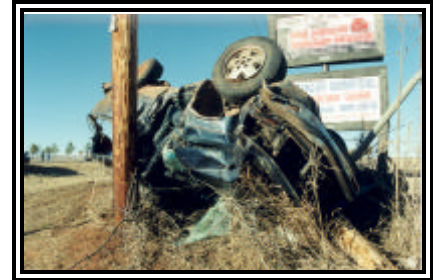
Figure 1. On-scene view of GMC Jimmy at final rest

leading. The Jimmy struck a utility pole after the tenth quarter turn while upside down with the left side area and came to rest on its roof adjacent to the pole (**Figure 1**). The restrained front seated occupants initiated lateral trajectories and loaded the manual restraints. The 4-month-old infant also initiated a lateral trajectory and loaded the harness system of the CSS which resulted in bilateral pulmonary contusions, left shoulder contusion, left abdominal abrasion, and a left thigh contusion. The severity of the rollover resulted in cerebral shear injury due to the infant's head motion. During the rollover, the infant's loading to the harness system caused the left side harness webbing to disengage from the adjustment slide and completely pull out of the harness slot. The infant was ejected from the CSS and from the vehicle through the left rear side window. Based on the lack of contact evidence in the vehicle and distance of the infant's final rest position relative to the vehicle, it appears the infant's trajectory out of the vehicle was unobstructed. She sustained multiple facial abrasions and lacerations, palpable skull fractures, and critical closed head injuries as a result of the ejection and impact with the ground. The driver struck the left side door frame and sustained multiple left scalp lacerations and avulsions. His left arm was partially ejected which resulted in a dislocated left elbow. He was transported by ambulance to a local hospital, transferred to a regional trauma center, and admitted. The front right passenger sustained a right fifth rib fracture, a right shoulder dislocation, a right clavicle fracture, a left lateral tibial plateau comminuted fracture, a left fibular head fracture, and seat belt-related abrasions as a result of contact with interior components and loading to the manual restraint. She was transported by helicopter to a regional trauma center and admitted. The infant was found on the roadside approximately 16 m (51') from the vehicle. She was transported by ambulance to a local hospital, transferred to a regional children's hospital, and expired five hours following the crash. The driver of the Tahoe was not injured and refused medical treatment at the scene.

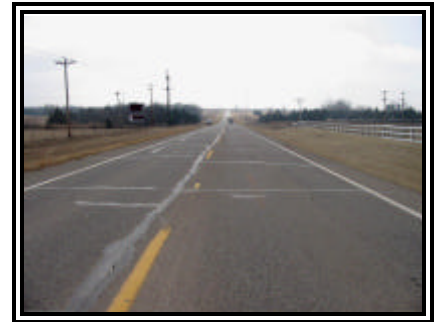
The 18-year-old driver of the GMC Jimmy was operating the vehicle southbound on the state roadway (**Figure 2**) at a driver-reported speed of approximately 100 km/h (60 mph). The 38-year-old female driver of the Chevrolet Tahoe was operating her vehicle southbound behind the Jimmy. The driver of the Jimmy stated that a slow-moving truck with a load of hay was traveling ahead of the Jimmy. As the Jimmy and Tahoe slowed behind the non-contact vehicle, the driver of the Tahoe initiated a passing maneuver around the Jimmy and the non-contact vehicle. The driver of the Jimmy did not detect the Tahoe overtaking his vehicle, and also initiated a passing maneuver around the non-contact vehicle. The driver of the Tahoe recognized the Jimmy encroaching onto the northbound lane and steered left in an attempt to avoid the collision. The driver of the Tahoe overcorrected right and braked as the vehicle traveled toward the left roadside and contacted the Jimmy while both vehicles were in the northbound lane.

Figure 2. Southbound approach to the crash site

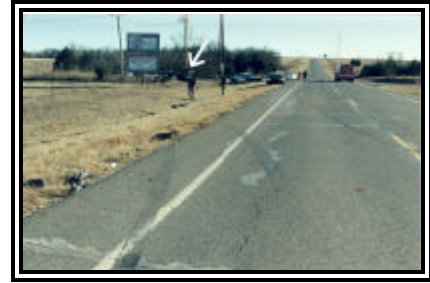
Figure 3. Southbound rollover trajectory for the Jimmy showing final rest position

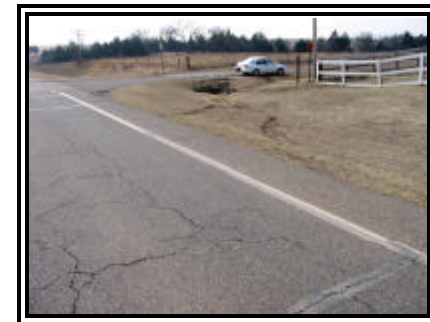
The Tahoe initiated a CW rotation and traveled back across the southbound lane in a CW yaw. The Tahoe traveled in a southeast direction an approximate distance of 55 m (180') on the southbound lane, and departed the right roadside. Furrows that measured approximately 10 m (30') in length from the left wheels were present along the negative slope of the roadside (**Figure 5**). The furrowing of the left wheels tripped a three-quarter-turn rollover with the left side leading. The Tahoe came to rest adjacent to the furrows on the right side. The rollover resulted in moderate damage to the Tahoe.

Figure 5. Right road departure and furrows from the Tahoe

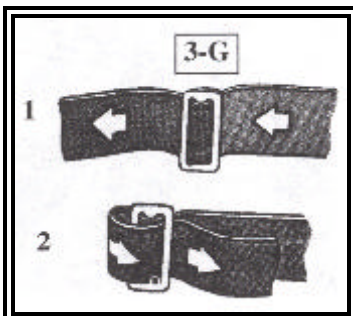
The harness was routed through the harness slots and the end of the left harness strap was routed through the adjustment slide that was attached to the end of the right harness strap. Based on the manufacturer's instructions, the end of the harness webbing should be re-threaded back through the adjustment slide to lock the harness straps (**Figure 16**). During the interview with the parents, the CSS was re-configured as it was prior to the crash. The harness was threaded through the adjustment slide once, and subsequently tied in a knot over both sides of the harness webbing adjacent to the adjustment slide (**Figure 17**). It was not re-threaded back through the adjustment slide. The left harness strap was threaded backwards through the harness retainer clip, and the right harness strap was routed under the locking tab on the retainer clip (**Figure 18**). The parents stated that the left harness strap was threaded in that position when it was removed from the box prior to use.

Figure 16. View of correct routing of the harness webbing through the adjustment slide

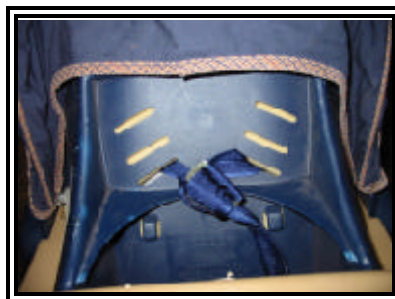
Figure 17. View of harness straps through the adjustment slide

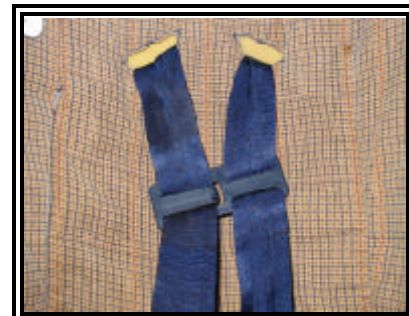
Figure 18. View of harness retainer clip position

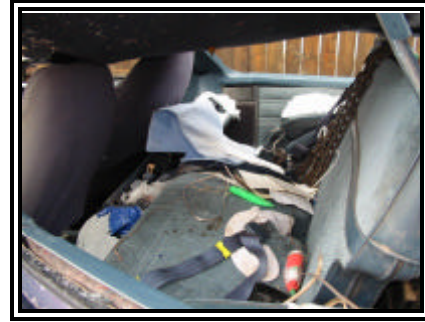
The rear-facing infant CSS was installed with the detachable base in the rear left position of the GMC Jimmy (**Figure 19**) with the manual 3-point lap and shoulder belt with a locking latch plate. There were no objects placed under the CSS base, and the carrying handle was in the upright position. The seat belt was routed through the belt path on the rear aspect of the base. The parents stated that the owner's manual for the GMC Jimmy was consulted, but did not offer any instructions as to how to install a CSS. The parents stated that the seat was installed tightly in the vehicle so that it would not move side-to-side, and it was checked by the parents prior to the crash. The parents also stated that the infant was restrained tightly in the CSS and the space between the harness and the child was no more than one finger width. The parents also mentioned that they regularly restrained the child in the CSS and placed blankets over the harness system, to limit the amount of space between the harness and the infant.

Figure 19. View of rear left position in GMC Jimmy

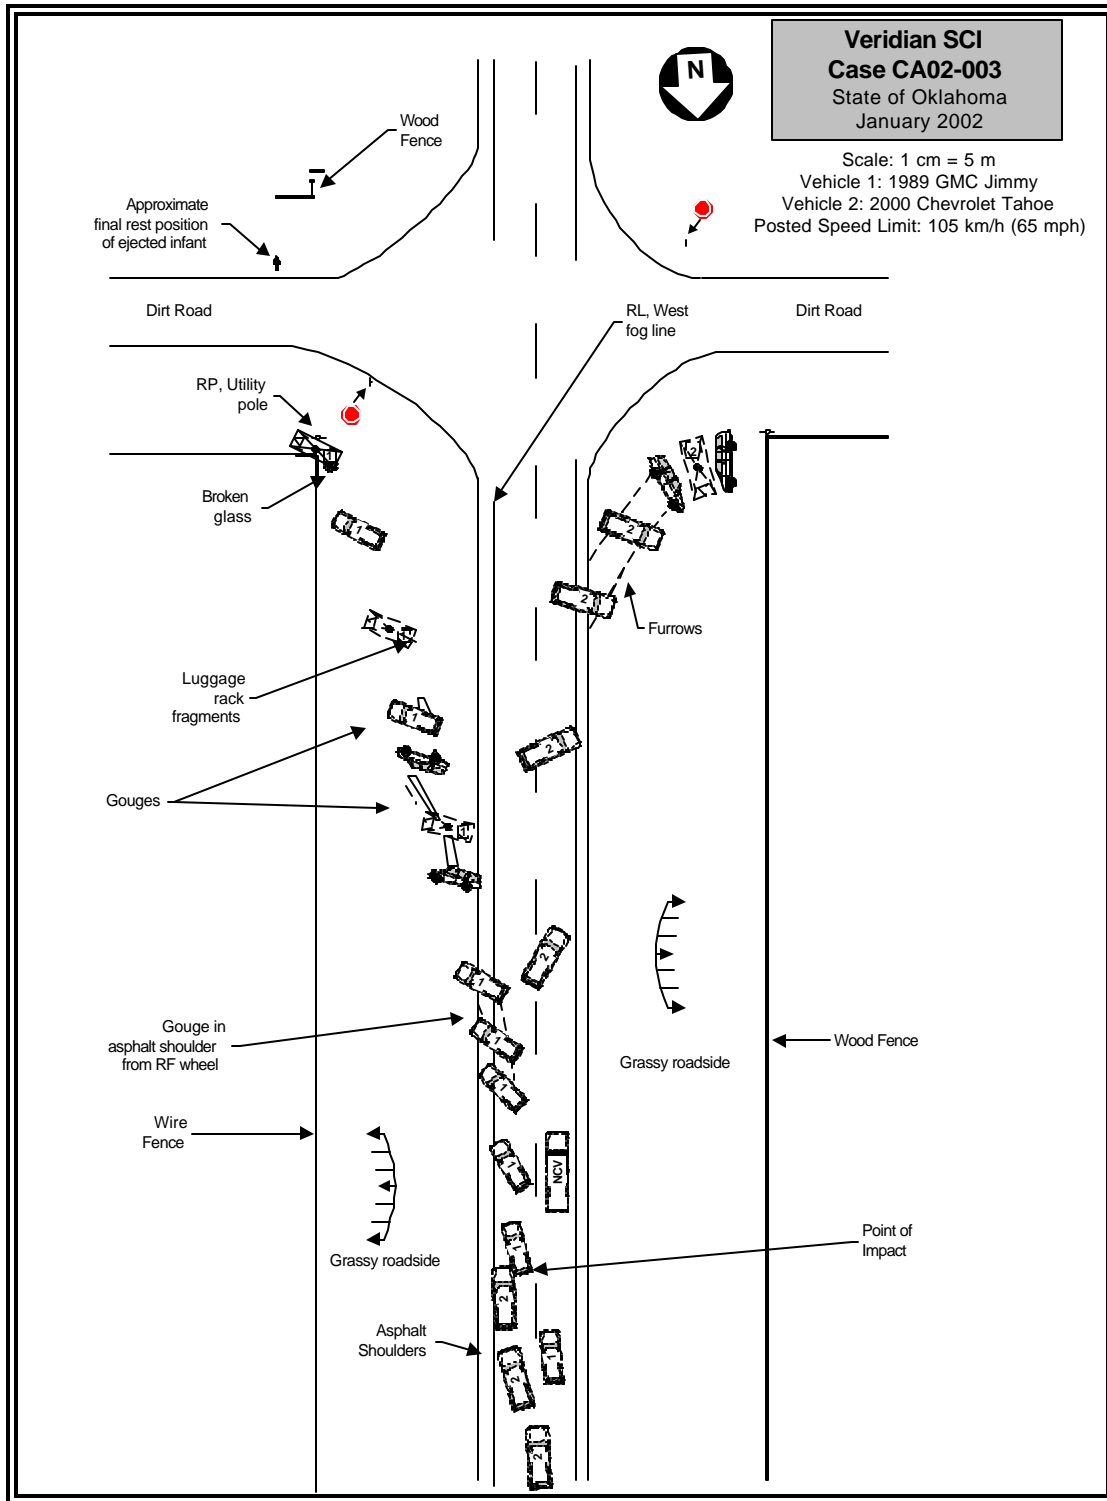
Figure 20. Scene schematic

This two-vehicle crash occurred on a two-lane undivided state roadway during the daylight hours of January 2002. The crash site was north of a four-leg intersection of the state roadway and a local dirt road. At the time of the crash, the asphalt road surface was dry and the weather was clear. The north/south roadway consisted of two asphalt travel lanes with paved shoulders separated by a dashed yellow centerline. The roadside environment consisted of grassy roadsides with negative slopes and fields. A wire fence with wood posts was located on the west roadside approximately 15 m (50') from the west road edge, and a wood fence was located on the east roadside approximately 15 m (50') from the east road edge. Utility poles were present on each roadside. Stop signs controlled east/west traffic entering the intersection. The scene schematic is included as **Figure 20**.

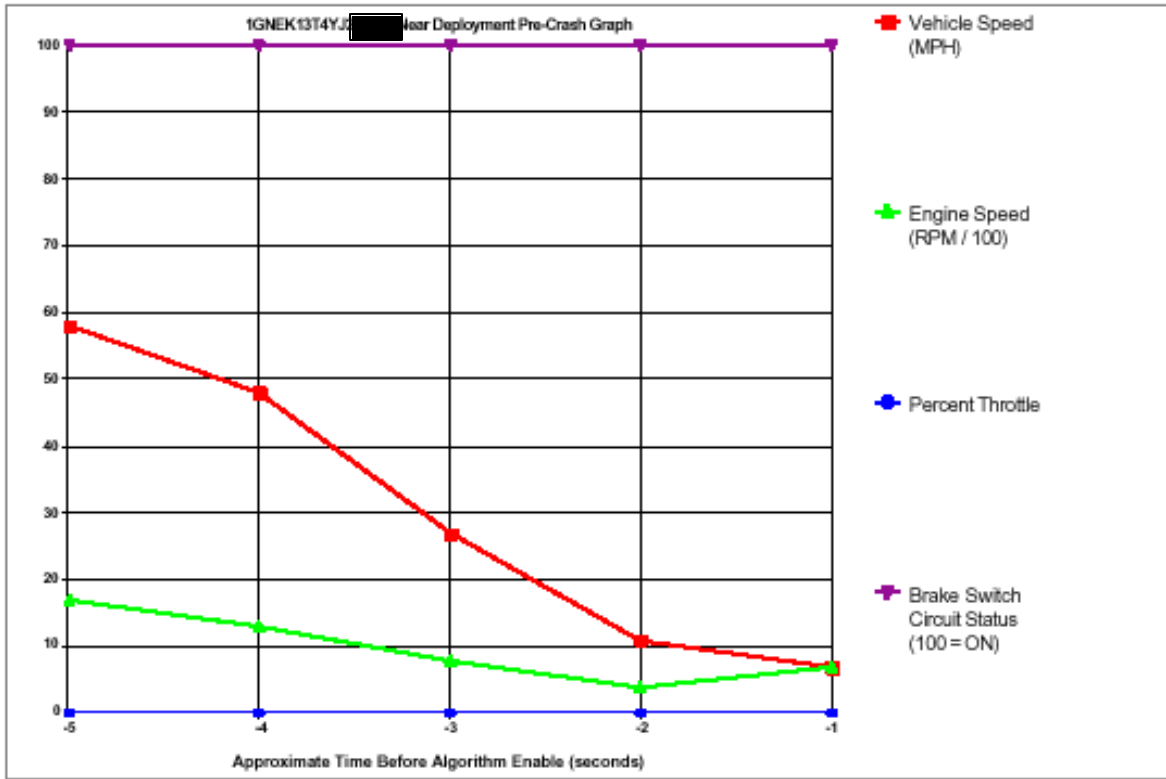
Figure 21. EDR summary report for the Chevrolet Tahoe

The data from the Tahoe's Event Data Recorder (EDR) was downloaded by the SCI investigator during the vehicle inspection. The EDR recorded a Near Deployment Event for the Tahoe which was attributed to the Tahoe's rollover. The data summary indicated the speed of the Tahoe five seconds prior to the near-event to have been 93 km/h (58 mph) and the speed one second before the near-event to have been 11 km/h (7 mph). Throughout the entire five seconds before the near-event, the throttle was at zero percent, and the brakes were fully applied. The EDR data summary is included as **Figure 21**.

Seconds Before AE	Vehicle Speed (MPH)	Engine Speed (RPM)	Percent Throttle	Brake Switch Circuit Status
-5	58	1664	0	ON
-4	48	1344	0	ON
-3	27	832	0	ON
-2	11	448	0	ON
-1	7	704	0	ON
