**VERIDIAN ON-SITE CHILD SAFETY SEAT CRASH INVESTIGATION
SCI TECHNICAL SUMMARY REPORT**

VERIDIAN CASE NO. CA02-006

VEHICLE - 1990 FORD F-150 PICKUP TRUCK

CRASH DATE - DECEMBER 2001

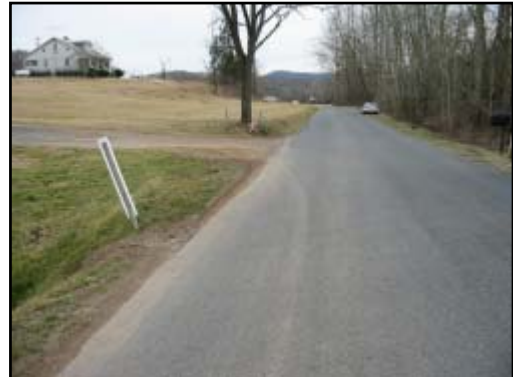
Figure 2. Southbound approach for the Ford F-150 pickup truck

The 43-year-old female driver of the Ford F-150 pickup truck was operating the vehicle southbound on the two-lane roadway (**Figure 2**). She reportedly fell asleep and relinquished control of the vehicle. The pickup truck drifted across the roadway and departed the left roadside in a tracking mode. There were no skid marks indicative of any attempted avoidance maneuvers.

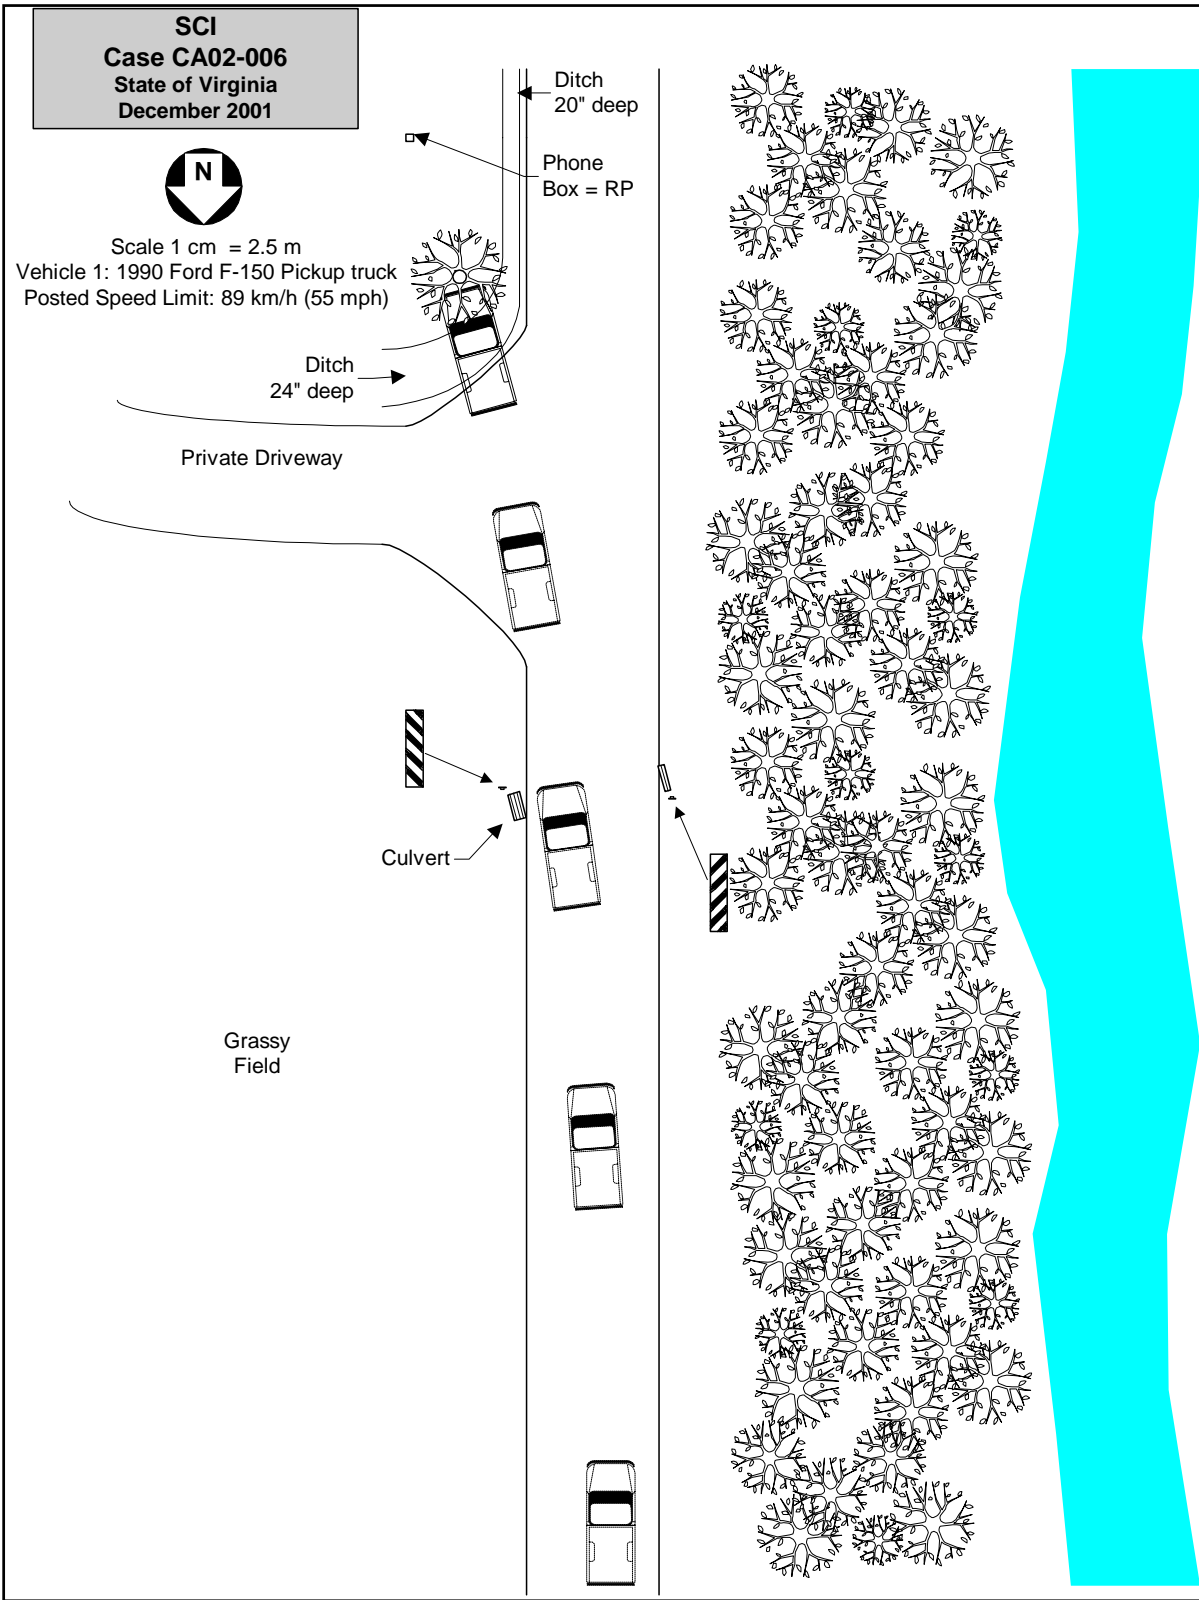
Figure 13. Scene schematic

measured approximately 1 m (3') in width and 51 cm (20") in depth and was parallel to the roadway. The ditch followed the south contour of the private driveway. It widened to 2 m (6') and measured 60 cm (24") in depth around the driveway contour in front of the struck tree. There were no traffic controls present at the scene, and the posted speed limit for the county roadway was 89 km/h (55 mph). The scene schematic is included as **Figure 13**.
