**VERIDIAN ON-SITE AIR BAG RELATED ADULT
DRIVER FATALITY INVESTIGATION**

VERIDIAN CASE NO. CA02-008

VEHICLE - 1998 FORD RANGER XLT

LOCATION - STATE OF ILLINOIS

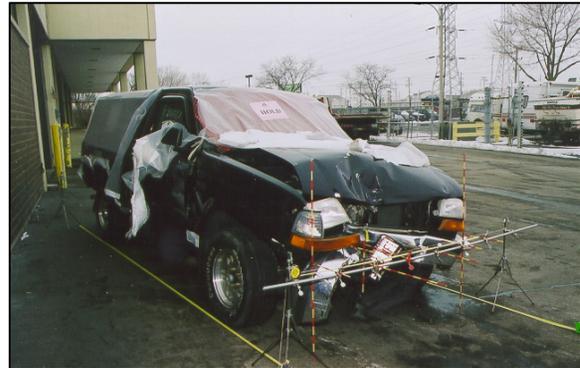
This on-site investigation focused on the injury mechanisms that caused the death of a 48 year old restrained female driver of a 1998 Ford Ranger XLT pickup truck (**Figure 1**). The Ford Ranger pickup truck was equipped with redesigned frontal air bags for the driver and front right passenger positions which deployed as a result of a frontal collision with a concrete base supporting a signpost. The driver of the Ford had Klippel-Feil Syndrome, a rare degenerative disease of the cervical vertebrae that produced a natural fusion of her neck. The driver lived a normal life despite her condition. She was

Figure 1 - Overall view of 1998 Ford Ranger pickup.

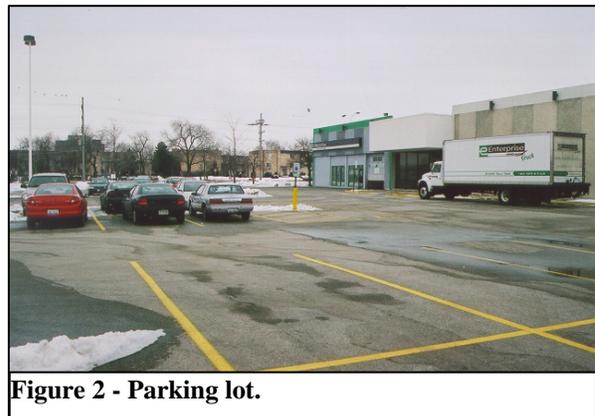
The 48 year old female driver of the 1998 Ford Ranger XLT pickup truck completed her shift at a nearby fast-food restaurant and was giving a co-worker a ride home, operating the vehicle in a southwesterly direction (diagonally) across the large parking area (**Figure 2**). As the vehicle approached the south exit of the parking lot, the driver failed to observe the signpost concrete support base. The police reported no tire marks present at the scene indicative of possible driver avoidance maneuvers.

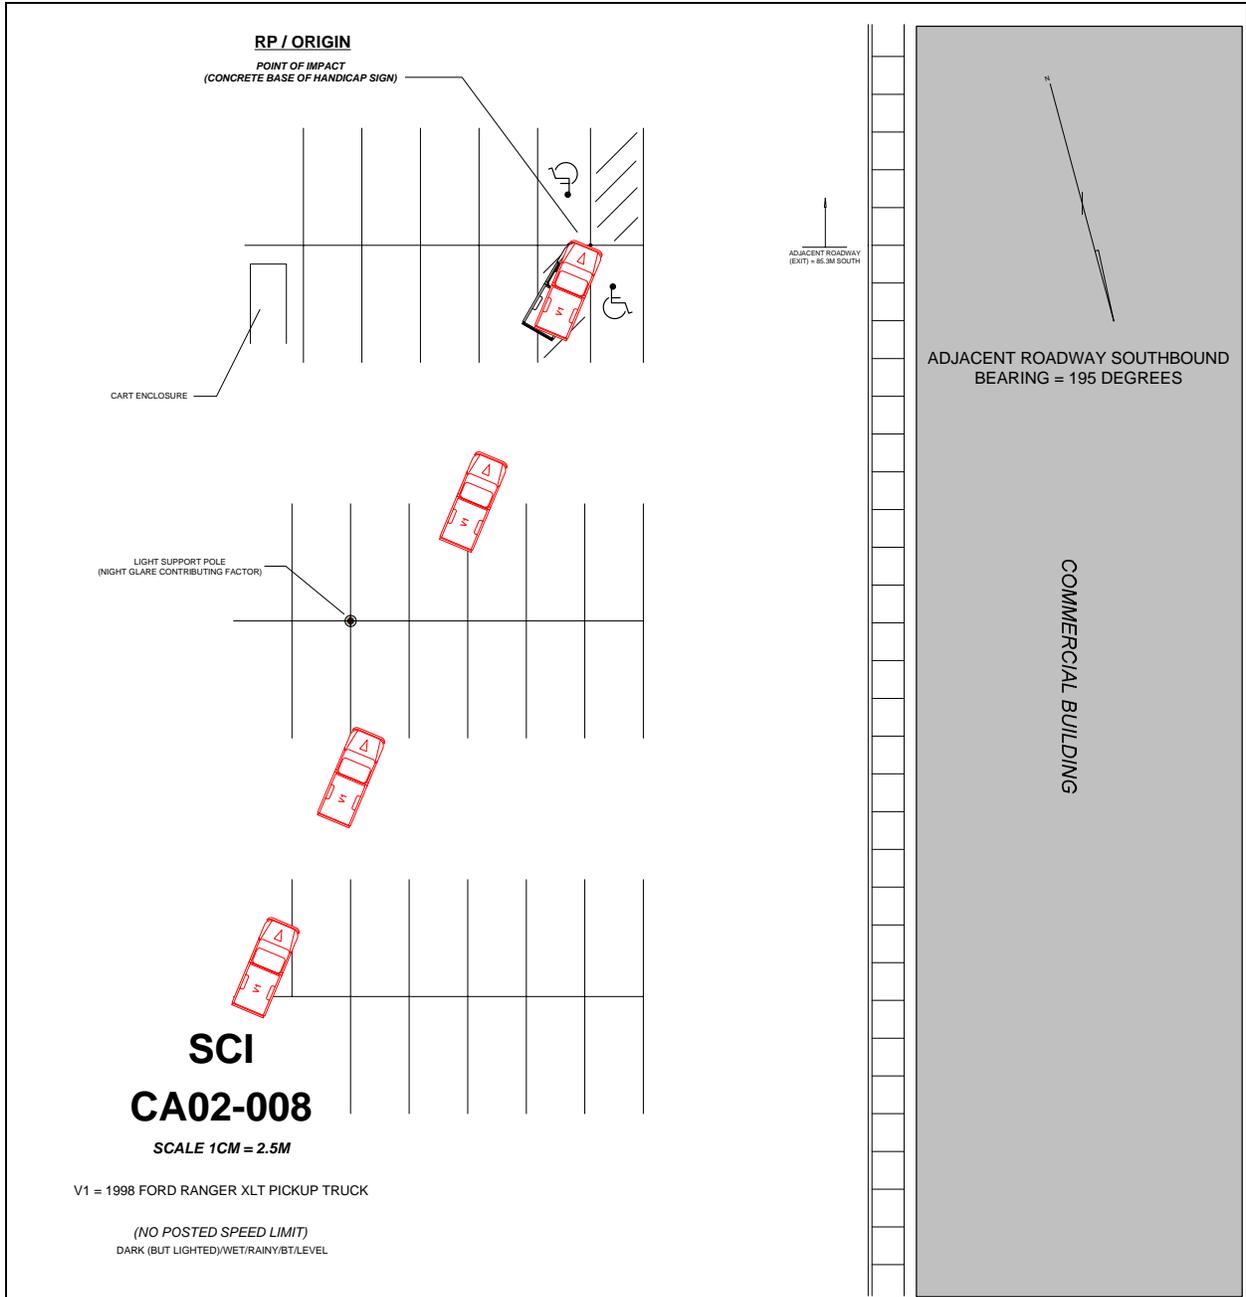
Figure 9 – Scene Schematic

Inclement weather conditions were identified as a major contributing factor in the pre-crash circumstances. Although the passenger reported to police that the vehicle's windshield wipers and headlights were in use prior to the collision, heavy rain may have inhibited ambient lighting of the immediate environment as a build-up of water droplets on the windshield produced excessive glare, thus reducing the driver's field of vision. The scene schematic is included as **Figure 9** at the end of the narrative report.
