On-Site Child Safety Seat Investigation / Vehicle Rollover
Dynamic Science, Inc. / Case Number: DS02013
1999 Chevrolet Blazer
Colorado
July, 2002

1. Report No. DS02013	2. Government Accession No.		3. Recipient Catalog No.	
4. Title and Subtitle On Site Child Safety Seat Investigation			5. Report Date January 17, 2006

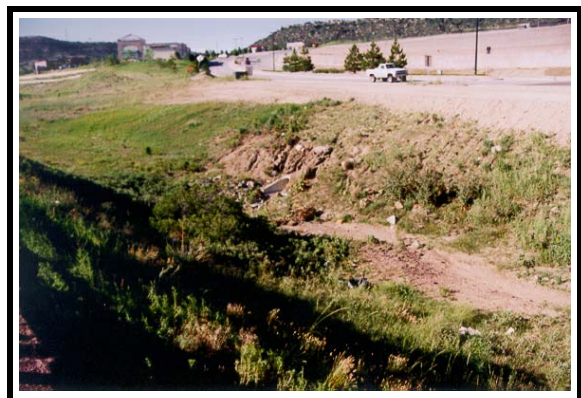
Figure 4. Area of rollover 2.

The case vehicle swerved from the right lane into the left lane. The driver then overcorrected to the right. The vehicle rotated clockwise, rolled over eight quarter turns as it headed towards the right shoulder area. The vehicle struck the metal guardrail with its left front (see Figure 3); there was minor damage to the top part of the guardrail. Witnesses indicated that during the rollover on the right shoulder area the driver was ejected out of the driver's window. The driver was found laying on the right shoulder area approximately 1.8 meters (6 ft) west of the guardrail. The vehicle continued in a clockwise yaw and rolled over three quarter turns, vaulted upward and the vehicle's rear left door struck the top backside of the guardrail. After striking the guardrail, the case vehicle then traveled down a 63% grade embankment rolling ten quarter turns. Both the front right and 2nd row right occupants were fully ejected. The vehicle traveled 24.4 meters (80 ft) down the embankment and came to final rest on top of a concrete drainage ditch facing south on all four wheels.

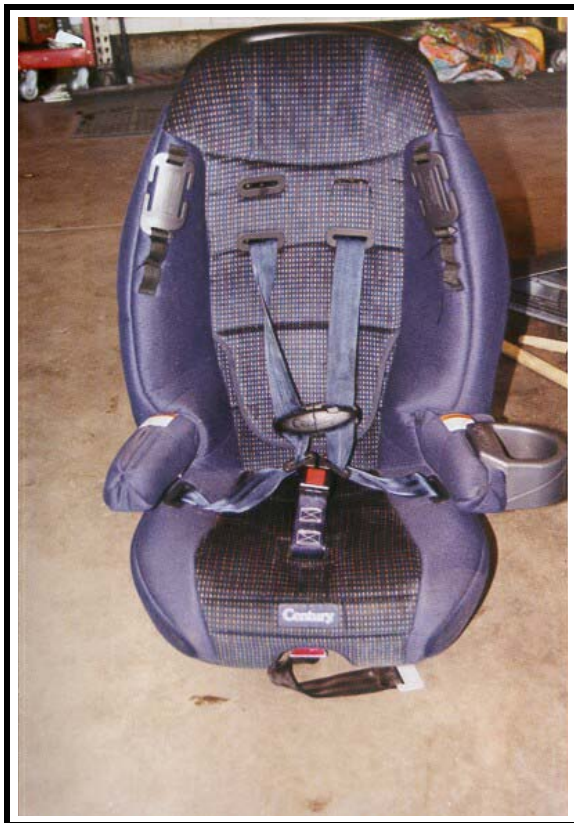
Figure 8. Frontal view child seat.

The child safety seat was inspected, but it had been removed from the vehicle prior to inspection. The 5-point harness appeared to operate properly and the latch locked into the buckle. The harness system was slotted through the bottom slot. The harness webbing showed usage and was abraded/scored (see Figure 11). The harness clip was very low. A tether was not present.

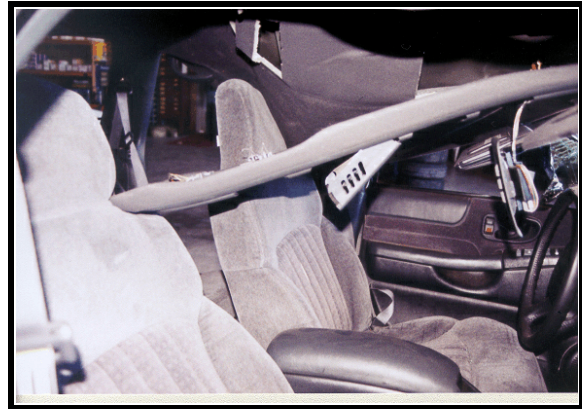
Figure 12. Driver's seated position

The 29-year-old male driver was seated in a generally upright posture. He was not wearing the available lap and shoulder belt. The seat was adjusted to between the rear most and middle track position. The seat back angle was 64 degrees. The driver had initially steered to the left, then sharply to the right. The driver was braking and actively steering. As the vehicle went into a clockwise rotation, the driver began pitching to the left against the door panel. As the vehicle continued rotating, it tripped and began a left side leading rollover. The vehicle rolled eight quarter turns as it headed towards the right shoulder area.

The vehicle then struck the metal guardrail with its left front. Witnesses indicated that during the rollover on the right shoulder area the driver was ejected out of the driver's window. The driver was crushed by the overturning vehicle. He was found laying on the right shoulder area approximately 1.8 meters (6 ft) west of the guardrail. He was fatally injured.

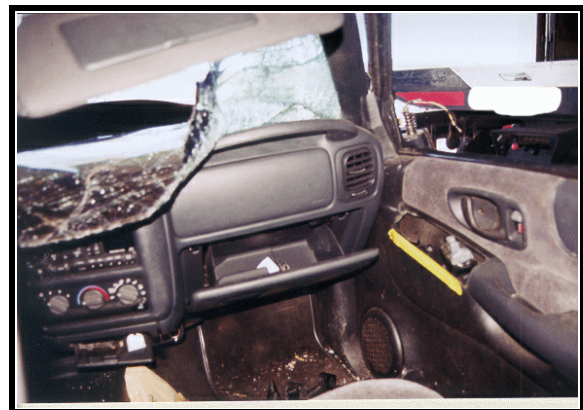
Figure 13. Front right occupant seated position

The 25-year-old male front right seat occupant was probably seated in a generally upright posture. He was not wearing the available lap and shoulder belt. The seat was adjusted to the rear most track position. The seat back angle was 59 degrees. The driver had initially steered to the left, then sharply to the right. The driver was braking and actively steering. This occupant was likely pitching from side to side in response to the driver's steering movements. As the vehicle continued rotating, it tripped and began a left side leading rollover. The vehicle rolled eight quarter turns as it headed towards the right shoulder area. The vehicle then struck the metal guardrail with its left front

The vehicle continued in a clockwise yaw and rolled over three quarter turns, vaulted upward and the vehicle's rear left door struck the top backside of the guardrail. After striking the guardrail, the case vehicle then traveled down a 63% grade embankment rolling ten quarter turns. This occupant was ejected through the right front window. He came to rest on the roadside 11.9 m (38.9 ft) east of the guardrail. During the rollover sequence he was likely caught between the vehicle and the ground and crushed prior to being fully ejected.

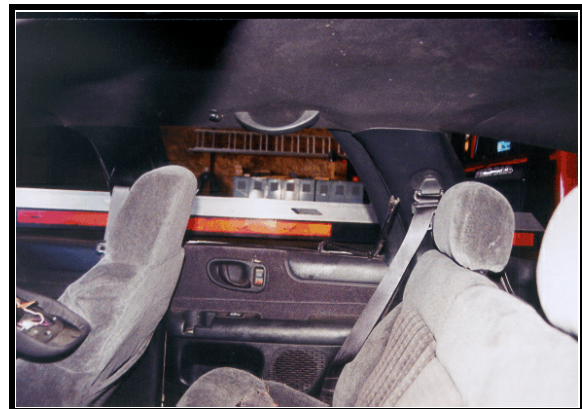
Figure 14. 2nd row right occupant seated position

The 25-year-old female 2nd row right seat occupant was probably seated in a generally upright posture. She was not wearing the available lap and shoulder belt. The seat back angle was 68 degrees. The driver had initially steered to the left, then sharply to the right. The driver was braking and actively steering. This occupant was likely pitching from side to side in response to the driver's steering movements. As the vehicle continued rotating, it tripped and began a left side leading rollover. The vehicle rolled eight quarter turns as it headed towards the right shoulder area. The vehicle then struck the metal guardrail with its left front. The vehicle continued in a clockwise yaw and rolled over three quarter turns, vaulted upward and the vehicle's rear left door struck the top backside of the guardrail. After striking the guardrail, the case vehicle then traveled down the embankment rolling ten quarter turns. This occupant was ejected through the right rear window. She came to rest on the roadside 13.6 m (44.6 ft) east of the guardrail. During the rollover sequence she was likely caught between the vehicle and the ground and crushed prior to being fully ejected.
