Advanced Occupant Protection Investigation / Rollover
Dynamic Science, Inc. / Case Number: DS02014
2001 Volkswagen Jetta
Colorado
July, 2002

1. Report No. DS02014	2. Government Accession No.		3. Recipient Catalog No.	
4. Title and Subtitle Advanced Occupant Protection System Investigation			5. Report Date April 13, 2004

**Dynamic Science, Inc.
Crash Investigation
Case Number: DS02014**

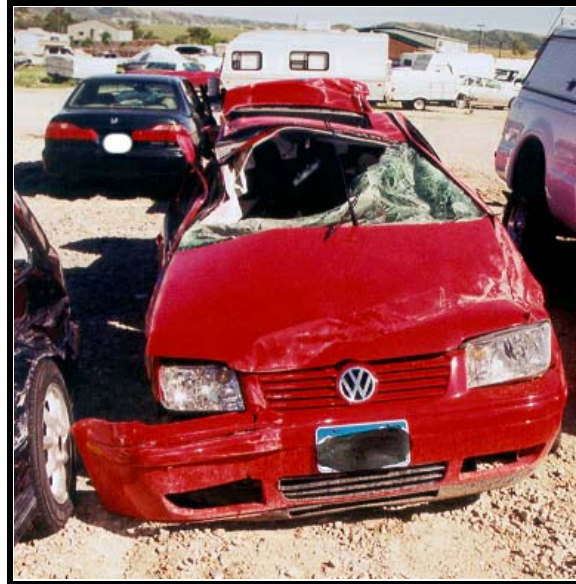
Figure 5. Front, Volkswagen Jetta

Damage Description: The Jetta sustained major damage about the entire vehicle. Both of the rear doors were jammed shut. The windshield was cracked and holed and all the remaining glazing disintegrated.
