On-scene Investigation / Vehicle to Vehicle  
Dynamic Science, Inc. / Case Number: DS02017  
2002 Toyota Camry  
California  
June, 2002

1. Report No. DS02017		2. Government Accession No.		3. Recipient Catalog No.	
4. Title and Subtitle In-Depth Accident Investigation				5. Report Date	
				6. Performing Organization Report No.

**Dynamic Science, Inc.**  
**Accident Investigation**  
**Case Number: DS02017**

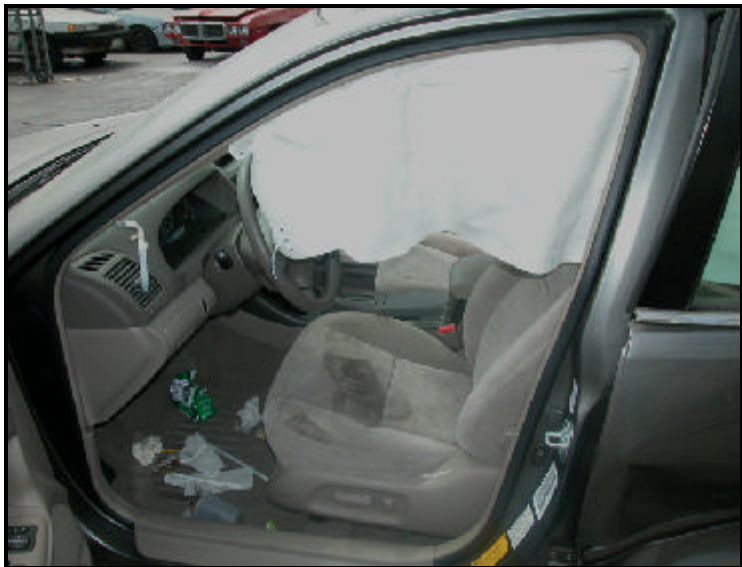
**Figure 4.** Driver's seat position

The 57-year-old driver of the case vehicle was seated in a normal, upright fashion. The fabric covered bucket seat was adjusted to between the middle and the rear most track position. The driver was wearing the continuous loop 3-point lap and shoulder belt. The shoulder belt upper anchorage was adjusted to the full up position. The driver's hands were at the 10 and 2 o'clock positions. Her right foot was on the accelerator, her left on the floor. She was wearing a long sleeve shirt. She was not wearing glasses or contact lenses.

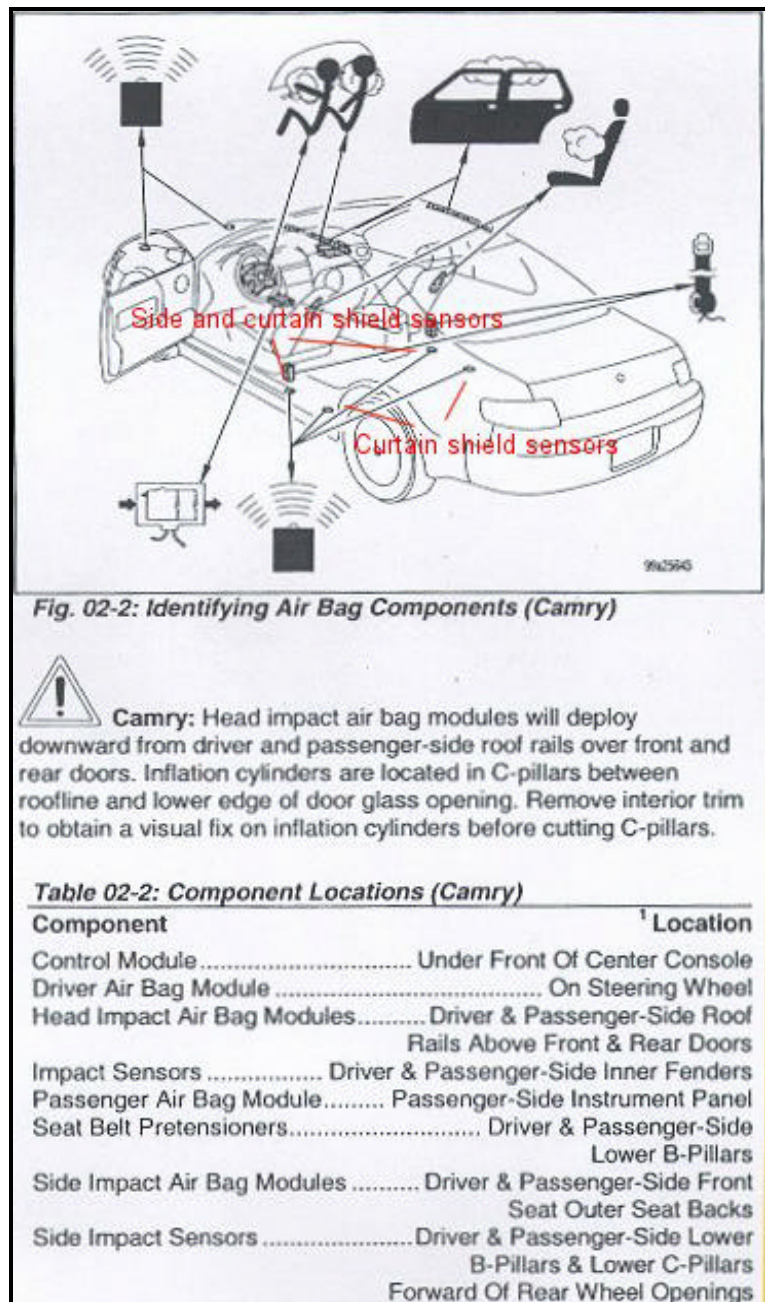
**Figure 8.** Camry air bag components

The SRS side air bag and side curtain system is controlled by the air bag sensor assembly. The sensor assembly consists of a safing sensor and air bag sensor. There are combination side and curtain shield air bag sensors located at the base of the left and right B pillars. There are curtain shield air bag sensors located forward of the C pillar.

The SRS side air bag and curtain shield air bag on the passenger side are activated even with no passenger in the front seat or rear seat.

The curtain shield air bags may activate when the side air bags are not activated. In this case it appears that the delta V was of sufficient magnitude and at the right location to cause only the side air curtains to deploy.

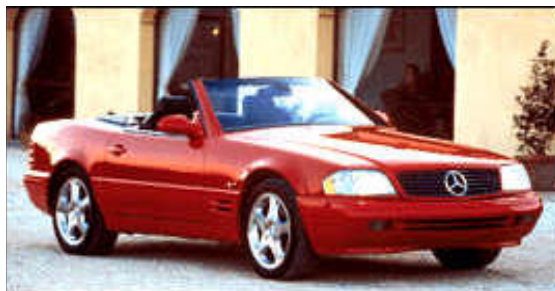
**Figure 11.** Exemplar view of Mercedes coupe

Description:	1999 Mercedes-Benz SL500R 2-door convertible coupe	
VIN:	WDBFA68F0XFxxxxxx	
Odometer:	Unknown	
Engine:	5.0 L, 8 cylinder	
Reported Defects:	None, per police	
Cargo:	Unknown	
Damage Description:	Moderate frontal damage. Vehicle towed from the scene.	
CDC:	Unknown	
Delta V:	Total	15.0 km/h (9.3 mph)
	Longitudinal	-14.8 km/h (-9.2 mph)
	Latitudinal	2.6 km/h (1.6 mph)
	Energy	20,510 joules (15,127 ft-lbs)
