On Site Side Air Curtain Investigation / Vehicle to Vehicle
Dynamic Science, Inc. / Case Number: DS02018
2002 Lexus GS300
California
June, 2002

1. Report No. DS02018		2. Government Accession No.		3. Recipient Catalog No.	
4. Title and Subtitle On Site Side Air Curtain Investigation				5. Report Date January 28, 2004

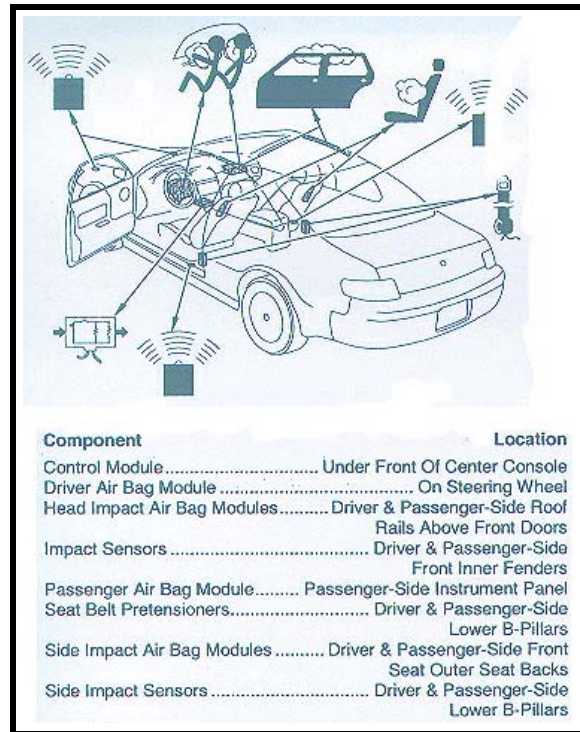
The case vehicle is equipped with six air bags². A driver's steering wheel mounted airbag, a front right passenger's airbag that is top-mounted in the instrument panel. The vehicle is equipped with a driver's and front right seat mounted side airbags, and side curtain airbags mounted above the side windows. The side curtain airbags are located on the right and left sides of the vehicle above the doors and behind the headliner (they extend from the A-pillar rearward to about the middle of the rear windows on both sides.) The side curtain airbag will expand to cover the side windows. The driver's and front right passenger's frontal airbags did not deploy. The driver's seat mounted side airbag did deploy. It measured approximately 24.0 cm (9.4 in.) by 29.0 cm (11.4 in.). It was housed within a plastic module. The side airbag was not tethered or vented. There was no evidence of occupant contact. The driver's side curtain airbag did deploy. It was vaguely rectangular in shape and measured approximately 32.0 cm (12.6 in.) by 142.0 cm (55.9 in.). It contained six individual "pockets" that inflate. The side curtain airbag was not vented. There was no obvious driver contact but a hair strand was found on one of the eight "tabs" that were attached about the side curtain.

Figure 8. Case vehicle airbag system.

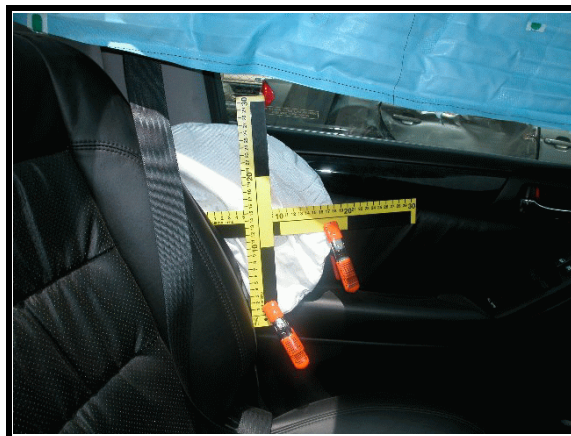
Figure 10. Seat back mounted side air bag
