On-scene Investigation / Vehicle to Vehicle
Dynamic Science, Inc. / Case Number: DS02022
2001 Saturn SL2 four door sedan
California
October, 2002

1. Report No. DS02022		2. Government Accession No.		3. Recipient Catalog No.	
4. Title and Subtitle In-Depth Accident Investigation				5. Report Date	
				6. Performing Organization Report No.

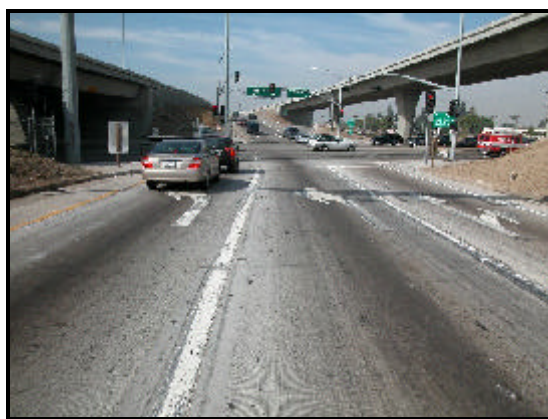
Figure 2. Case vehicle and Ford Ranger approach (West)

The case vehicle was stopped for a red traffic light at a freeway off-ramp heading west. The Ford was also stopped for the red traffic light of the freeway off-ramp, to the left of the case vehicle and heading west. The Toyota was northbound approaching the intersection at a minimum pre-braking travel speed of 66 km/h (41 mph). When the traffic light turned green for the case vehicle and the Ford, both vehicles entered the intersection. The driver of the case vehicle accelerated to a speed of 24 km/h (15 mph)². At a point between 4 and 3 seconds before impact, the driver of the case vehicle began braking. The speed of the case vehicle just prior to impact was 11 km/h (7 mph). The driver of the Toyota saw the vehicles enter the intersection and began braking and steering to the left. However, the Toyota failed to stop for the red traffic light and struck the left side of the Ford. The Ford rotated in a clockwise direction and there was a second impact between these two vehicles. The Toyota continued forward and struck the left side of the case vehicle. The total velocity change for the case vehicle as calculated by the Missing Vehicle algorithm of the WinSmash collision model was 22 km/h (14 mph). The longitudinal and lateral delta V components were -4 km/h (-2 mph) and 22 km/h (14 mph), respectively.

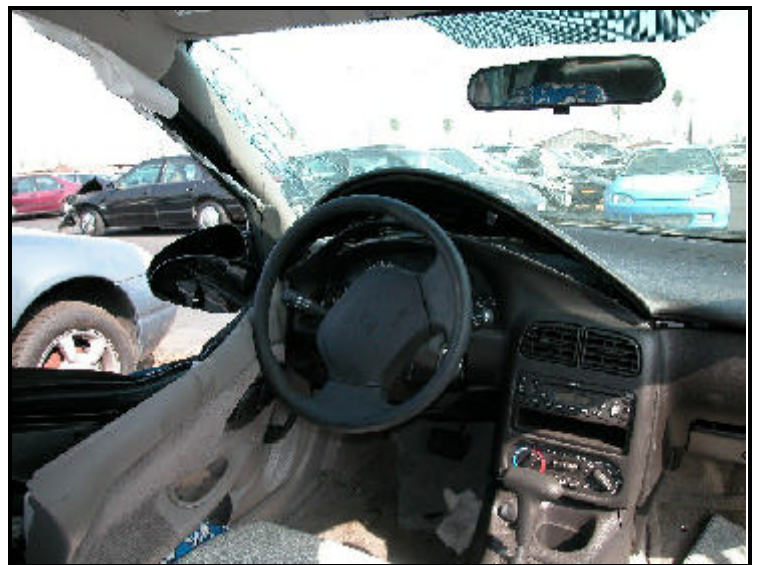
Figure 12. Driver's seated position

The 18-year old driver of the case vehicle was seated in the fabric covered bucket seat in a normal, upright fashion. The seat was adjusted to the rear most track position. The seat back was slightly reclined. The seat back was covered by flower print seat cover. He was wearing the available lap and shoulder belt. The shoulder belt upper anchorage was in the mid position. Both of his hands were on steering wheel, with the left slightly higher than right. He was wearing all plastic sunglasses and a short sleeve shirt. At impact, the head curtain side air bag deployed. The driver responded to the 280 degree direction of force by moving to his left and slightly forward. His head likely engaged the air bag, but there were no resultant visible contacts to the air bag and the driver stated that he did not have any facial or head injuries. The side glass did disintegrate—most likely due to distortion from the intruding vehicle. The driver did sustain several minor lacerations from the flying glass. His left flank engaged the intruding door panel—causing a contusion.

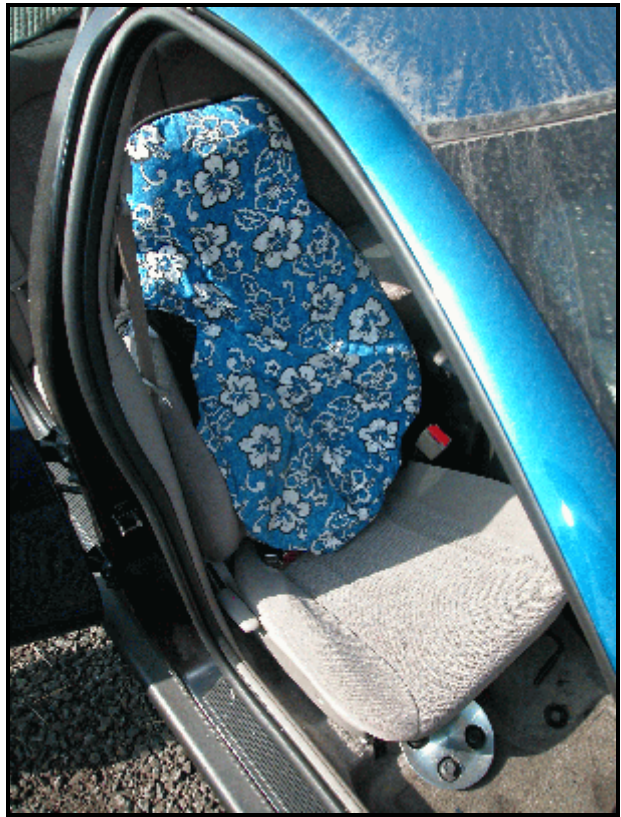
Figure 13. Front right passenger seated position

The 22-year-old male front right passenger was seated in the fabric covered bucket seat in a normal, upright fashion. The seat was adjusted to the rear most track position. The seat back was slightly reclined. The seat back was covered by flower print seat cover. He was wearing the available lap and shoulder belt. The shoulder belt upper anchorage was in the mid position. At impact, he responded to the 280 degree direction of force by moving to his left and slightly forward. He loaded the seat belt causing an abrasion to the left side of his abdomen. He complained of pain to his knees (from coming together) but there was no visible injury.

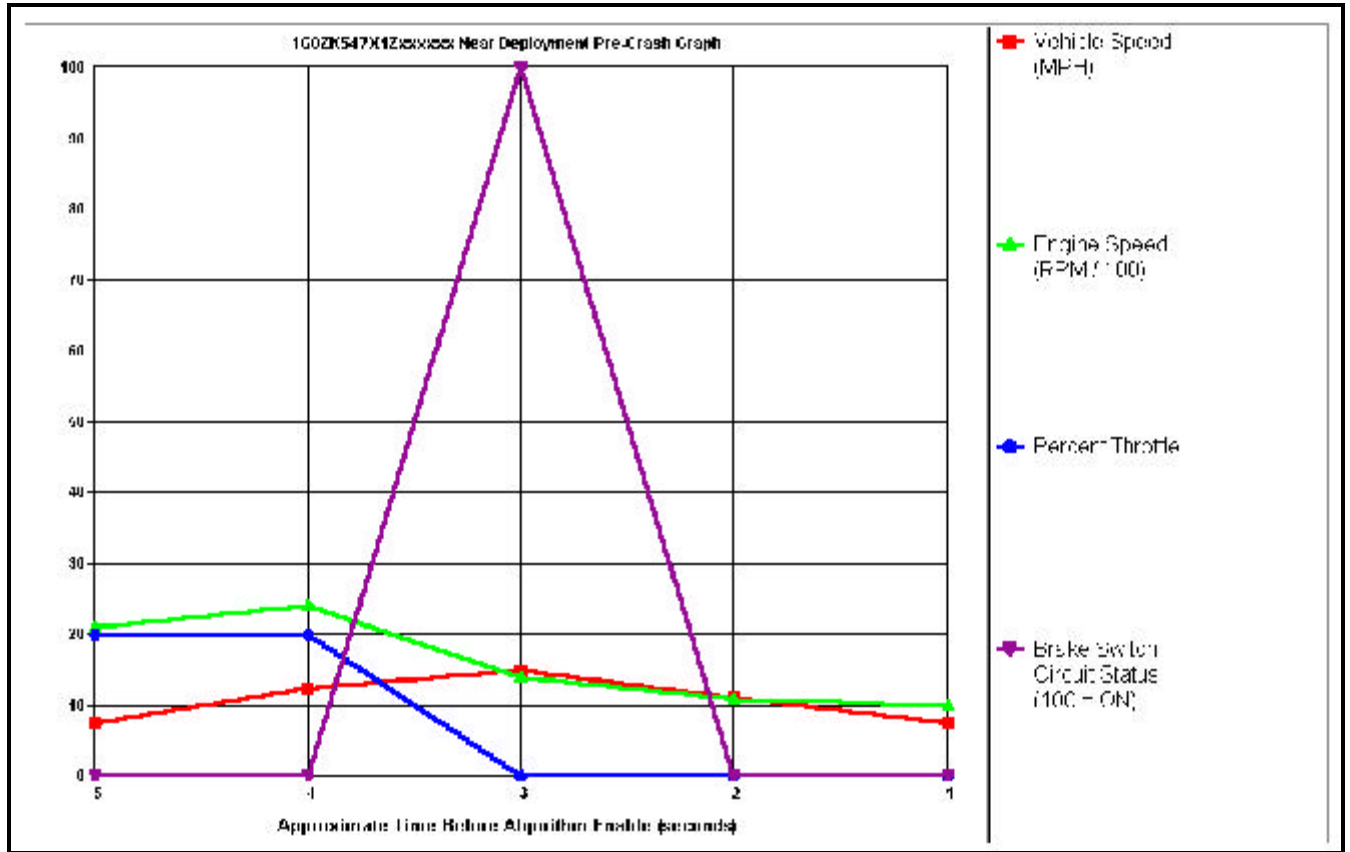
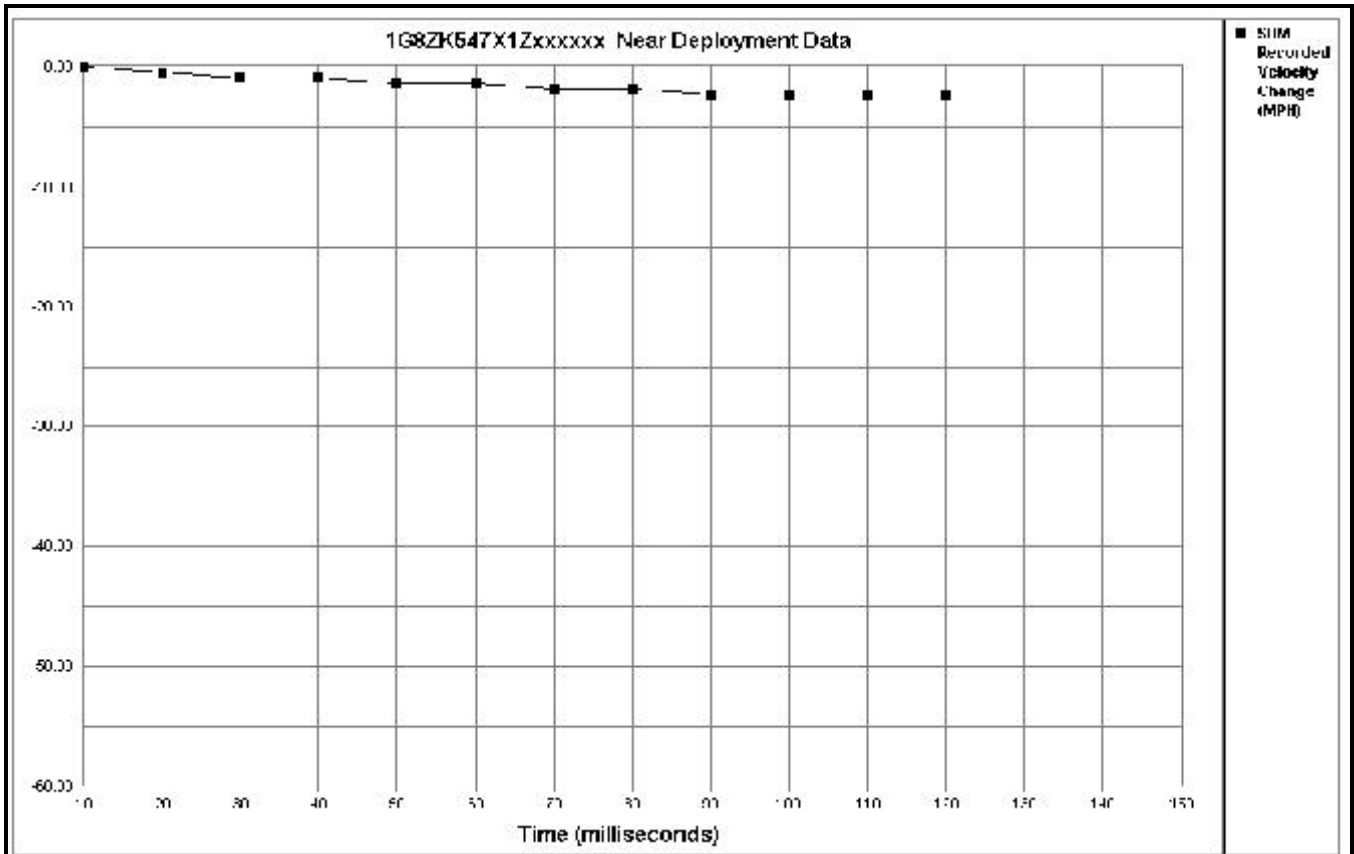
Attachment 2. Vetronix report for case vehicle (2001 Saturn SL2)

The impact was sufficient to generate a Near Deployment Event. A Near Deployment Event is an event severe enough to “wake up” the sensing algorithm but not severe enough to deploy the front air bags. The Sensing Diagnostic Module (SDM) recorded a forward velocity change of -3.5 km/h (-2.2 mph) at the 120 ms mark with a maximum velocity change of -4.2 km/h (-2.6 mph) at the 100 ms mark. At impact, the driver’s head curtain side air bag deployed in the case vehicle. The driver and front right passenger air bags did not deploy.

SR/Yawning Lamp Status	OFF
Driver's Side Switch Circuit Status	BUCKLED
Passenger Front Air Bag Suppression Switch Circuit Status	Air Bag Not Suppressed
Ignition Cycles At Rear Deployment	3565
Ignition Cycles At Investigation	3573
Maximum SDM Recorded Velocity Change (MPH)	-2.55
Algorithm Index to Maximum SUV Recorded Velocity Change (msec)	100
