**VERIDIAN ON-SITE SIDE IMPACT INFLATABLE OCCUPANT PROTECTION
SYSTEM CRASH INVESTIGATION
SCI TECHNICAL SUMMARY REPORT**

VERIDIAN CASE NO. CA02-024

VEHICLE - 2001 VOLVO V70 T5

CRASH DATE - MAY 2002

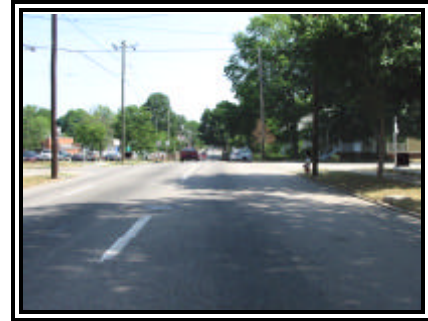
The 45-year-old female driver of the 2001 Volvo V70 was operating the vehicle northbound on the middle lane of the northbound one-way roadway on approach to the four-leg intersection (**Figure 2**). She estimated the speed of her vehicle at 56 km/h (35 mph). The 17-year-old male driver of the 1999 Ford Mustang was operating the vehicle eastbound on approach to the four-leg intersection (**Figure 3**). For unknown reasons, the driver of the Ford Mustang disregarded the stop sign and entered the intersection as the Volvo was traveling through the intersection. The driver of the Volvo braced her arms against the steering wheel and applied the brakes when she realized the imminent collision. It was not known if the driver of the Mustang attempted any avoidance maneuvers.

Figure 2. Northbound approach for the Volvo V70

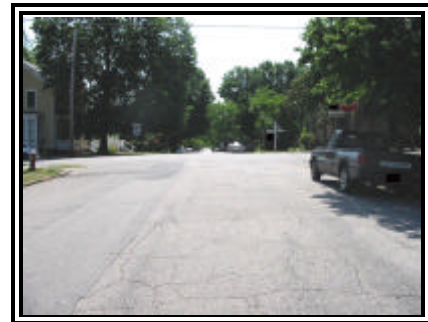
Figure 3. Eastbound approach for the Ford Mustang

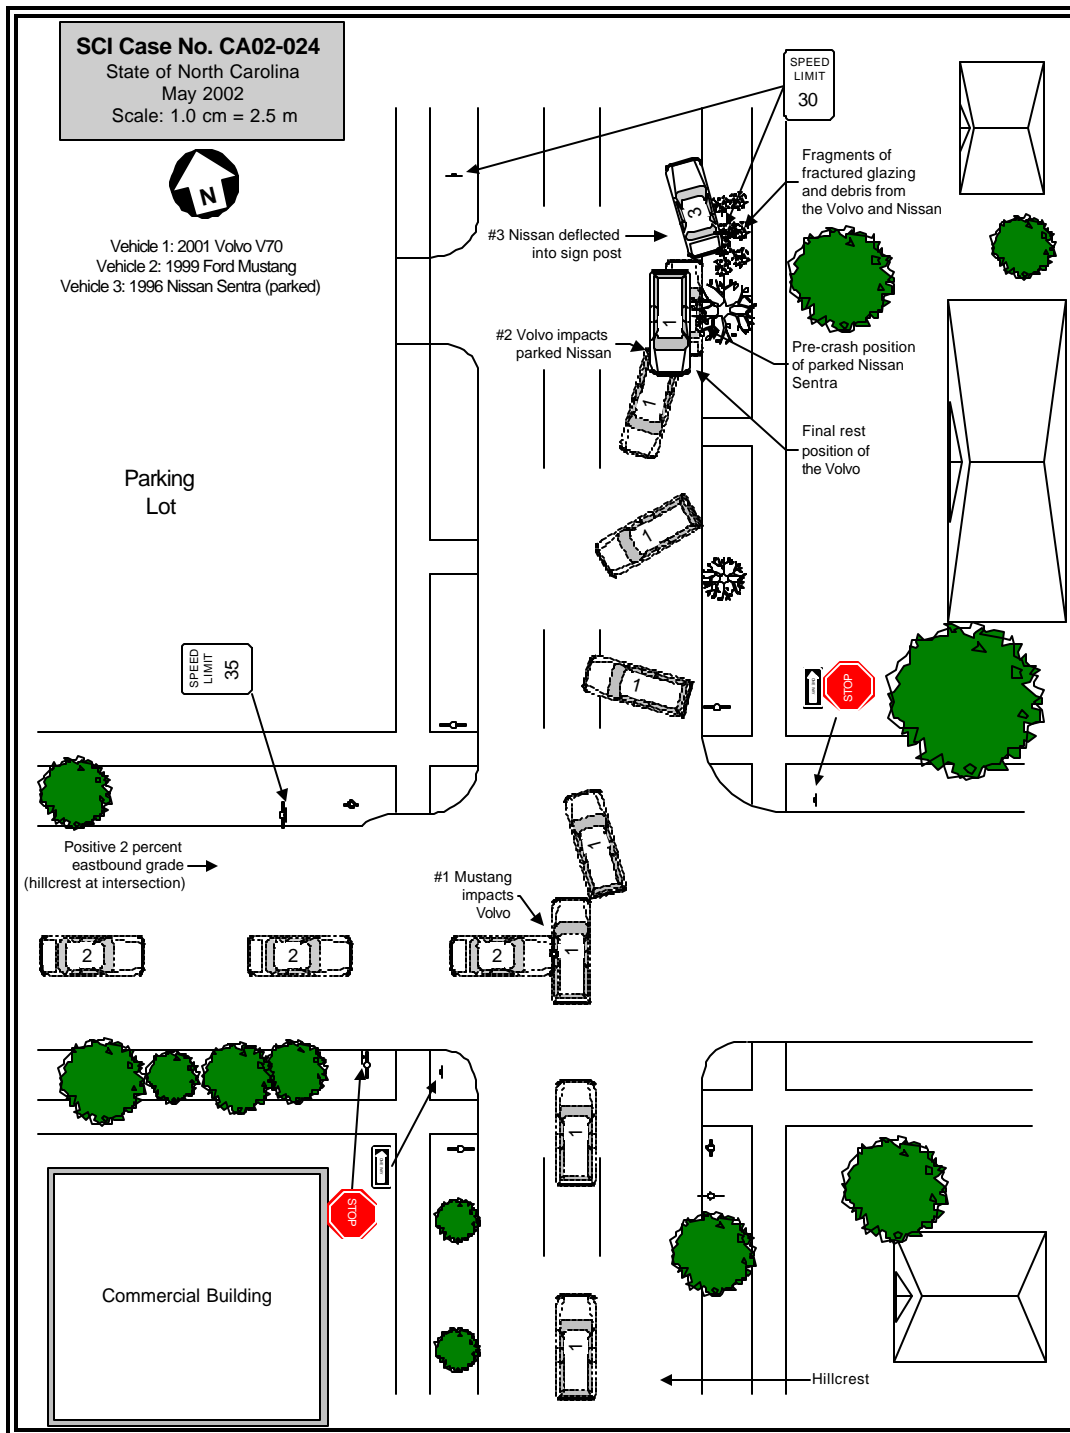
Figure 13. Scene schematic

straight and had a downhill grade at the crash site. A hillcrest was located south of the intersection. The undivided east/west roadway consisted of two travel lanes in each direction and was bordered by concrete curbs. The east/west roadway had a hillcrest at the intersection. Traffic through the intersection was governed by stop signs for east/west traffic approaching the intersection. The stop sign on the southwest corner of the intersection for eastbound traffic was occluded by branches from an adjacent tree. The posted speed limit for the north roadway was 48 km/h (30 mph) and the posted speed limit for the east/west roadway was 56 km/h (35 mph). The scene schematic is included as **Figure 13** of this report.
