On-scene Investigation / Vehicle to Vehicle
Vehicle defect / Fire
Dynamic Science, Inc. / Case Number: DS02025
2000 Crown Victoria Police Interceptor
California
November, 2002

1. Report No. DS02025		2. Government Accession No.		3. Recipient Catalog No.	
4. Title and Subtitle In-Depth Accident Investigation				5. Report Date	
				6. Performing Organization Report No.

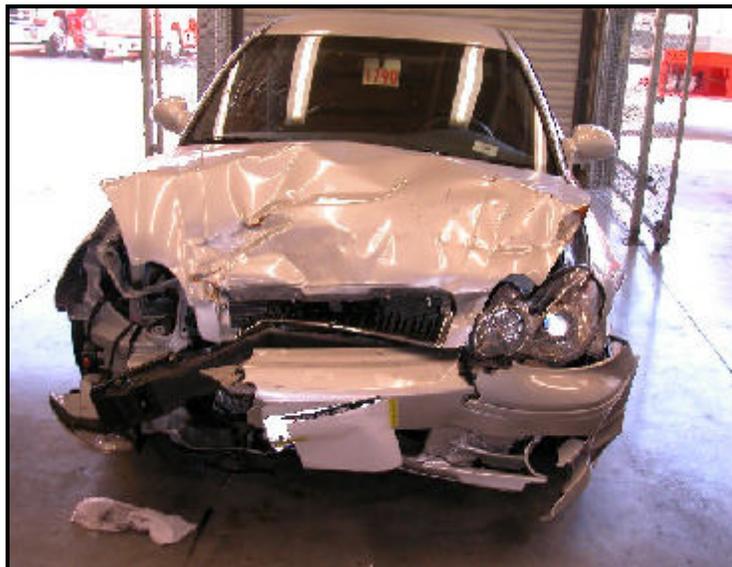
Figure 5. Front, other vehicle (Sonata)

The other vehicle sustained 117 cm (46 in) of direct contact damage beginning at the right front bumper corner. The residual crush measured along the exposed areas of the reinforcement bar was as follows: C1=10 cm (4 in), C2=13 cm (5 in), C3=24 cm (9 in), C4=23 cm (9 in), C5=9 cm (3 in), C6=0 cm (0 in). The maximum crush was located at C3. The principle direction of force was within the 12 o'clock sector and was an estimated 0 degrees.

The damaged components included the bumper fascia and reinforcement bar, hood, grille, and radiator. There was no glazing damage and all doors remained closed and operational.

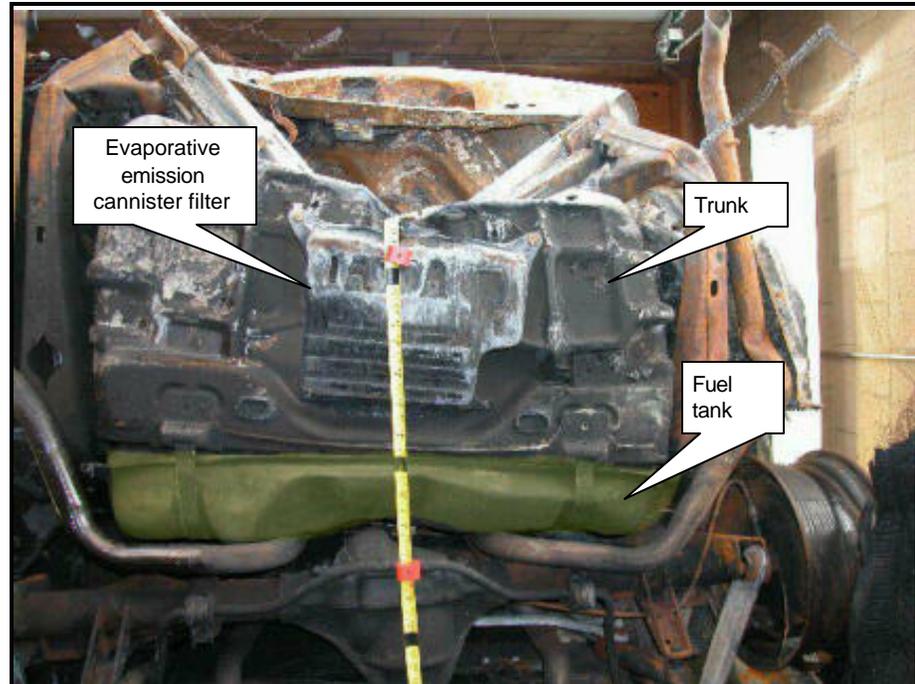
Figure 7. Under side of case vehicle

The rear 2/3 of the case vehicle was damaged by the fire. The interior was completely gutted. The trunk compartment was badly burned, however, the flares and ammunition were not damaged. This vehicle sustained approximately 118 cm (47 in) of direct contact damage that extended across the middle and right of the vehicle's rear bumper. The rear bumper reinforcement bar was rotated upwards. The residual crush measured along the bar was as follows: C1=16 cm (6 in), C2=41 cm (16 in), C3=69 cm (27 in), C4=69 cm (27 in), C5=54 cm (21 in), C6=50 cm (20 in). The maximum crush was located 6 cm (2 in) right of C3 and measured 75 cm (30 in). The principle direction of force was within the 6 o'clock sector and was an estimated 180 degrees. The damaged components (from the crash) included the bumper fascia and reinforcement bar, trunk lid, and rear fenders. There was a 10 cm (4 in) reduction of the right wheelbase. Both front doors remained closed and operational. The rear doors were locked and could not be opened. The controls to unlock the rear doors are in the front of the vehicle and were not operating at the time of the inspection. It does appear, however, that the right rear door would have been jammed shut due to the impact.

Shortly after the vehicle came to rest it caught on fire. The fire was a result of fuel leakage from two punctures to the right side of the fuel tank. The puncture to the front of the tank was 2.4 cm (0.9 in) wide. It was located 9.0 cm (3.5 in) from the bottom of the tank and 2.4 cm (0.9 in) from the right side. The puncture to the rear of the tank was 3 cm (1.2 in) wide. It was located 7.7 cm (3.0 in) from the bottom of the tank and 2.0 cm (0.8 in) from the right side. The punctures occurred as the wrecking bar was forced forward. The blade end of the bar penetrated the front of the trunk, penetrated the back of the fuel tank, and then penetrated the front of the fuel tank. As restitution took place, the bar was drawn backward—leaving the front puncture open. Fuel flowed out of the two holes—primarily the front hole and began pooling on the ground. DSI estimates that the fuel would have flowed out of the tank at a rate of between 15 and 19 liters (4 and 5 gallons) per minute. At this point, the gasoline ignited. The ignition source is not known for sure, but it was likely related to sparks from dragging metal components. There were no indications of any crash related damage to the fuel lines or the tank filler pipe.

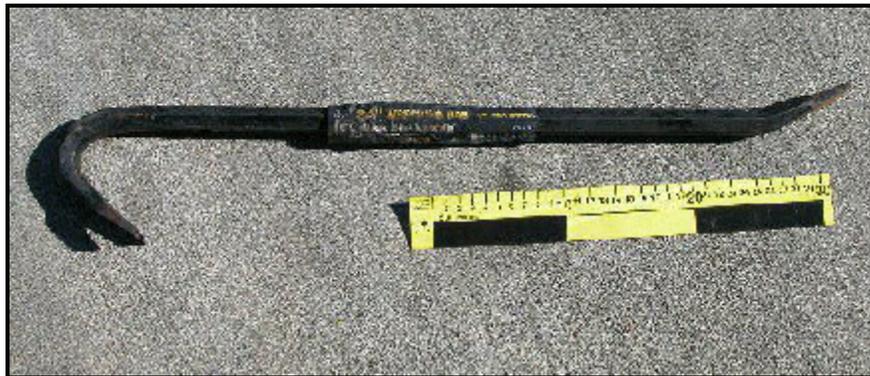
Figure 12. Wrecking bar

Emergency Search and Rescue Kit containing urban rescue equipment. The following items were in the black polyester bag⁴: 2 hard hats, 4 pair of leather gloves, goggles, dust masks, 2 utility knives, 2 flashlights with batteries, 2 orange safety vest, light sticks, duct tape, rope, barricade tape, triage tags, 2 whistles, and a 61 cm (24 in) long wrecking bar (see Figure 13). The bag had been positioned in

the trunk to the right. The wrecking bar was placed in the bag so that the curved end faced the rear of the vehicle and the pointed end faced the front of the vehicle.
