**GENERAL DYNAMICS ON-SITE AMBULANCE CRASH INVESTIGATION
CASE NO: CA02-028
VEHICLE: 1999 FORD E-350 SUPER DUTY VAN CHASSIS W/WHEELED
COACH TYPE III AMBULANCE BODY
LOCATION: NEW JERSEY
CRASH DATE: JULY 2002**

Contract No. DTNH22-01-C-17002

<p>1. <i>Report No.</i> CA02-028</p>	<p>2. <i>Government Accession No.</i></p>	<p>3. <i>Recipient's Catalog No.</i></p>	
<p>4. <i>Title and Subtitle</i> General Dynamics On-Site Ambulance Crash Investigation Vehicle: 1999 Ford E-350 Chassis Location: State of New Jersey</p>		<p>5. <i>Report Date:</i> October 2004</p>	
		<p>6. <i>Performing Organization Code</i></p>	
<p>7. <i>Author(s)</i> Crash Data Research Center</p>		<p>8. <i>Performing Organization Report No.</i></p>	
<p>9. <i>Performing Organization Name and Address</i> Transportation Sciences Crash Data Research Center Advanced Engineering Services A General Dynamics Company P.O. Box 400 Buffalo, New York 14225</p>		<p>10. <i>Work Unit No.</i> C00410.0000.0049</p>	
		<p>11. <i>Contract or Grant No.</i> DTNH22-01-C-17002</p>	
<p>12. <i>Sponsoring Agency Name and Address</i> U.S. Department of Transportation National Highway Traffic Safety Administration Washington, D.C. 20590</p>		<p>13. <i

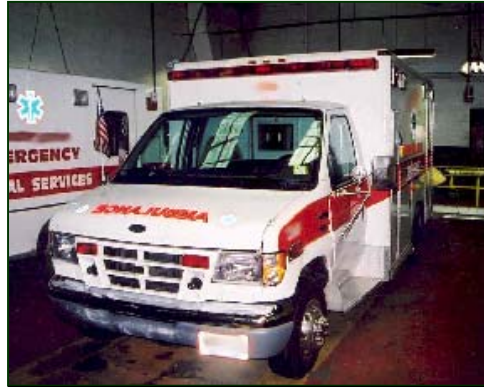
Figure 1. Overall view of the involved ambulance.

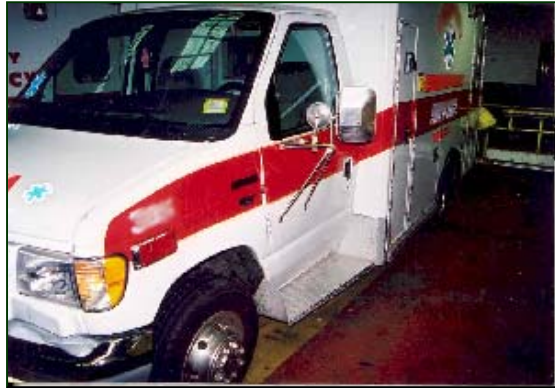
Figure 2. Quarter view of the E-350 chassis,

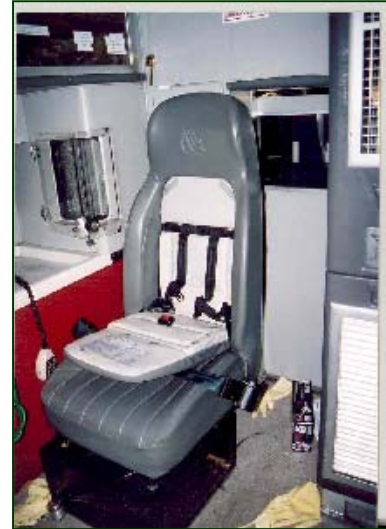
Figure 4. Jump seat/child safety seat.

This lap belt system yielded routine usage wear marks; however, this seat was not occupied at the time of the crash.

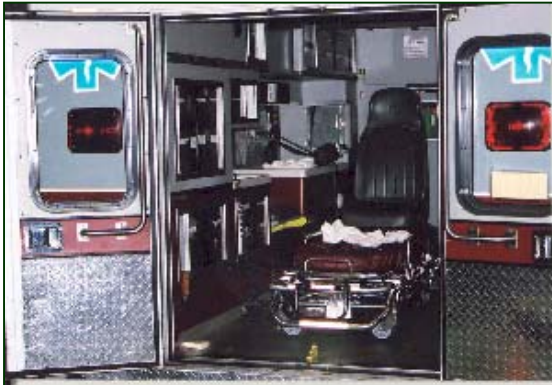
Figure 5. Overall view of the left interior of the patient compartment.

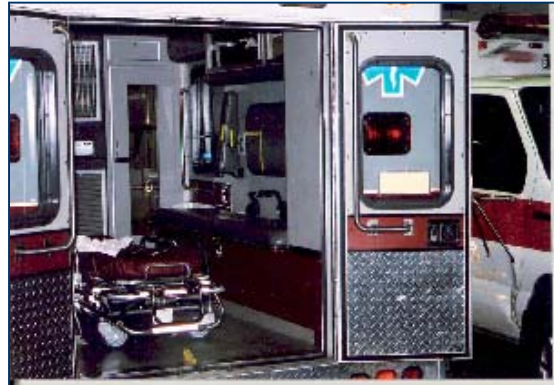
Figure 6. Overall view of the right interior of the patient compartment.

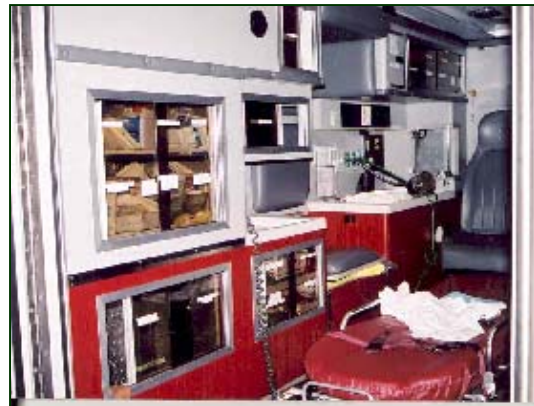
Figure 7. Left side interior of the patient compartment.

panels. A narrow band of padding was positioned horizontally above these compartments. A rear bulkhead extended from the padded strip to the ceiling of the patient compartment. A small compartment was located in the forward aspect of the bulkhead, immediately aft of the jump seat location. All of these compartments remained closed and without damage. There was no occupant contact evidence on the left side interior.

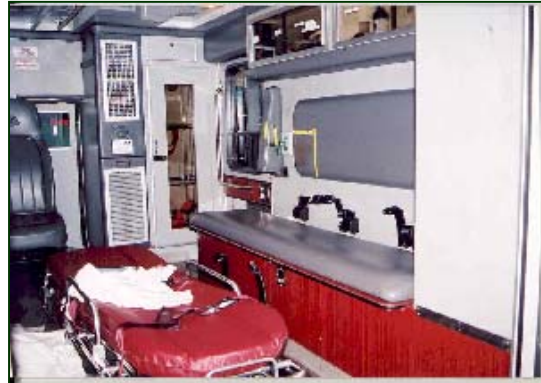
Figure 8. Right side interior of the patient compartment.

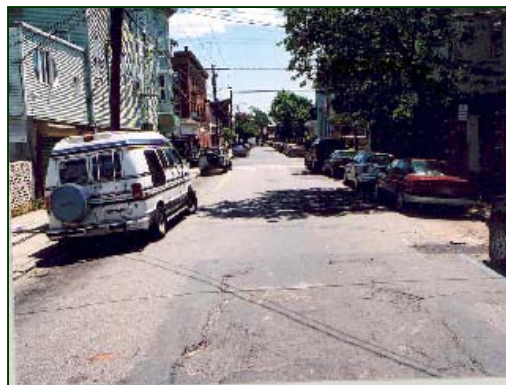
Figure 9. Pre-crash trajectory of the ambulance.

vehicle's overhead emergency lights and siren activated. The driver stated that he was traveling at an estimated speed of 48 km/h (30 mph) on the city street that permitted parallel parking at both curb lines. As he approached the intersection, the driver decelerated to approximately 40 km/h (25 mph) and entered the intersection. Buildings located at the corners of the intersection obscured the driver's view of southbound traffic approaching the intersection. Although a stop sign was present at the mouth of the intersection for eastbound traffic, the ambulance driver proceeded through the regulatory sign without stopping.

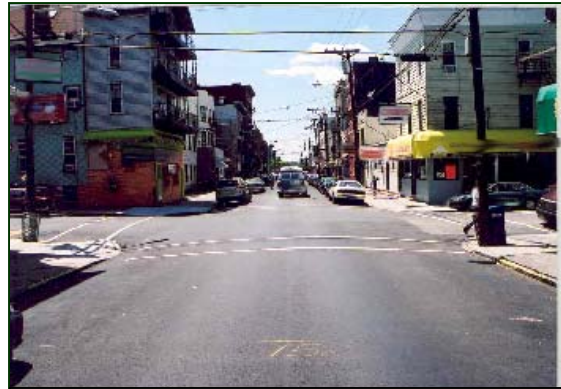
A taxicab was proceeding in a southerly direction on the intersecting roadway (**Figure 10**). The 52-year old male driver and three passengers, assumed to be fares, occupied the taxicab. Buildings at the intersection obstructed the taxi cab driver's view of the approaching ambulance. As the taxicab entered the intersection, the ambulance crossed its path of travel from right to left. The ambulance driver did not initiate avoidance maneuvers and there was no pre-crash evidence (i.e., skid marks) to indicate the driver of the taxicab attempted to avoid the impending crash. The Crash Schematic is attached as **Figure 21**, Page 19.

Figure 10. Pre-crash trajectory of the taxicab.

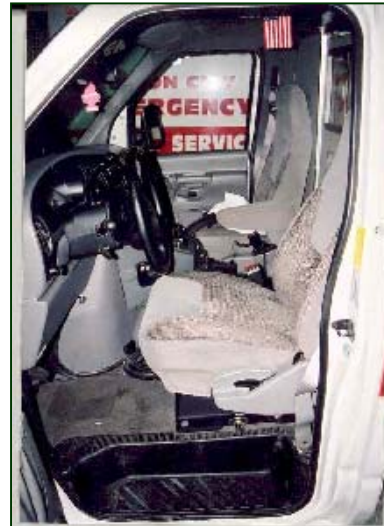
The interior cab (driving compartment) of the ambulance was not damaged as a result of the crash. There was no deployment of the frontal air bags and the safety belt pretensioners did not fire. The driver was properly restrained by the manual safety belt system and did not contact interior components.

Figure 17. Interior view of the driver’s compartment.

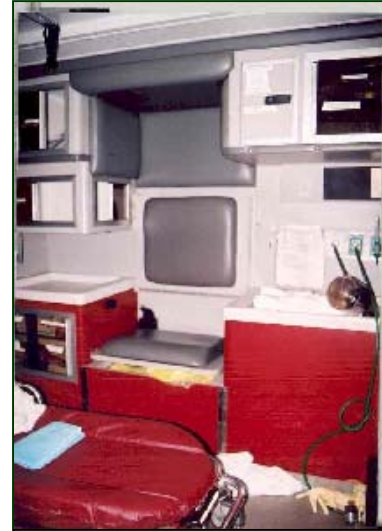
Figure 18. CPR seat.

At impact with the taxicab, the EMT probably moved forward and to his left in response to the impact force. Although he was restrained in a side facing jump seat by the lap belt, he was positioned between compartments of the patient compartment interior. These compartments restricted his lateral movement. The subsequent impacts with the parked vehicles did not displace the EMT. As a result of the lateral right side rollover, the EMT moved forward toward the right side of the patient compartment. The lap belt held him in position as the vehicle rolled onto its right side. The EMT did not contact interior components during this event to cause injury. His eyeglasses; however, were displaced from his face.

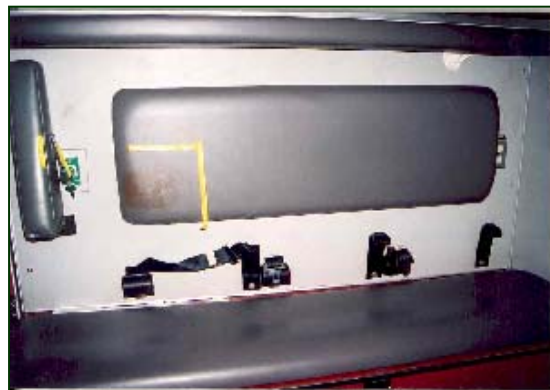
The patient was seated in a normal seated position on the side facing bench seat on the right side of the patient compartment. She was not a medical transport; therefore she was allowed to sit on the bench seat by the ambulance crew. The patient was restrained by the manual lap belt in the center of the three bench seat positions (**Figure 20**). At impact with the taxicab, the patient moved to her right and forward with respect to her left side facing position. She loaded the manual lap belt webbing. The secondary collisions with the parked vehicles did not displace her from her initial position. The lap belt with the automatic locking retractor, held her in position. During the rollover event, the patient loaded the right wall and padded backrest of the patient compartment. There was no evidence of occupant contact at her position and she was not reported as injured. She came to rest lying on her back against the padded backrest, restrained by the lap belt.

Figure 20. Bench seated position of the patient.
