On-scene Investigation / Vehicle to Object  
Dynamic Science, Inc. / Case Number: DS02028  
2001 Subaru Outback station wagon  
Colorado  
October, 2002

1. Report No. DS02028		2. Government Accession No.		3. Recipient Catalog No.	
4. Title and Subtitle In-Depth Accident Investigation				5. Report Date	
				6. Performing Organization Report No.

**Dynamic Science, Inc.**  
**Accident Investigation**  
**Case Number: DS02028**

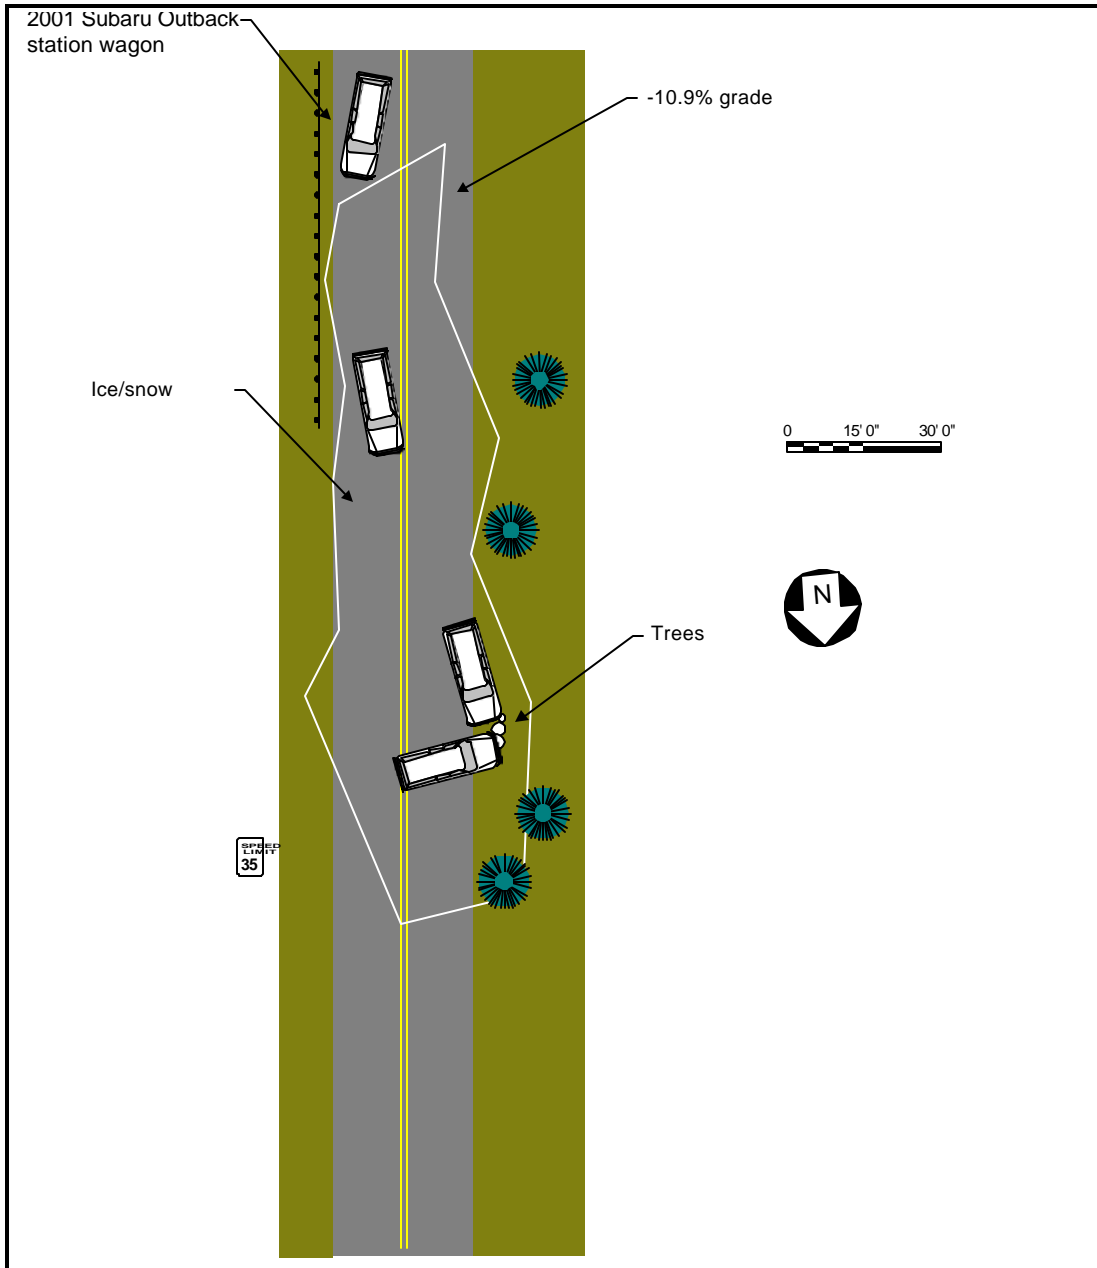
Figure 4. Scene diagram

The total velocity change calculated by the barrier algorithm of the WinSmash collision model was 40 km/h (25 mph). The longitudinal and lateral delta V components were -39 km/h (-25 mph) and -7 km/h (-4 mph), respectively. Both frontal air bags deployed as a result of the tree impact. The driver's seat belt pretensioner was found locked in the used position. The front right passenger seat belt pretensioner was found locked in the stowed position. The vehicle spun counterclockwise 90 degrees and came to rest facing west.
