**VERIDIAN ON-SITE SIDE IMPACT OCCUPANT PROTECTION
INVESTIGATION**

VERIDIAN CASE NO. CA02-030

VEHICLE - 2001 BMW 740i

CRASH DATE - JULY, 2002

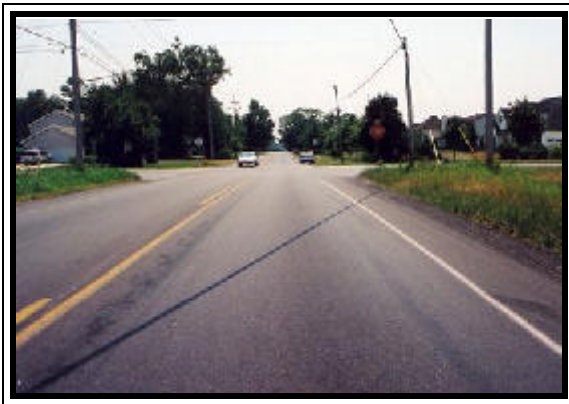
The restrained 16 year old female driver of the 1990 Dodge Shadow 2-door hatchback was operating the vehicle southbound (**Figure 1**) at a (police reported) unknown speed, and on approach to the rural 4-leg intersection. She came to a complete stop, and failed to observe the westbound 2001 BMW as she proceeded straight through the intersection. The police reported no tire marks at the scene indicative of driver avoidance maneuvers, however, the damage pattern sustained to the Dodge confirmed a low pre-impact speed or acceleration from a stop. The front right passenger position was occupied by a restrained 17 year old female.

Figure 1. Southbound approach for the 1990 Dodge Shadow.

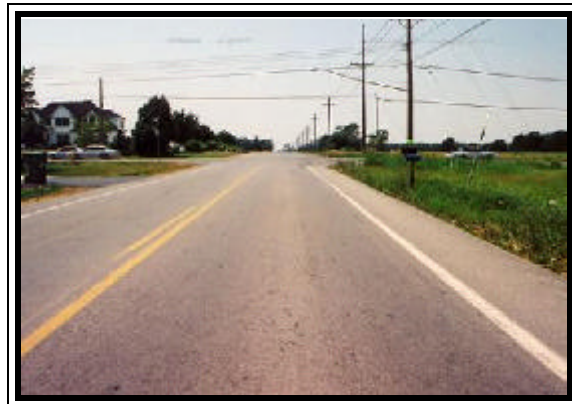
The 49 year old male driver of the 2001 BMW 740il was operating the vehicle westbound (**Figure 2**) at a (police reported) unknown speed when he observed the Dodge cross his path of travel. The BMW driver reported through the surrogate interview no avoidance maneuvers in anticipation of the impending crash.

Figure 2. Westbound approach for the 2001 BMW 740il.

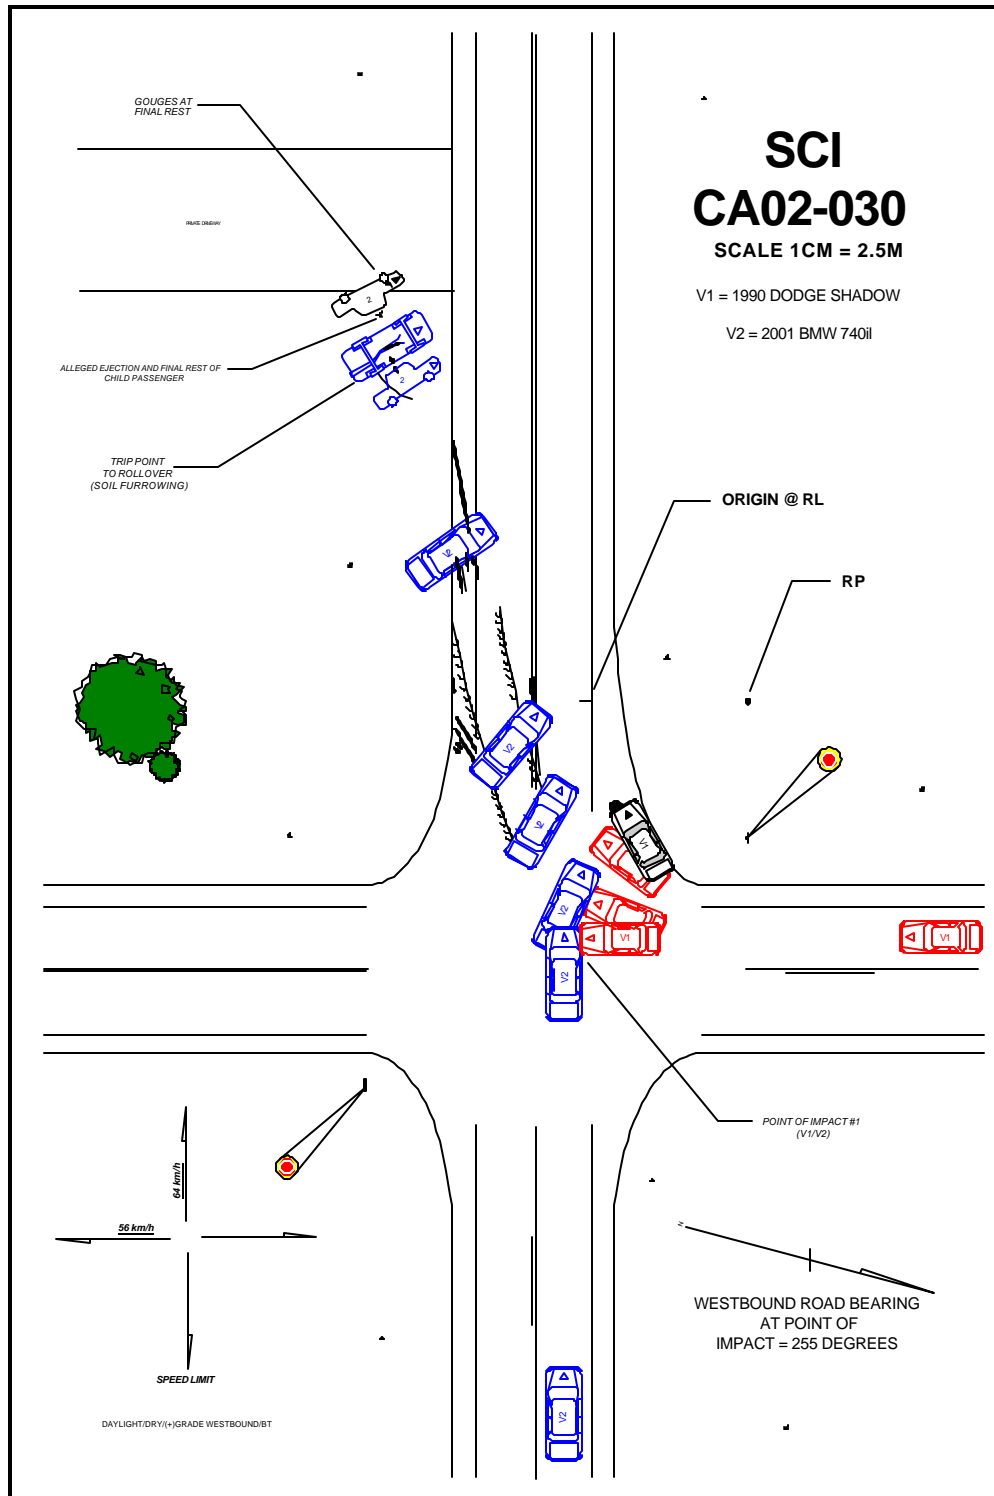
Figure 14. Scene Diagram.

lane of a (straight) 4-leg rural intersection which was controlled by stop signs for north/southbound traffic (see **Figure 14 - page 11**). The westbound lane had a positive grade with a hillcrest located just west of the intersection. The asphalt surfaced intersection was bordered by 1.2 meter (3.3 feet) paved shoulders with a 4.0 cm (1.6 in) vertical apron. Environmental features included grass fields to the north and shallow ditches, residential lawns/driveways, and tree clusters to the south. The posted speed limit for north/southbound traffic was 56 km/h (35 mph), and 64 km/h (40 mph) for east/westbound traffic.
