**VERIDIAN ON-SITE AMBULANCE CRASH INVESTIGATION
SCI TECHNICAL SUMMARY REPORT**

VERIDIAN CASE NO. CA02-033

VEHICLE - 1995 FORD E-350 TYPE III AMBULANCE

CRASH DATE - JULY 2002

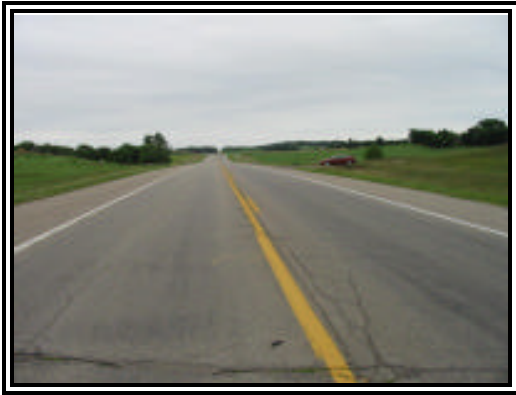
Figure 2. Northbound approach for the ambulance

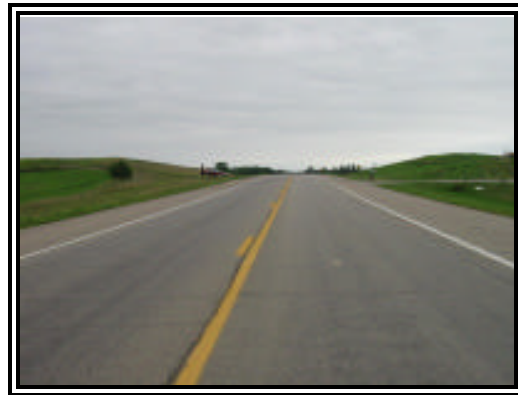
Figure 3. Southbound approach for the Cavalier

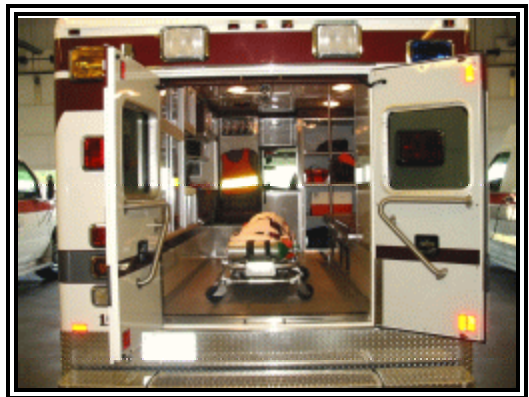
Figure 8 illustrates the approximate configuration of the Horton ambulance patient compartment interior. A center-mount Ferno ambulance cot fastener system was installed in the ambulance. The fastening system consisted of a front “antler” bracket mounted to the center aspect of the floor that secured the front wheels of the cot and a rear spring-loaded fastener rail mounted on the left aspect of the floor that fastened directly to the cot frame. A non-padded stainless steel assist rail was located on the ceiling above the ambulance cot area. The front right side exterior cabinet was accessible from the interior of the patient compartment by two sets of plexiglass doors hinged on the outboard aspects. The remaining interior cabinetry consisted of sliding plexiglass doors configured with full-length aluminum pull handles. Each cabinet with plexiglass doors was configured with an aluminum trim picture frame with 45 degree angles at the corners. Two cabinets with plexiglass doors were located along the left wall on the rear aspect and measured 45.7 cm (18.0") in depth. The rear left side cabinets were vertically oriented and the combined measurements were 64.8 cm (25.5") in width and 121.9 cm (48.0") in height. Additional cabinets with plexiglass doors were located forward of the rear cabinets at the top and bottom aspects of the wall. The top cabinet was hinged at the top aspect and the bottom was configured with sliding doors. Both cabinets measured 53.3 cm (21.0") in width and 30.5 cm (12.0") in height. A Lifepack 12 defibrillator was located on the top aspect of the lower center cabinet. The defibrillator was secured to the shelf with a 2.5 cm (1") wide strap which was routed through the defibrillator’s handle on the top aspect. Two additional cabinets that measured 127.0 cm (50.0") in width and 30.5 cm (12.0") in height were located over and under the work space area on the forward aspect of the left wall. The specific cabinet locations are illustrated in the ambulance interior schematic in **Appendix A**.

Figure 8. View of exemplar patient compartment

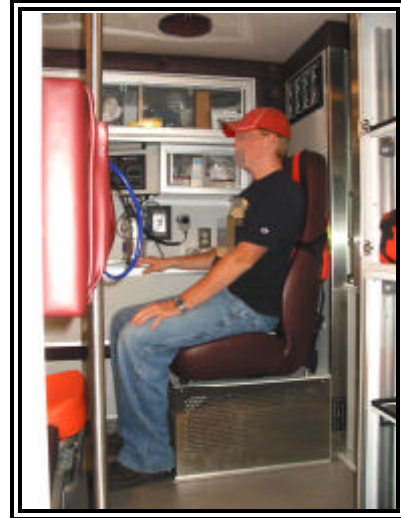
The 19-year-old PCP was seated in the rear-facing technician seat in the patient compartment of the ambulance (Figure 25). The adjustable seat track was adjusted to the full-rear position and the fixed seat back was upright. The PCP was wearing a short-sleeve polo shirt, black EMS pants, and low-cut duty boots with a steel safety toe. He was restrained by the two-point lap belt with an ALR. He stated that he did not actively pull excess webbing into the retractor to tighten the fit of the lap belt. His height allowed his head to clear the top of the seat back. At impact with the Cavalier, he initiated a rearward trajectory toward the front of the patient compartment. He rebounded forward, possibly jack-knifing over the lap belt and was redirected rearward at the impact with the ditch bank. During the frontal impacts, his head extended over the seat back and struck the HVAC vent which resulted in two 4 cm (2") lacerations on the right posterior parietoccipital region with a distracted central piece about 4 cm (2") wide. As the ambulance rotated CW, he was redirected in a lateral direction and loaded the lap belt. He was probably displaced vertically as the rear of the ambulance impacted the ground. He was redirected laterally as the ambulance rolled down the grassy embankment and loaded the lap belt. His upper torso jack-knifed over the lap belt which resulted in a distal terminal ileum injury with complete disruption of the mesentery with approximately 20 cm (8") of avascular small bowel, a complete muscular disruption of a 5 cm (2") segment of the sigmoid colon with associated mesenteric rent, and small retroperitoneal hematoma. He also sustained an omental tear, abdominal contusions and abdominal abrasions. As he moved laterally, his head possibly contacted the inboard aspect of the front right cabinetry in the patient compartment which resulted in a left front scalp contusion and a concussion. During the rollover event, he sustained a right foot contusion from possible contact with the floor, seat base, or left interior wall of the patient compartment. The PCP came to rest upside down suspended from the lap belt. The front right passenger cut the lap belt and assisted the PCP down onto the ceiling of the ambulance. The PCP was reportedly semi-conscious and assisted out of the rear doors by the front right passenger and witnesses to the crash. He was transported by ambulance to a local hospital and transferred to a regional trauma center for treatment. He was admitted for six days and released.

Figure 25. View of PCP in exemplar ambulance illustrating his pre-crash position

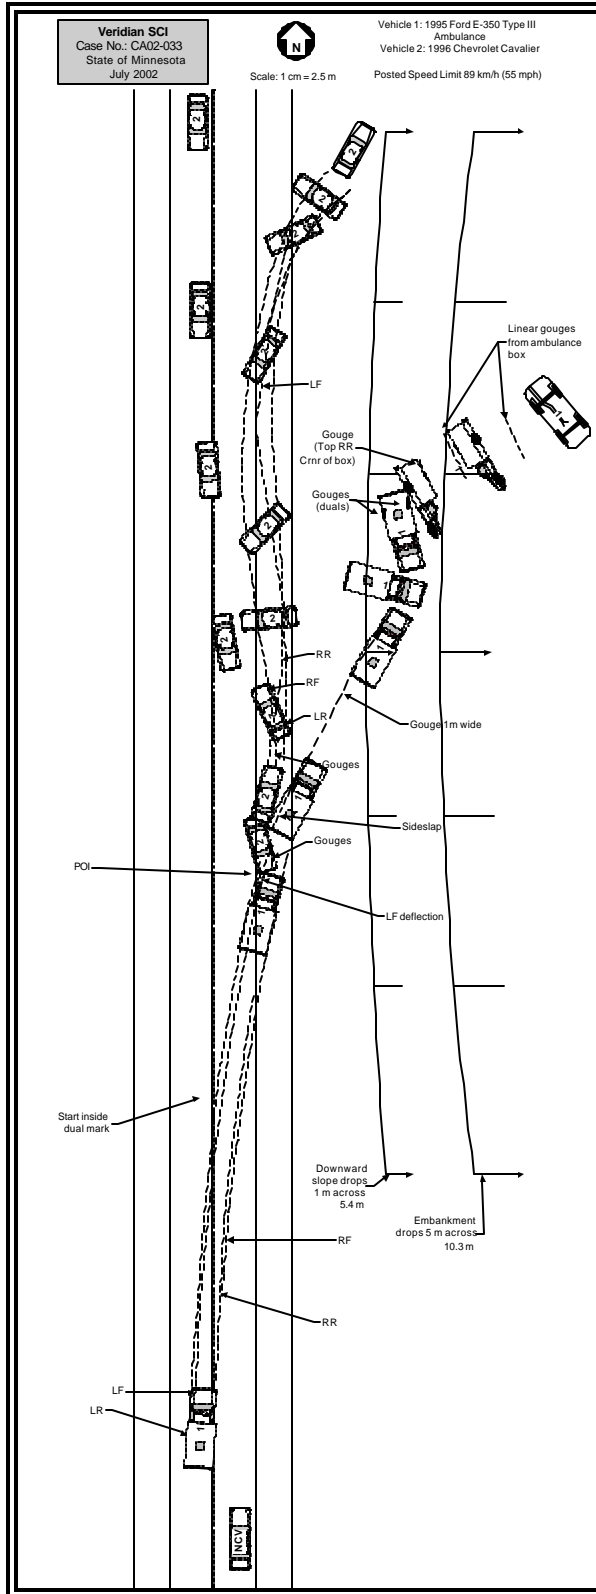
Figure 26.
Scene
schematic

This two-vehicle crash occurred during daylight hours in July 2002. At the time of the crash, there were no adverse weather conditions and the asphalt roadway surface was dry. The crash occurred on a two-lane undivided north-south county roadway. The roadway was configured with one travel lane in each direction separated by a solid yellow centerline for southbound traffic and a broken yellow centerline for northbound traffic. The roadway was straight and the crash occurred near a sag between two small hills. Northbound traffic had a slight negative grade on approach to the crash site. The roadway was bordered by asphalt shoulders and the roadside environment consisted of agricultural fields. The east roadside had a negative sloped grassy ditch bank which began at the road edge. The slope descended at a rate of 1.0 m (3.3') over a length of 5.4 m (17.7') starting 10.0 m (32.8') east of the road edge. A steep grassy embankment began 14.0 m (45.9') east of the road edge with a descent of 5.0 m (16.4') over a length of 10.3 m (33.8'). There was no traffic control present at the crash site, and the posted speed limit was 89 km/h (55 mph). The scene schematic is included as **Figure 26** of this report.
