ON-SITE SIDE IMPACT OCCUPANT PROTECTION INVESTIGATION

VEHICLE: 2000 VOLVO S80

CASE NO: CA02-042

CRASH DATE: SEPTEMBER, 2002

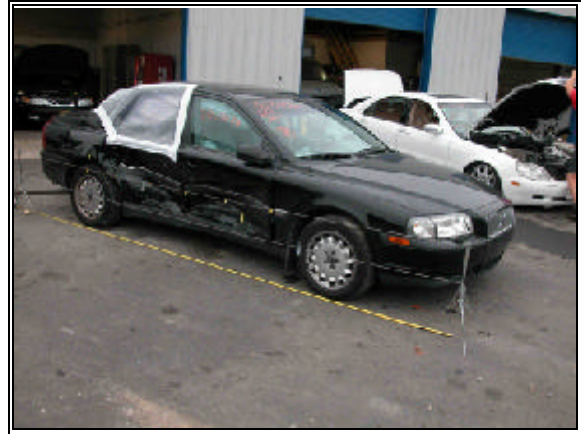
This investigation focused on the performance of the side impact protection system of a 2000 Volvo S80. The Volvo was involved in an intersection crash with a 1996 Chevrolet Cavalier. The Volvo S80, **Figure 1**, was equipped with an Advanced Occupant Protection System (AOPS) that consisted of 3-point lap and shoulder restraints with retractor pretensioners in all five seat positions and dual stage frontal air bags. The Volvo was also equipped with a side impact protection system consisting of seat-mounted side impact air bags for the front occupants and inflatable side curtains. The Volvo's right side impact occupant protection and the frontal occupant protection systems deployed as a result of the crash. The Volvo was occupied by a 41 year old restrained male driver and an eight year old restrained male right rear passenger. Neither occupant of the Volvo sustained injuries in the crash. The Chevrolet Cavalier was equipped with frontal air bags for the driver and front right passenger. The frontal air bags deployed in the Chevrolet as a result of the crash. The Cavalier was occupied by a restrained female driver and an unrestrained female front right passenger. A 3 year old female was seated on the lap of the front right passenger at the time of the crash. The child occupant of the Chevrolet sustained fatal injuries as a result of the deploying front right passenger air bag.

Figure 1: Front right view of the Volvo S80.

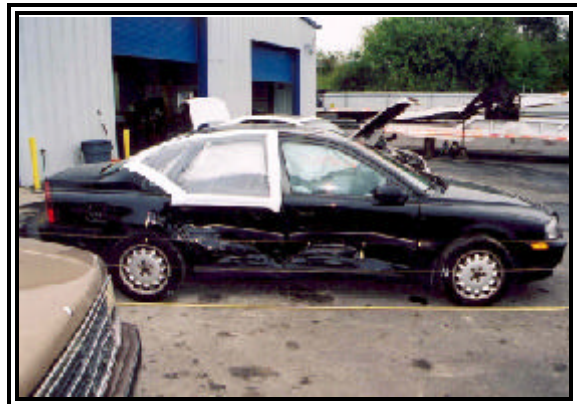
Figure 4: Right side view of the Volvo S80.

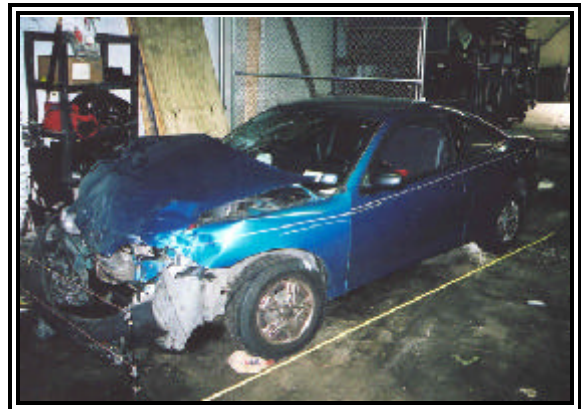
Figure 13: Left front view of the Chevrolet.

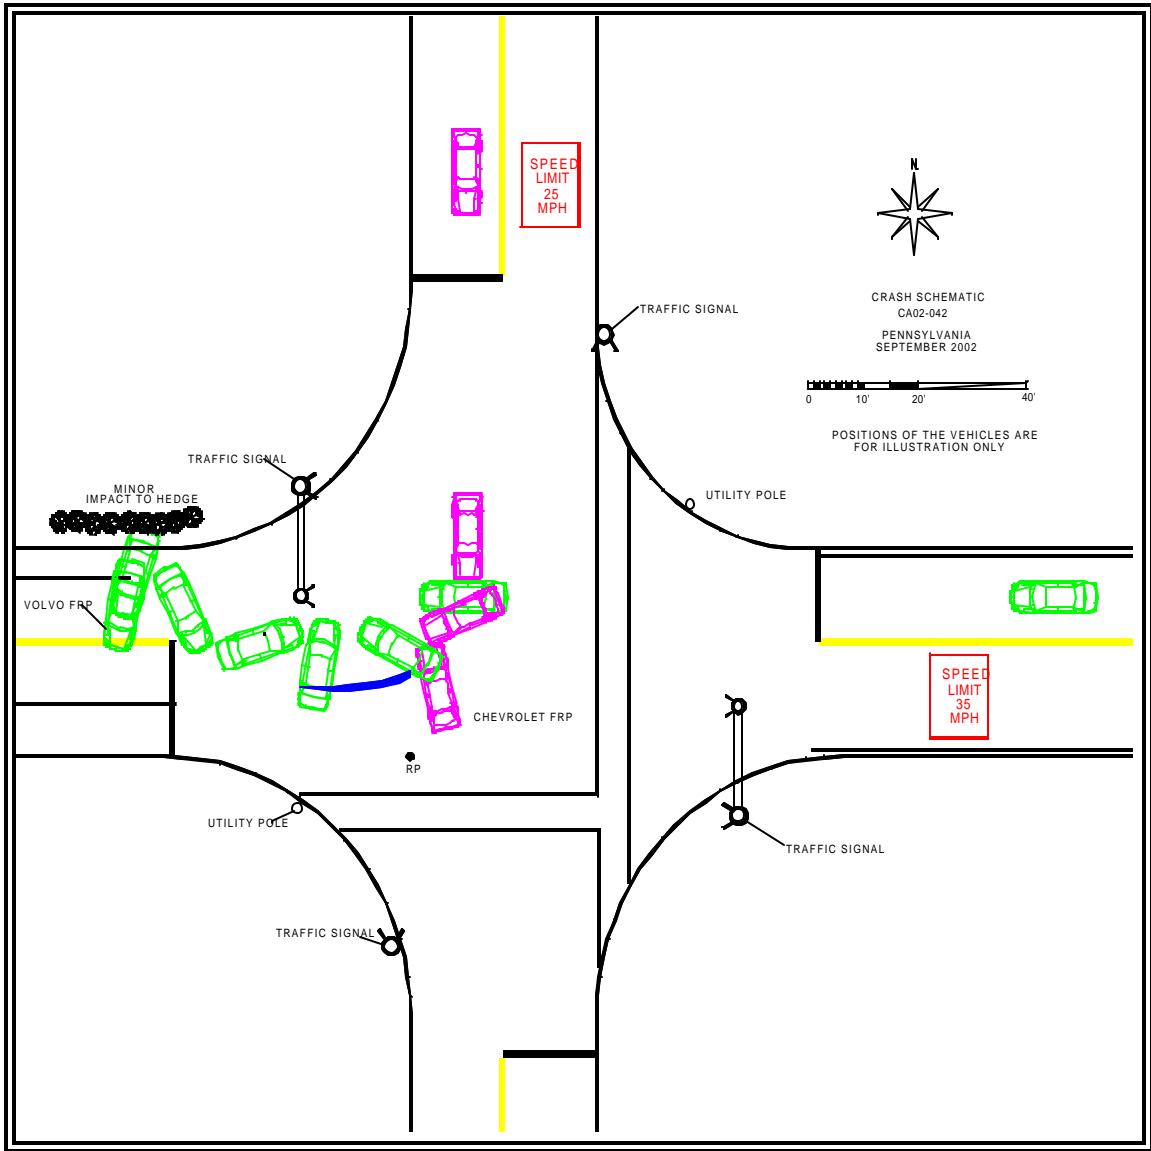
The lateral momentum of the Volvo (relative to the Chevrolet) caused the Chevrolet to rotate approximately 180 degrees clockwise upon separation from the Volvo. The Chevrolet came to rest facing north within the center of the intersection approximately 7.6 m (25.0 ft) south of the impact. The Chevrolet's impact was centered approximately 25 cm (10 in) aft of the Volvo's right B-pillar. The force of the impact rearward of the Volvo's center of gravity caused the vehicle to rotate approximately 270 degrees clockwise during its slide to rest. The Volvo came to rest facing south 18.9 m (62.0 ft) west of the point of impact. A 6 m (20 ft) scuff mark attributed to the left rear tire of the Volvo defined its post-crash trajectory. In the late stages of the Volvo's post-impact trajectory the back plane of the vehicle contacted the road side hedge and then rolled forward to final rest. **Figure 22** at the end of this report is a schematic of the crash.

Figure 22: Crash schematic.
