**SIDE IMPACT AIR BAG NON-DEPLOYMENT/DRIVER FATALITY INVESTIGATION**

**VERIDIAN CASE NO: CA02-054**

**VEHICLE: 2001 BUICK REGAL**

**CRASH DATE: OCTOBER, 2002**

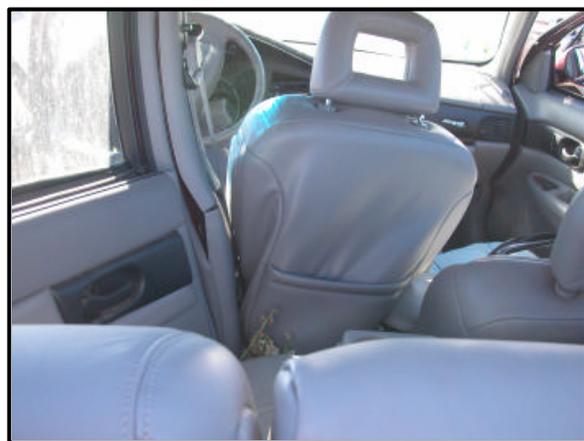
**Figure 9: Interior view through the backlight.**

The Regal's front left and rear left occupant spaces sustained moderate intrusion as a result of the exterior crash forces. **Figure 8** is a view of the right lateral view of the driver's interior. **Figure 9** is a rear interior view through the backlight. The lateral intrusion into the driver's foot well measured 35.1 cm (13.8 in). The left corner of the instrument panel intruded laterally 12.7 cm (5.0 in). The lateral intrusion of the left front door measured at the center aspect of the arm rest was 25.9 cm (9.8 in). The lateral intrusion of the left rear door measured at its center aspect was 27.9 cm (11.0 in). The intrusion of the left B-pillar measured at the D-ring elevation and beltline was 38.4 cm (15.1 in) and 48.9 cm (19.3 in), respectively. The left B-pillar was in contact with the outboard aspect of the driver's seat back. The intruding left side had deformed the seat back laterally approximately 30 cm (12 in). The inboard aspect of the driver's seat contacted and fractured the center console.

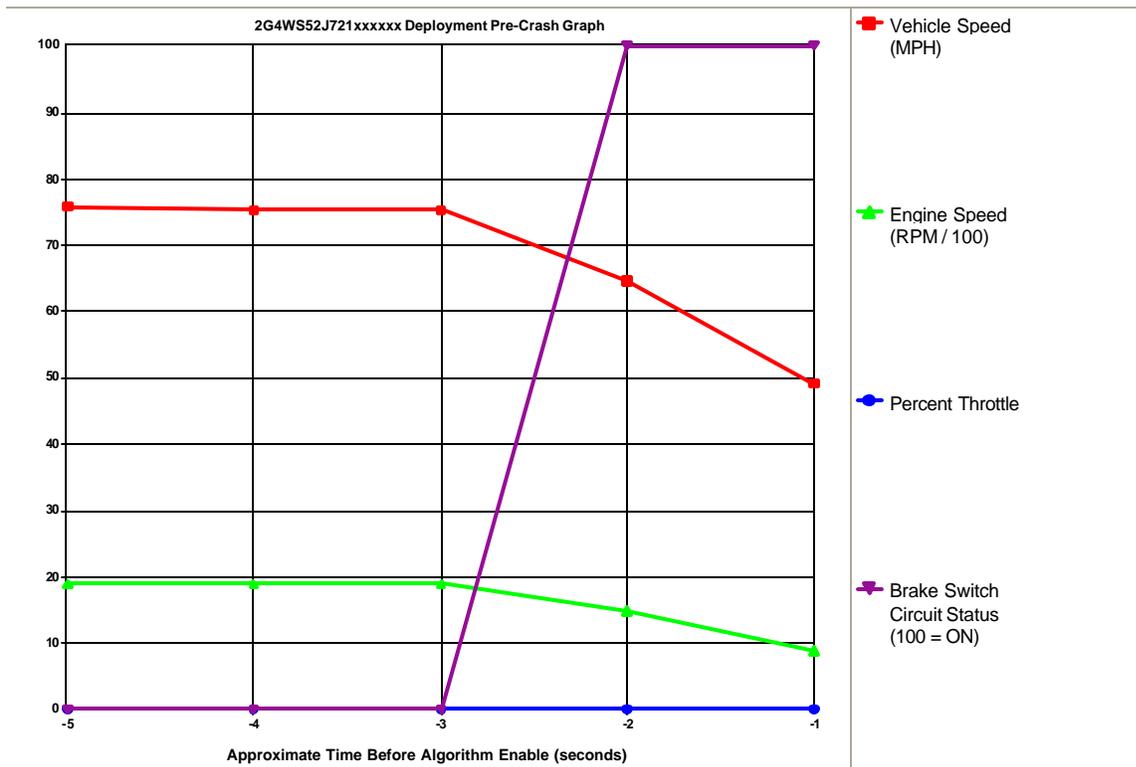
### System Status At Deployment

SIR Warning Lamp Status	OFF
Driver's Belt Switch Circuit Status	BUCKLED
Passenger Front Air Bag Suppression Switch Circuit Status	Air Bag Not Suppressed
Ignition Cycles At Deployment	1999
Ignition Cycles At Investigation	2001
Maximum SDM Recorded Velocity Change (MPH)	-23.87
Algorithm Enable to Maximum SDM Recorded Velocity Change (msec)	107.5
Time Between Non-Deployment And Deployment Events (sec)	1.4
Time From Algorithm Enable to Deployment Command Criteria Met (msec)	12.5

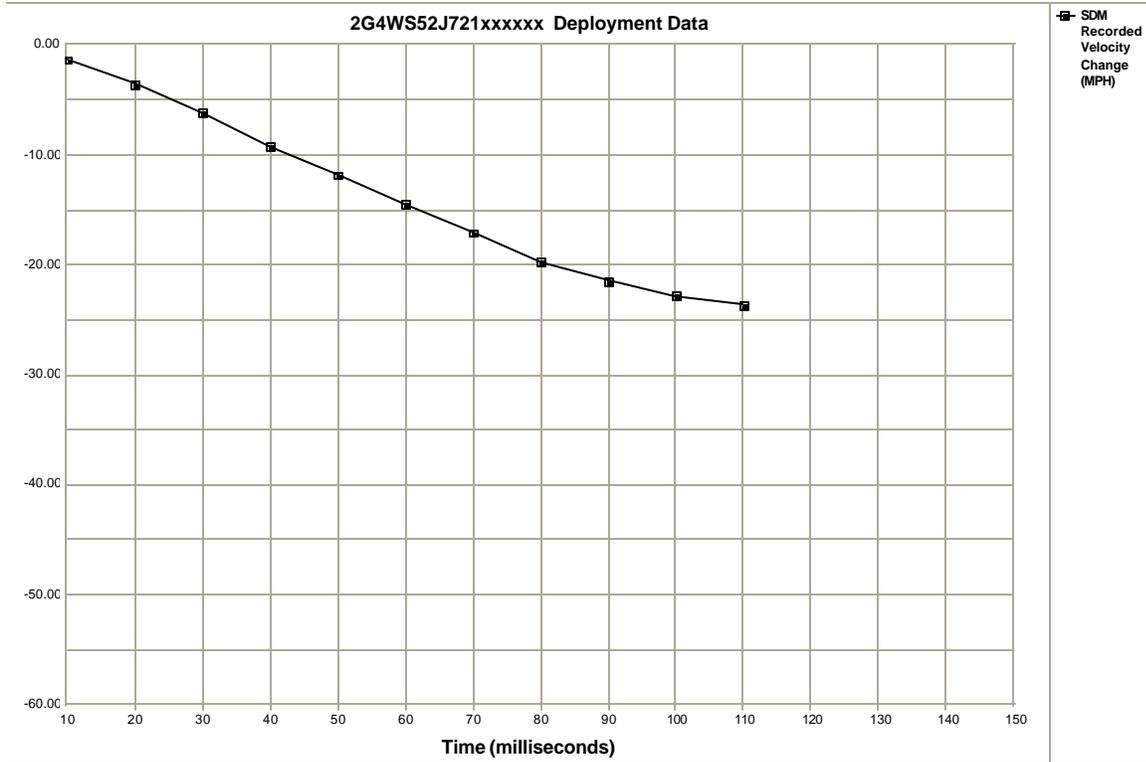
Time (milliseconds)	10	20	30	40	50	60	70	80	90	100	110	120	130	140	150
SDM Recorded Velocity Change	-1.32	-3.51	-6.14	-9.21	-11.85	-14.48	-17.11	-19.75	-21.50	-22.82	-23.70	N/A	N/A	N/A	N/A

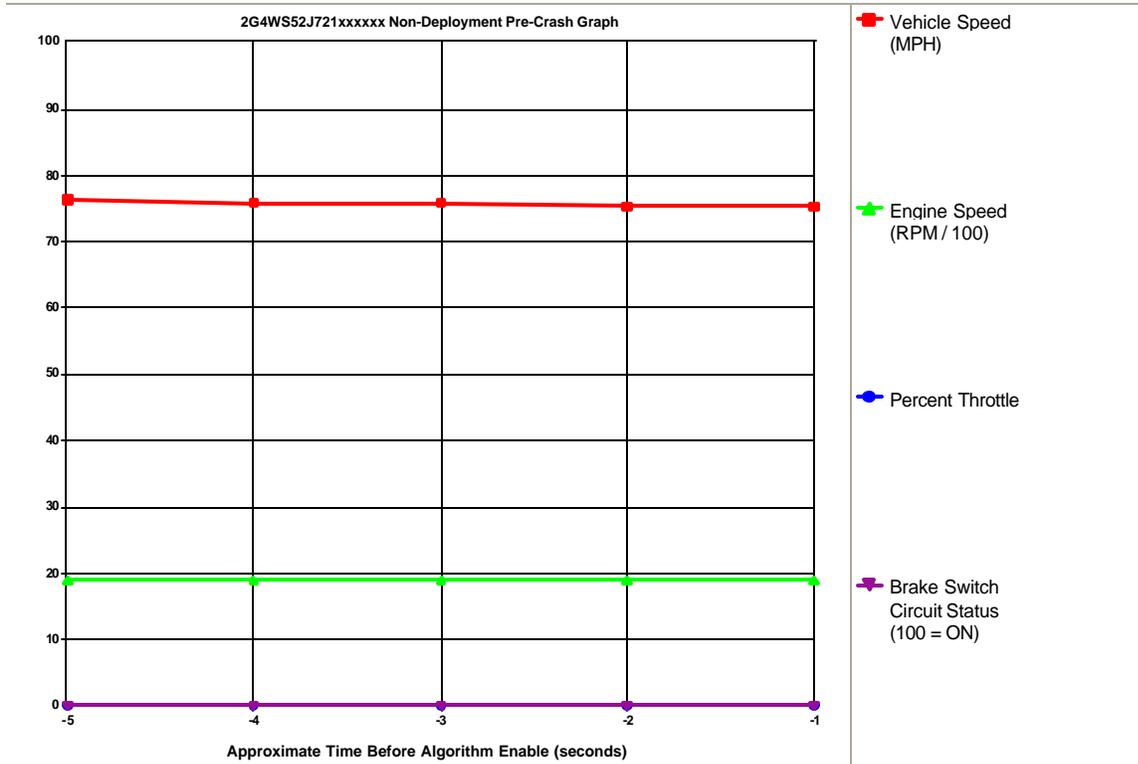
### System Status At Non-Deployment

SIR Warning Lamp Status	OFF
Driver's Belt Switch Circuit Status	BUCKLED
Passenger Front Air Bag Suppression Switch Circuit Status	Air Bag Not Suppressed
Ignition Cycles At Non-Deployment	1999
Ignition Cycles At Investigation	2001
Maximum SDM Recorded Velocity Change (MPH)	-1.49
Algorithm Enable to Maximum SDM Recorded Velocity Change (msec)	80

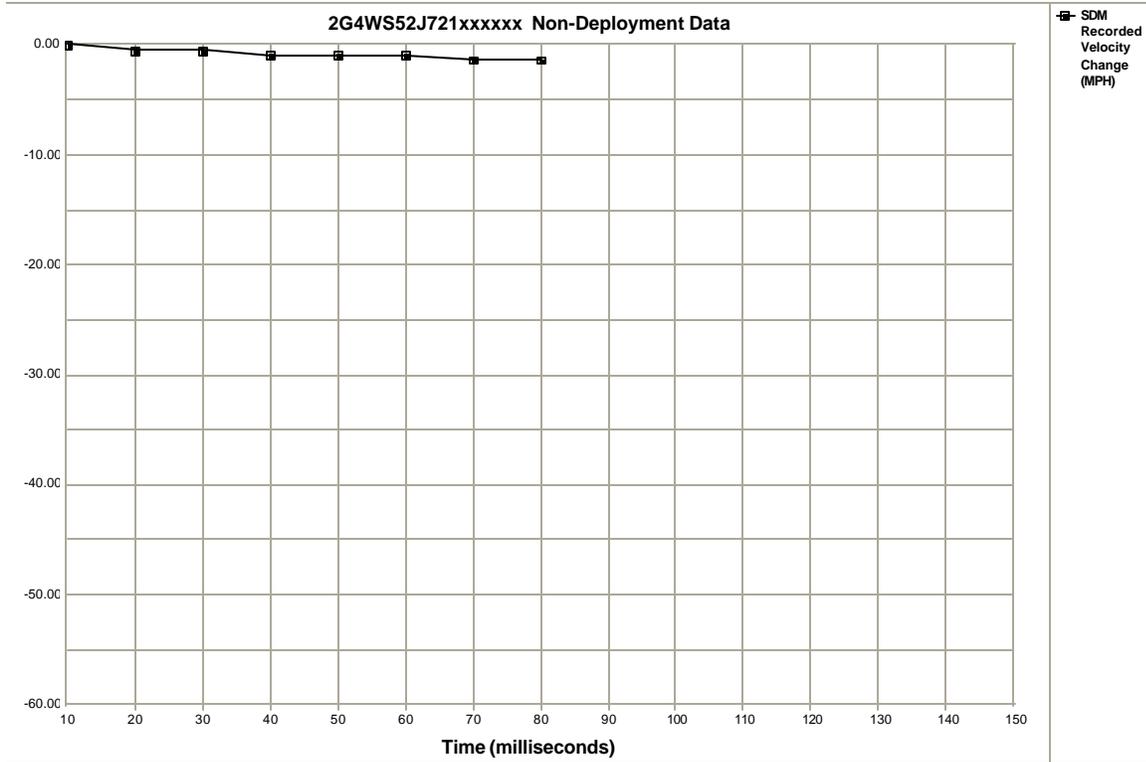
Time (milliseconds)	10	20	30	40	50	60	70	80	90	100	110	120	130	140	150
SDM Recorded Velocity Change	0.00	-0.44	-0.44	-0.88	-0.88	-0.88	-1.32	-1.32	N/A
