**GENERAL DYNAMICS REMOTE CERTIFIED ADVANCED COMPLIANT
VEHICLE CRASH INVESTIGATION**

SCI TECHNICAL SUMMARY REPORT

NASS/SCI COMBO CASE NO. 03-08-109C

VEHICLE – 2003 GMC SIERRA

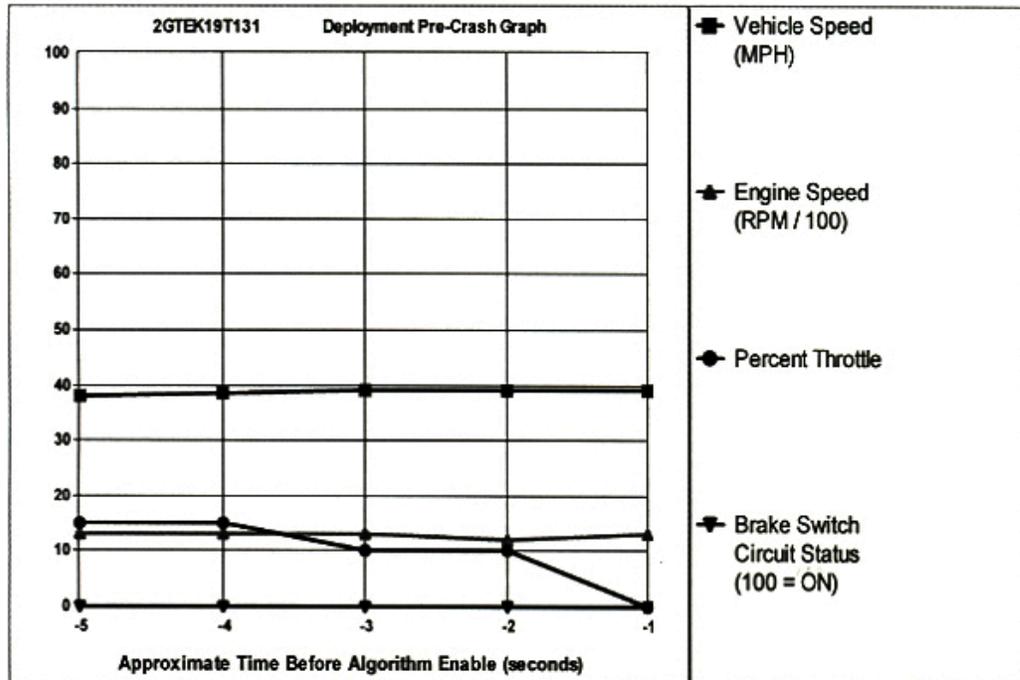
SIR Warning Lamp Status	OFF
Driver's Belt Switch Circuit Status	BUCKLED
Ignition Cycles At Deployment	532
Ignition Cycles At Investigation	538
Maximum SDM Recorded Velocity Change (MPH)	-26.83
Algorithm Enable to Maximum SDM Recorded Velocity Change (msec)	177.5
Driver First Stage Time Algorithm Enabled to Deployment Command Criteria Met (msec)	17.5
Driver Second Stage Time Algorithm Enabled to Deployment Command Criteria Met (msec)	20
Passenger First Stage Time Algorithm Enabled to Deployment Command Criteria Met (msec)	N/A
Passenger Second Stage Time Algorithm Enabled to Deployment Command Criteria Met (msec)	N/A
Time Between Non-Deployment And Deployment Events (sec)	N/A
Frontal Deployment Level Event Counter	1
Event Recording Complete	Yes
Multiple Events Associated With This Record	No
One Or More Associated Events Not Recorded	No

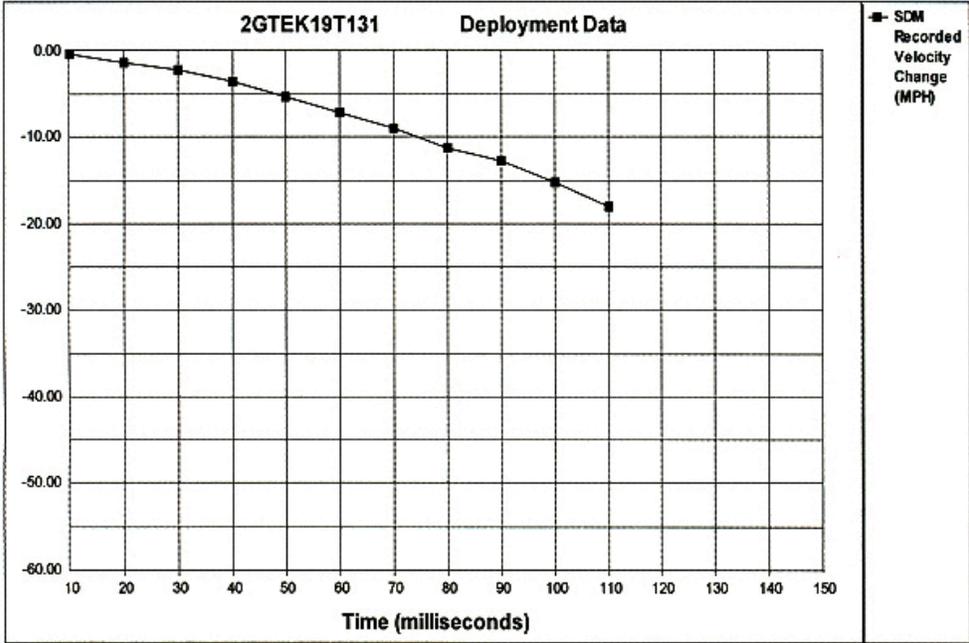
Time (milliseconds)	10	20	30	40	50	60	70	80	90	100	110	120	130	140	150
Recorded Velocity Change (MPH)	-0.31	-1.24	-2.17	-3.41	-5.27	-7.13	-8.99	-11.16	-12.71	-15.19	-17.98	N/A	N/A	N/A	N/A
