VEHICLE CRASH INVESTIGATION

SCI TECHNICAL SUMMARY REPORT

NASS/SCI COMBO CASE NO. 03-42-050E

VEHICLE – 2003 HONDA ODYSSEY

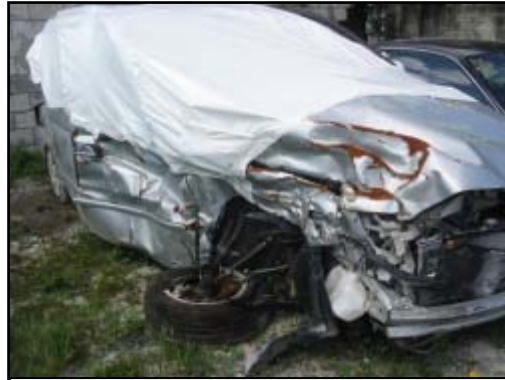
Figure 1. 2003 Honda Odyssey.

This remote investigation focused on the performance of the Certified Advanced 208-Compliant (CAC) safety system in a 2003 Honda Odyssey (**Figure 1**). The manufacturer of this vehicle has certified that this 2003 Honda Odyssey meets the advanced air bag requirements of the Federal Motor Vehicle Safety Standard (FMVSS) No. 208. The system included dual stage frontal air bags, seat track position sensors for the front left and front right seats, and an occupant presence sensor for the front right seat. The Honda was also equipped with retractor

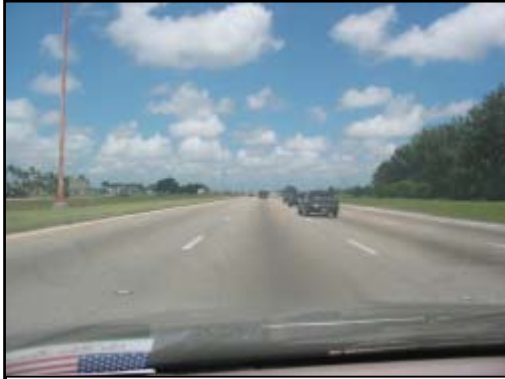
Figure 2. Honda's northbound approach to crash site.

The 40-year-old female driver of the 2003 Honda Odyssey was operating the vehicle northbound in the second lane on the state road (**Figure 2**). The 53-year-old female driver of the 2002 Ford Taurus was operating the vehicle northbound on the same road in the first lane (left lane) alongside the Honda. The 54-year-old male driver of the Jeep was operating the vehicle southbound (**Figure 3**) on the same road in the left lane. The driver of the Honda attempted to change lanes from the second lane to the first lane.

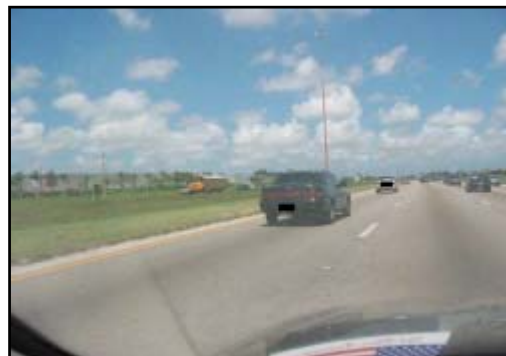
Figure 4. Northbound view of the area of impact between the Honda and the Ford.

As the Honda entered the first lane, the left rear of the Honda impacted the front right area of the Ford in a sideswipe-type impact configuration (**Figure 4**). The resultant directions of force were within the 12 o'clock sector for the Honda and 6 o'clock for the Ford. The sideswipe-type impact was out of scope for the WINSMASH program therefore, a delta V was not computed for this impact.

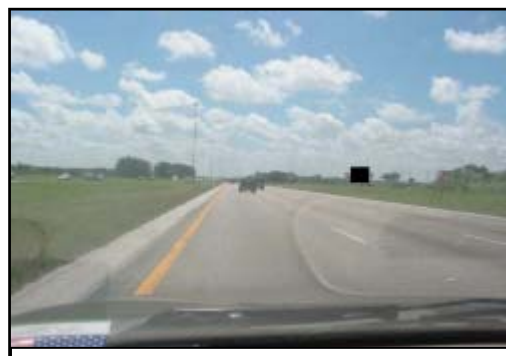
Figure 5. Southbound view of area of impact between the Honda and the Jeep.

Upon impact with the Ford, the driver of the Honda relinquished directional control of the vehicle. The Honda departed the west road edge and entered the grass median. The Honda continued traveling across the median in a northwest direction and entered the southbound lanes. As the Honda entered the first lane the frontal aspect of the Jeep impacted the front right aspect of the Honda (**Figure 5**). The resultant directions of force were within the 2 o'clock sector for the Honda and 11 o'clock for the Jeep. A WINSMASH Collision Deformation Classification (CDC) algorithm was used to calculate an approximate delta V for both vehicles due to the lack of crush measurements for the Honda. The total calculated delta V for the Honda was 32 km/h (20 mph). The longitudinal and lateral components for the Honda were -16 km/h (-10 mph) and -28 km/h (-17 mph),

respectively. The total calculated delta V for the Jeep was 36 km/h (22 mph). The longitudinal and lateral components for the Jeep were -34 km/h (-21 mph) and 12 km/h (7 mph), respectively. The downloaded EDR data from the Honda indicated that the “Equivalent barrier collision speed” was approximately 32 km/h (20 mph) longitudinally.

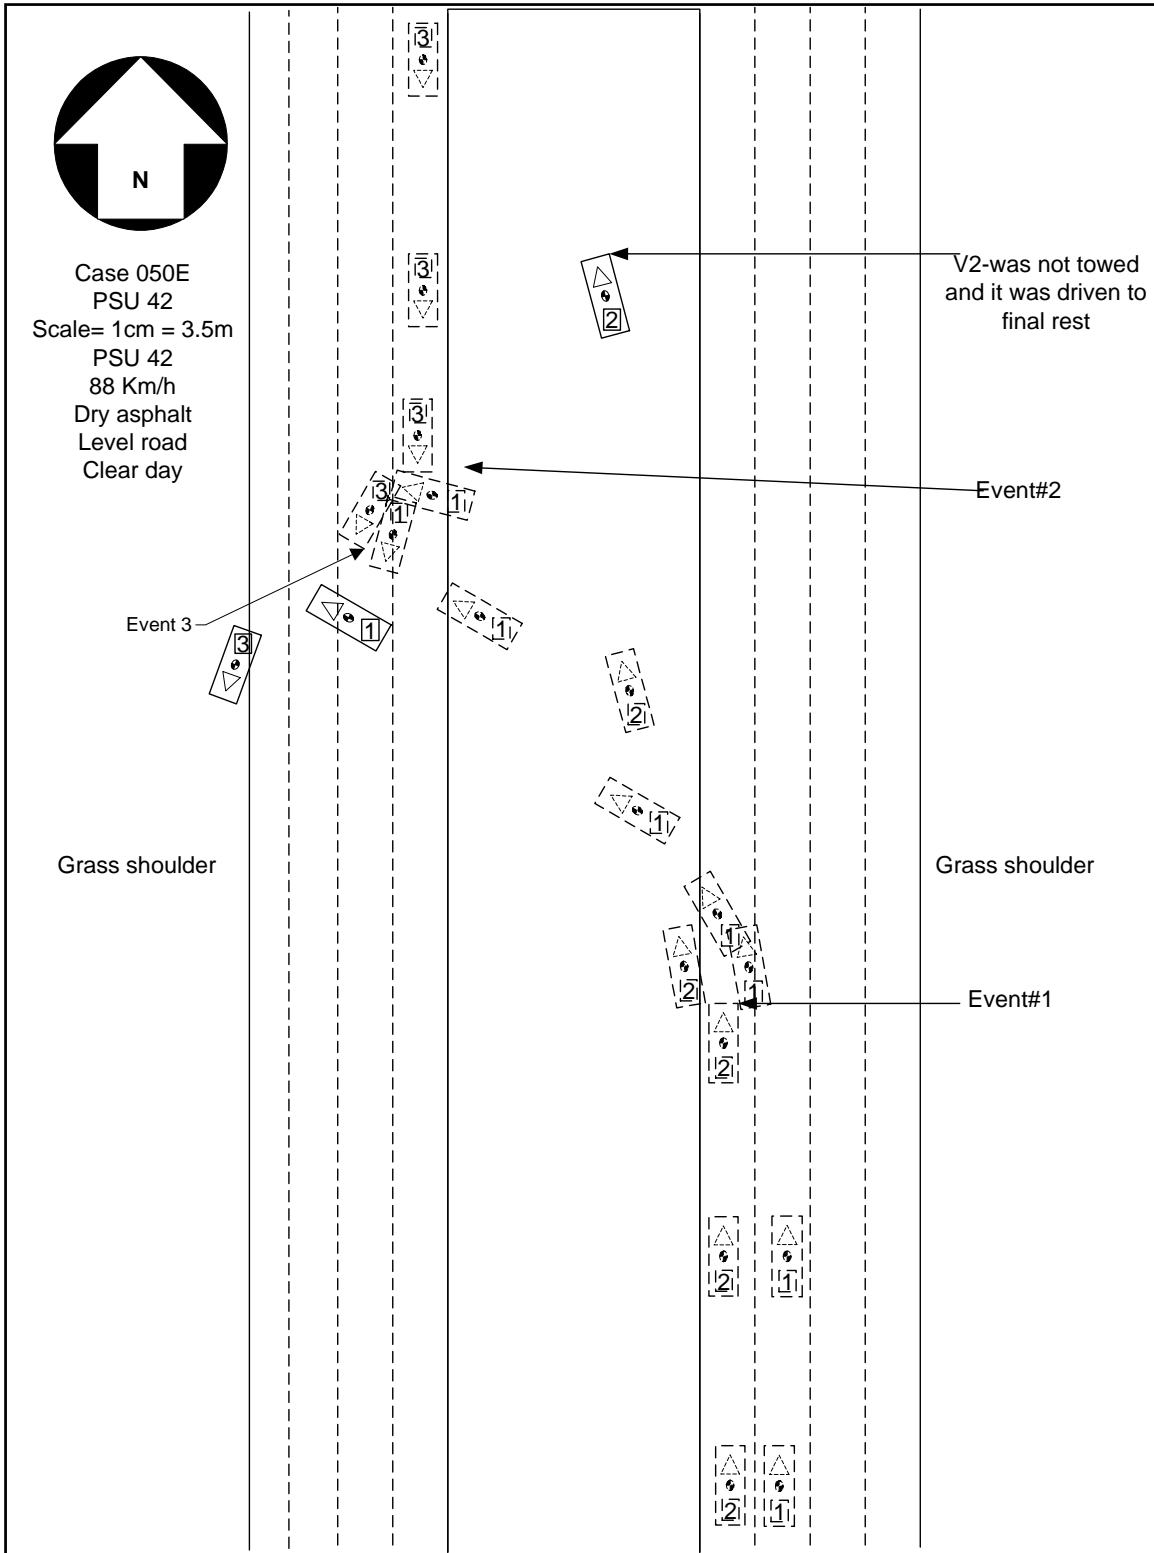
Figure 11. NASS Scene Schematic.

This three-vehicle crash occurred during the morning hours of February 2003 in the state of Florida. At the time of the crash, there were no adverse weather conditions and the asphalt road surface was wet. The crash occurred on the north and south bound lanes of an eight-lane divided state route with four through traffic lanes in each direction. The roadway was bordered by concrete shoulders on both road edges. A grass median that divided the north/south roadway was approximately 16.0 meters (52.0"). The roadway was straight and level at the crash site. The posted speed limit for the roadway was 88 km/h (55 mph). The NASS scene schematic is included as **Figure 16** of this report.
