TRANSPORTATION RESEARCH CENTER

SCI/NASS COMBINATION CERTIFIED ADVANCED 208-COMPLIANT VEHICLE INVESTIGATION

CASE NUMBER - NASS-2003-49-135C
LOCATION - Texas
VEHICLE - 2003 CHEVROLET TAHOE
CRASH DATE - June 2003

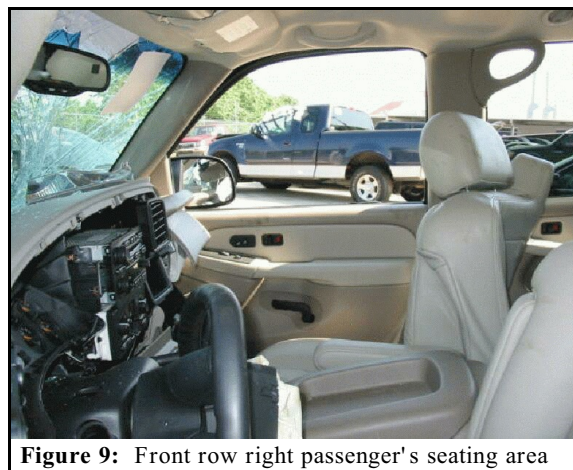
The case vehicle's front right passenger (23-year-old male, white, non-Hispanic, 178 centimeters, 91 kilograms [70 inches, 201 pounds]) was restrained by the available, integrated, manual, three-point, lap-and-shoulder safety belt system. He was in a normal, upright seated posture, with his back against the seat back, his feet on the floor and his hands in an unknown position (**Figure 9**).

Figure 9: Front row right passenger's seating area
