TRANSPORTATION RESEARCH CENTER

SCI/NASS COMBINATION SIDE IMPACT INFLATABLE OCCUPANT PROTECTION REPORT

CASE NUMBER - NASS-2003-49-205A
LOCATION - Texas
VEHICLE - 2001 OLDSMOBILE AURORA
CRASH DATE - September 2003

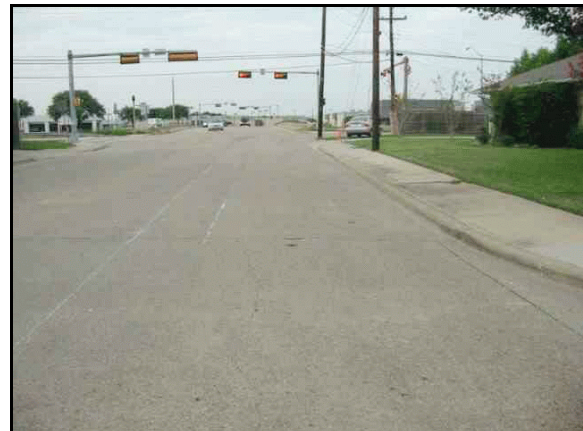
Figure 1: Long view of the case vehicle's northbound approach toward the collision in the intersection

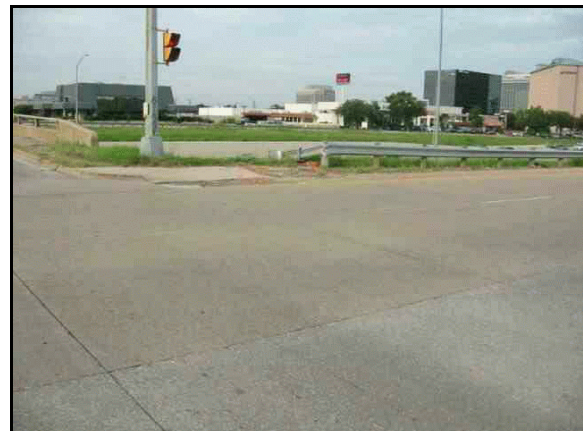
Figure 2: Approximate area of first impact and the case vehicle's post-impact northeasterly trajectory toward final rest against the guardrail

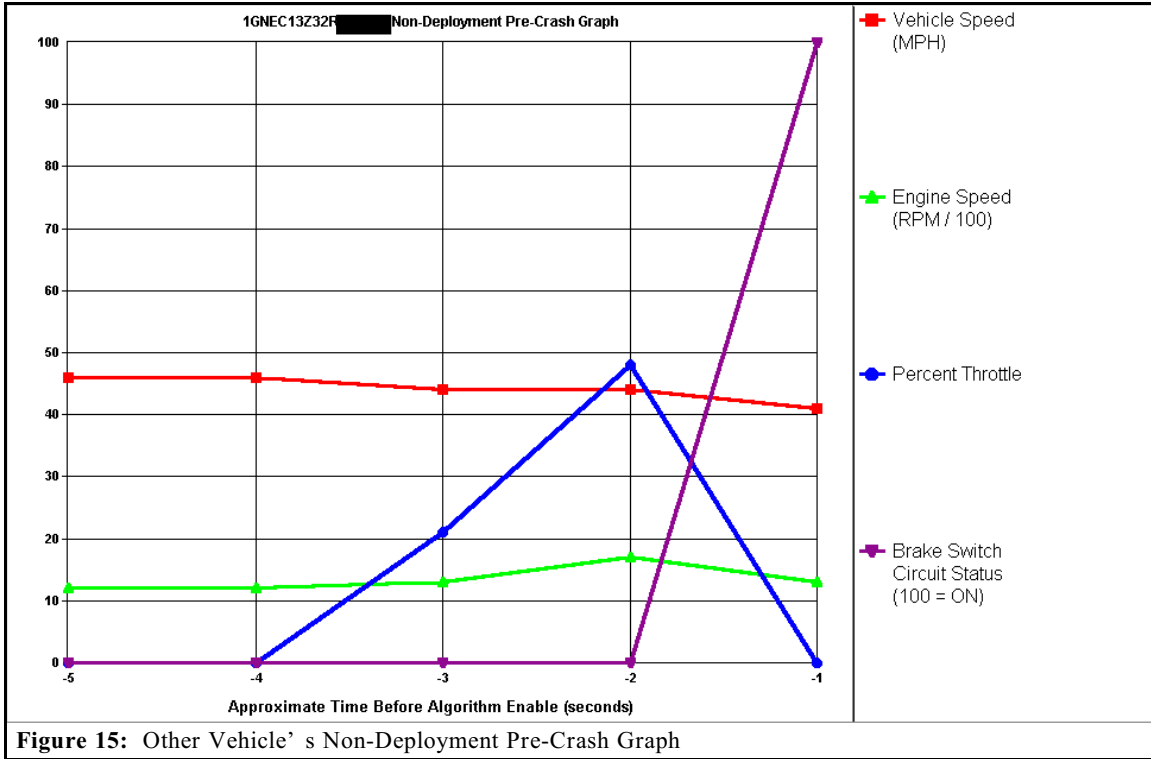
The SDM Pre-Crash Data (**Figure 14**) and the Pre-Crash Graph (**Figure 15**) show that the case vehicle was traveling 74 km.p.h. [46 m.p.h.] with the zero throttle and the brake light circuit off at five seconds prior to algorithm enable. The driver increased throttle input over the next three seconds, to 48 percent, with engine rpm increasing proportionally and with travel speed dropping slightly to 71 km.p.h. [44 m.p.h.] at approximately two seconds prior to algorithm enable. The Tahoe' s driver released the throttle, applied the brakes and the Tahoe' s speed dropped to 66 km.p.h. [41 m.p.h.] at approximately one second prior.

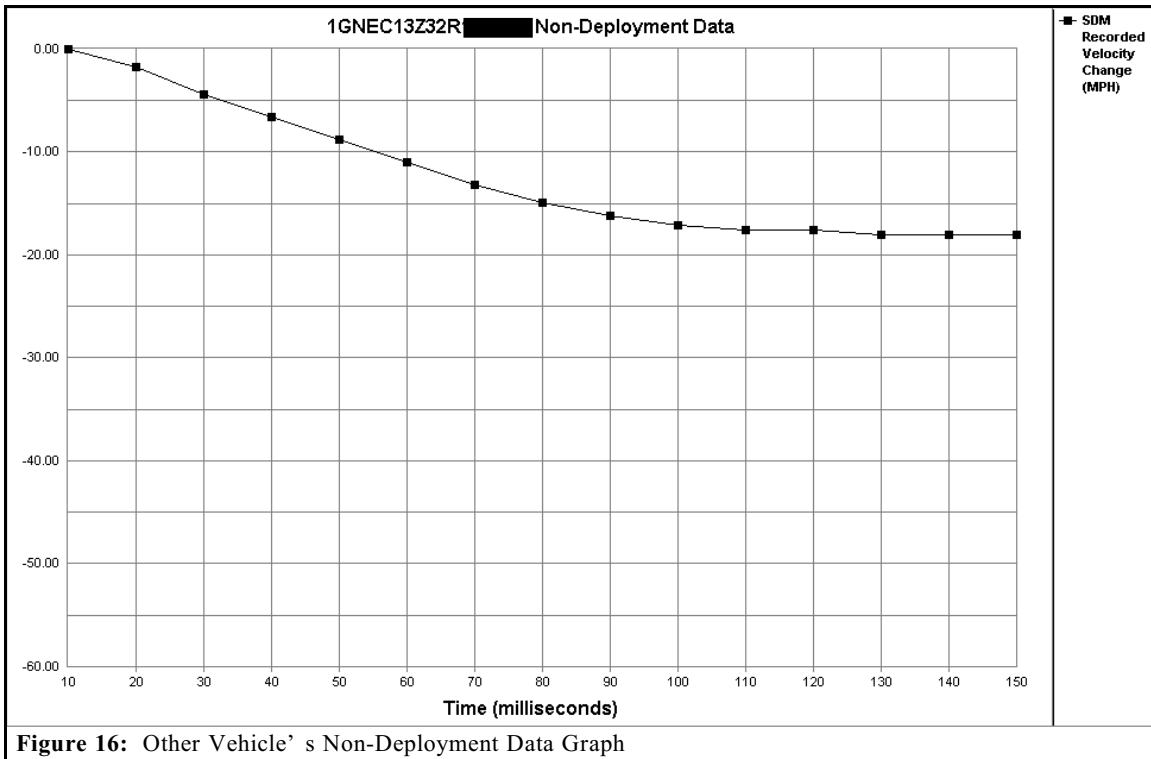
The SDM Non-Deployment Velocity Change Data (**Figure 14**) and Velocity Change Graph (**Figure 16**) show a steep decline to -29.0 km.p.h. [-17.99 m.p.h.] at 130 milliseconds [0.130 seconds]. The data show that this reading was maintained for the interval 130 - 150 milliseconds, after which the SDM stopped recording. The maximum recorded longitudinal velocity change is reported as -29.2 km.p.h. [-18.15 m.p.h.], at 127.5 milliseconds [0.1275 seconds] after algorithm enable. Note, the exact moment of maximum velocity change did not fall on one of the 10 millisecond increments that are reported in the data table (**Figure 14**) or included in the plotted graph (**Figure 16**).
