Combination Child Safety Seat Investigation / Vehicle to Vehicle
Dynamic Science, Inc. / Case Number: 2003-74-110B
1994 Chevrolet Camaro
Nebraska
May, 2003

| 4. Title and Subtitle Combination Child Safety Seat Investigation | | 5. Report Date December 16, 2003 | |
| 16. Abstract This child seat involved crash occurred in Nebraska within the confines of a four-leg intersection in May, 2003 at 1750 hours. The speed limit is 89 km/h (55 mph) for travel north and south. The case vehicle was a 1994 Chevrolet Camaro Z28 convertible driven by an unrestrained 20-year-old male. The convertible top of the vehicle was down at the time of the crash. A 17-month-old male occupied the right rear seat position. The child was seated in a Cosco Alpha Omega convertible child safety seat. The other vehicle was a 2003 Honda CR-V EX four-door sport utility vehicle being driven by a 44-year-old female. This vehicle was equipped with advanced dual stage frontal air bags. The case vehicle was traveling north, approaching the intersection, and began a left hand turn to go west. The other vehicle was traveling southbound. As the Chevrolet Camaro turned it was struck in the right side by the front of the Hon

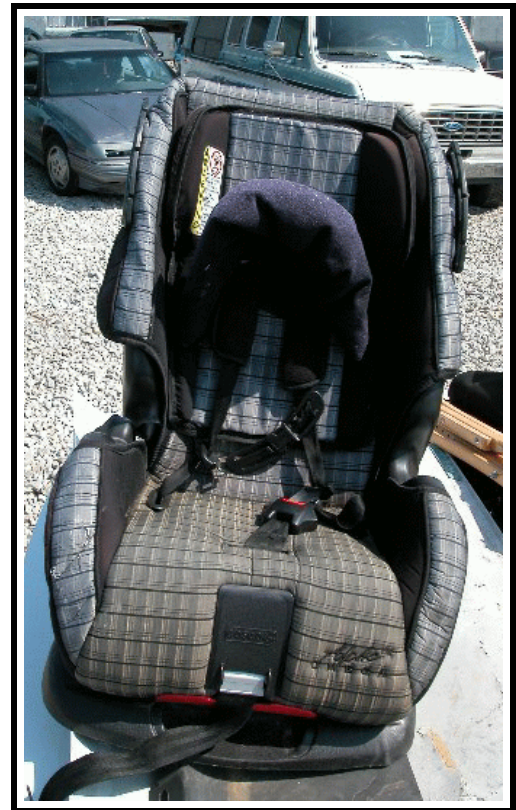
Figure 12. Front, Cosco CSS

The impact and subsequent intrusion fractured and displaced the right side of the shell. The fracture ran vertically down the right side of the shell and compressed the bottom of the base.
