Certified Advanced 208 Compliant Investigation / Single vehicle crash  
Dynamic Science, Inc. / Case Number: 2003-74-186G  
2003 Honda Odyssey  
Nebraska  
October, 2003

1. Report No. 2003-74-186G		2. Government Accession No.		3. Recipient Catalog No.	
4. Title and Subtitle Certified Advanced 208 Compliant Investigation				5. Report Date April 14, 2004

**Dynamic Science, Inc.**  
**Crash Investigation**  
**Case Number: 2003-74-186G**

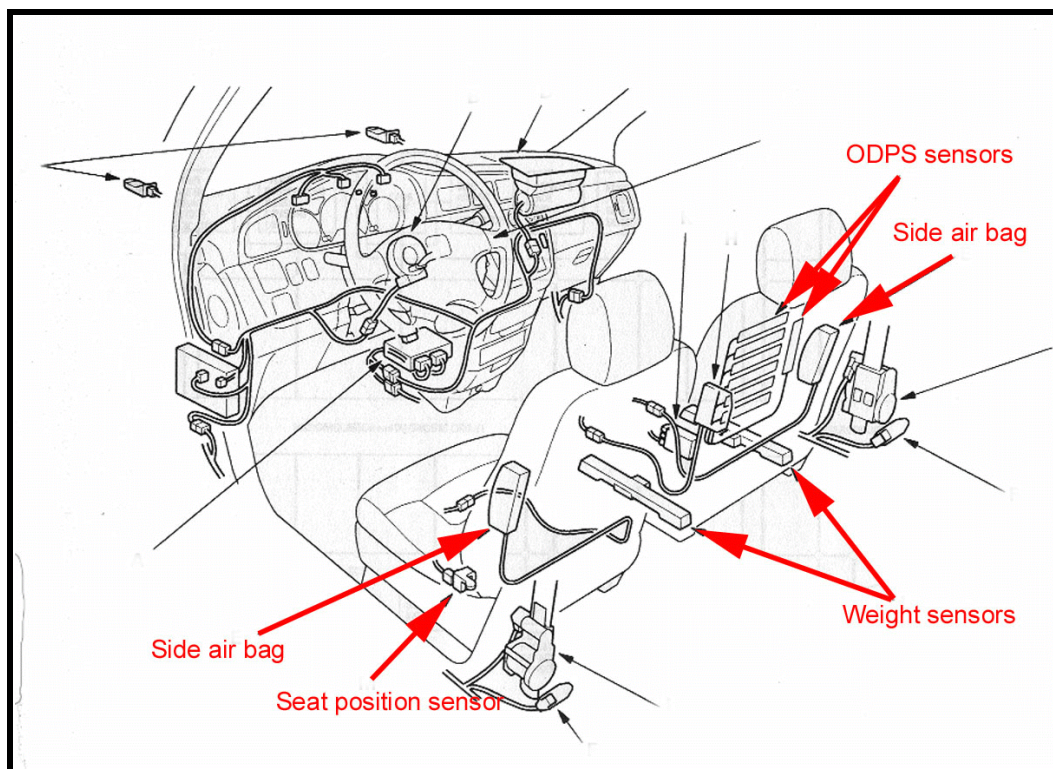
**Figure 11.** Overview of Odyssey air bag system

The vehicle was also equipped with seat back mounted side air bags for the front seat positions. There were no side air bag deployments. The side air bag system includes an Occupant Position Detection System (OPDS) for the front right seat. The system consists of sensors and an OPDS unit in the front passenger's seat back. The passenger's seat-back incorporates position sensors running from top to bottom. These determine the height of the occupant. A further sensor is incorporated into the right seat-back bolster, this determines the lateral position of the occupant. Signals from these sensors allow the OPDS to determine the passenger's seated position. In a side-on collision OPDS can then calculate if it is safe to deploy the side airbag or not. If the OPDS determines that it is unsafe to deploy the side air bag, a cutoff indicator on the instrument panel will alert the driver and the bag will be suppressed. The side impact sensors are located in the lower B pillars.
