TRANSPORTATION RESEARCH CENTER

ON-SITE ADVANCED OCCUPANT PROTECTION SYSTEM INVESTIGATION

CASE NUMBER - IN-03-004
LOCATION - TEXAS
VEHICLE - 2003 NISSAN ALTIMA S
CRASH DATE - December 2002

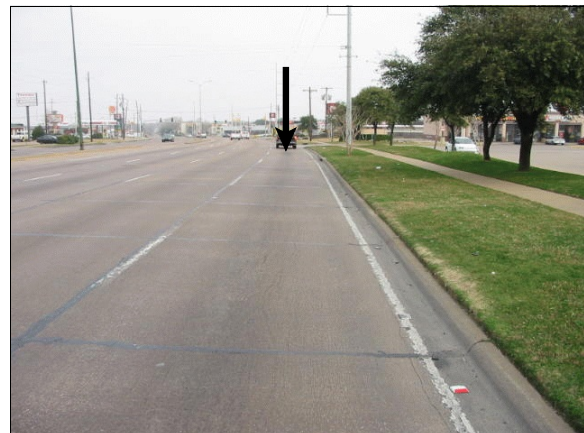
Figure 1: Case vehicle’s northerly travel path in outside northbound lane of northbound roadway; Note: arrow indicates approximate point of impact and roadway begins to curve gently leftward (case photo #01)

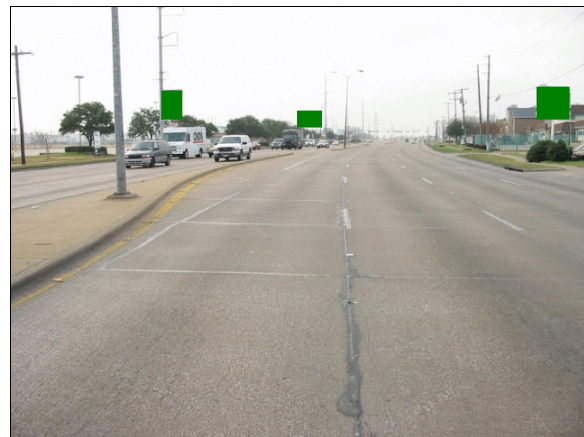
Figure 2: Approximate location of crash’s initial impact between Ford SUV and GMC pickup near beginning of southbound roadway’s left-hand turn lane (case photo #05)

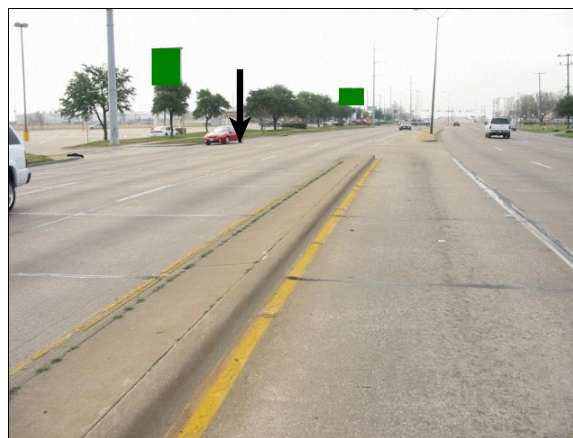
Figure 3: Ford's and GMC's south-southeasterly travel path from southbound left-hand turn lane diagonally across median, northbound lanes, and four-leg intersection into impact (arrow) in outside northbound lane (case photo #07)

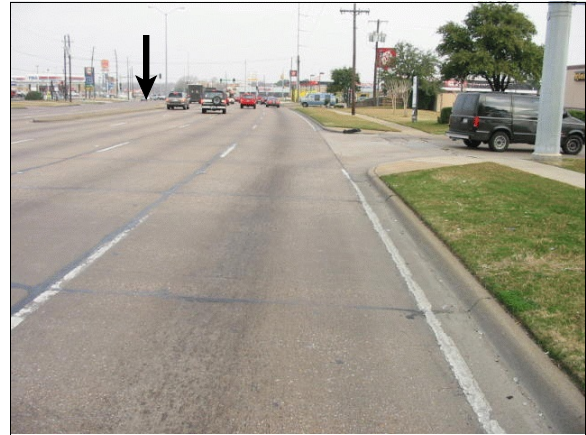
Figure 4: Approximate area of impact between case vehicle and Ford; Note: arrow indicates approximate location of initial impact between Ford and GMC (case photo #03)

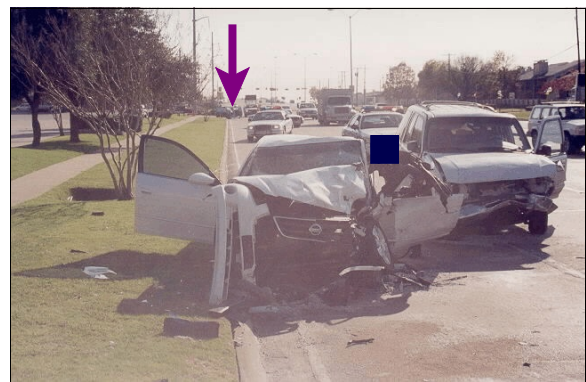
Figure 6: On-scene police photo looking south in outside through lane of northbound roadway showing final rest positions of case vehicle and Ford SUV; Note: arrow indicates final rest position of GMC pickup (case photo #60)

Based on the police photographs and this contractor's inspection of the case vehicle, this contractor believes that the extensive damage sustained by the case vehicle could not have been caused solely by an impact from the Ford (**Figures 5, 6, and 7**). As a result, this contractor believes that the Ford's impact with the back (**Figure 8** below) of GMC pickup (1st event) involved sustained contact, and the Ford pushed the GMC diagonally across the median and roadways and into the northbound roadway's outside through

The GMC pickup continued in a south-southeasterly direction after impacting the case vehicle. The GMC traveled a considerable distance (not measured) from its impact with the case vehicle to its final rest position, approximately a city block away (Figure 6 above). In this contractor's opinion, the GMC's driver must have accelerated for unknown reasons, either intentionally or unintentionally, because the GMC departed the right (eastern) side of the northbound roadway and obliquely traversed the grassy roadside (Figures 13 and 14), most likely traveling along a sidewalk bordering the roadway before finally re-entering the northbound roadway where it came to rest heading southwest in the junction of a commercial driveway and the northbound roadway straddling the outside north- bound lane (Figure 15).

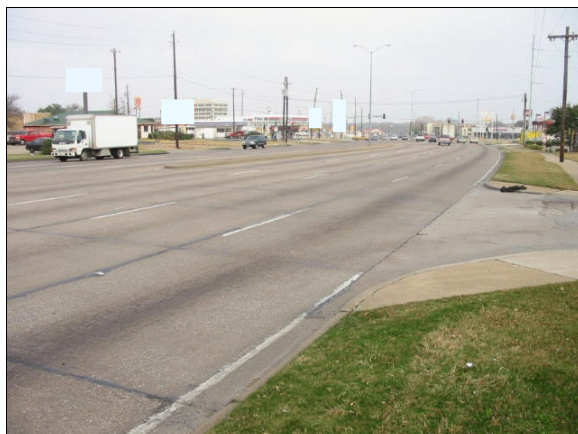
lane (Figure 9). It is this contractor's opinion that the front (Figure 10) of the GMC pickup (2nd event) impacted the case vehicle's front and left sides (Figure 7 above) and that the GMC was in sustained contact with and being pushed south-southeasterly by the Ford. It is unclear whether the Ford and GMC had exactly the same heading angle or whether the GMC's heading angle was slightly clockwise relative to the Ford's. In this contractor's opinion, the GMC was redirected along the case vehicle's left fender, eventually separating from the case vehicle as it continued southward. Next, the front left of the case vehicle was impacted (3rd event) by the front of the Ford (Figure 11). The case vehicle's driver and front right supplemental restraints (air bags) deployed, most likely as a result of the impact with the GMC.

Figure 9: North-northwesterly view of Ford's and GMC's south-southeasterly, diagonal, travel path across northbound lanes, through four-leg intersection, and into impact with case vehicle (case photo #11)

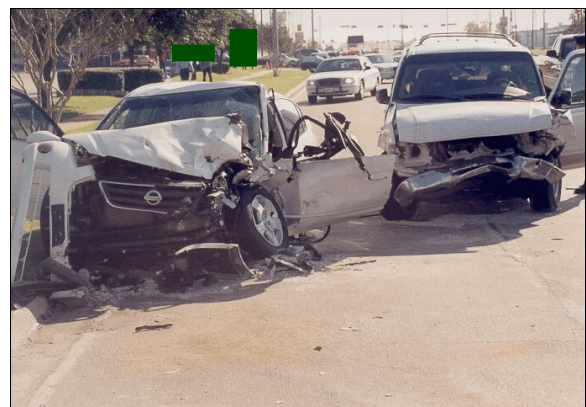
Post-Crash: Based on the on-scene police photographs, the case vehicle was redirected to its right and came to rest against the curb near its initial point of impact (Figure 11). As a result of impacting the case vehicle, the Ford rotated approximately 140 degrees counterclockwise. Subsequently, the Ford's right quarter panel side slapped (4th event) the case vehicle's left quarter panel. The two vehicles separated, and the Ford

Figure 11: On-scene police photo looking south in outside through lane of northbound roadway showing final rest positions of case vehicle—against curb, and Ford SUV—straddling center and outside through lanes (case photo #61)

came to rest heading north, straddling the right center and outside through lanes of the northbound roadway (Figure 11 above and Figure 12).

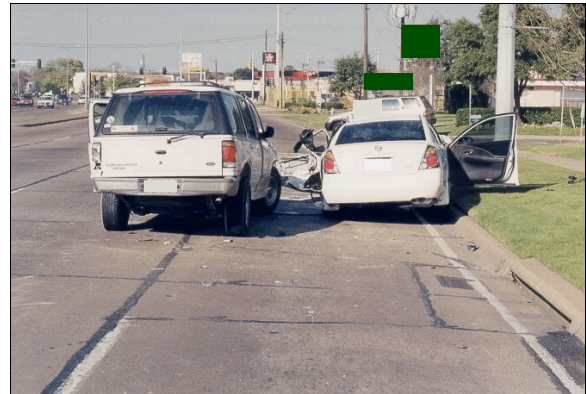
Figure 12: On-scene police photo looking north in outside through lane of northbound roadway showing final rest positions of case vehicle—against curb and Ford SUV—straddling right center and outside lanes (case photo #65)

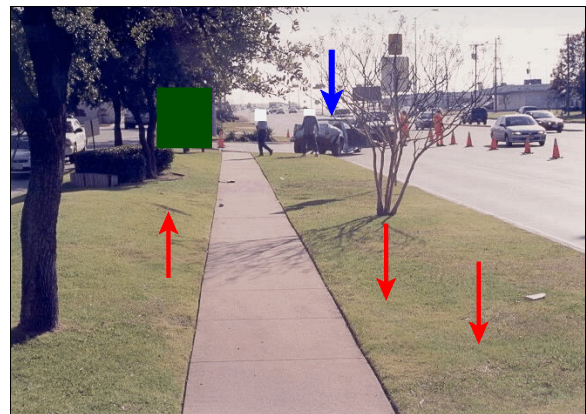
Figure 13: On-scene police photo looking south along sidewalk on east roadside showing (blue arrow) GMC pickup's final rest position on roadway and tire marks (red arrows) on roadside (case photo #66)

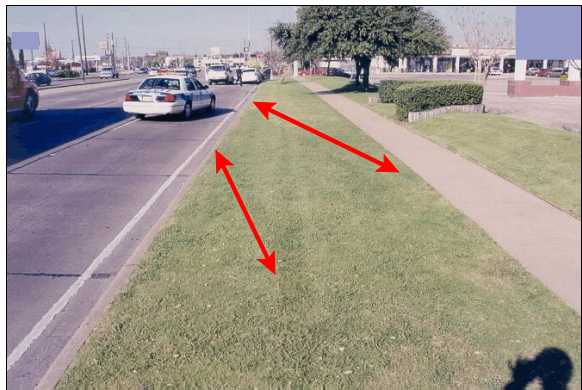
Figure 14: On-scene police photo looking north along eastern roadside showing case vehicle and Ford SUV at final rest and tire marks from GMC pickup in grass (case photo #67)

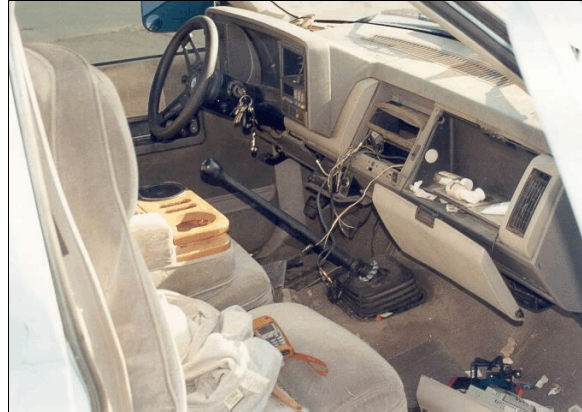
Braking was achieved by a power-assisted, front disc and rear drum, rear anti-lock system. The GMC's wheelbase was 298 centimeters (117.5 inches), and the odometer reading is unknown because the GMC's interior was not inspected. Furthermore, the vehicle was not equipped with front occupant supplemental restraints (air bags), but there were manual, three-point, lap-and-shoulder, safety belt systems for the front outboard seating positions (**Figure 31**). The interior was equipped with bucket seats for the driver and front right passenger.

Figure 31: On-scene police photo showing GMC pickup's front seating area (case photo #72)
